June 28, 2023

# Burnaby Midtown Bikeway Assessment Ride

The Burnaby Local Committee of HUB Cycling conducted an assessment ride of Burnaby's segment of the Midtown Bikeway on Saturday, May 6th, 2023. In its current form, Burnaby's portion of the Midtown Bikeway is lacking or missing features that make it an "All Ages and Abilities (AAA)" bike route.

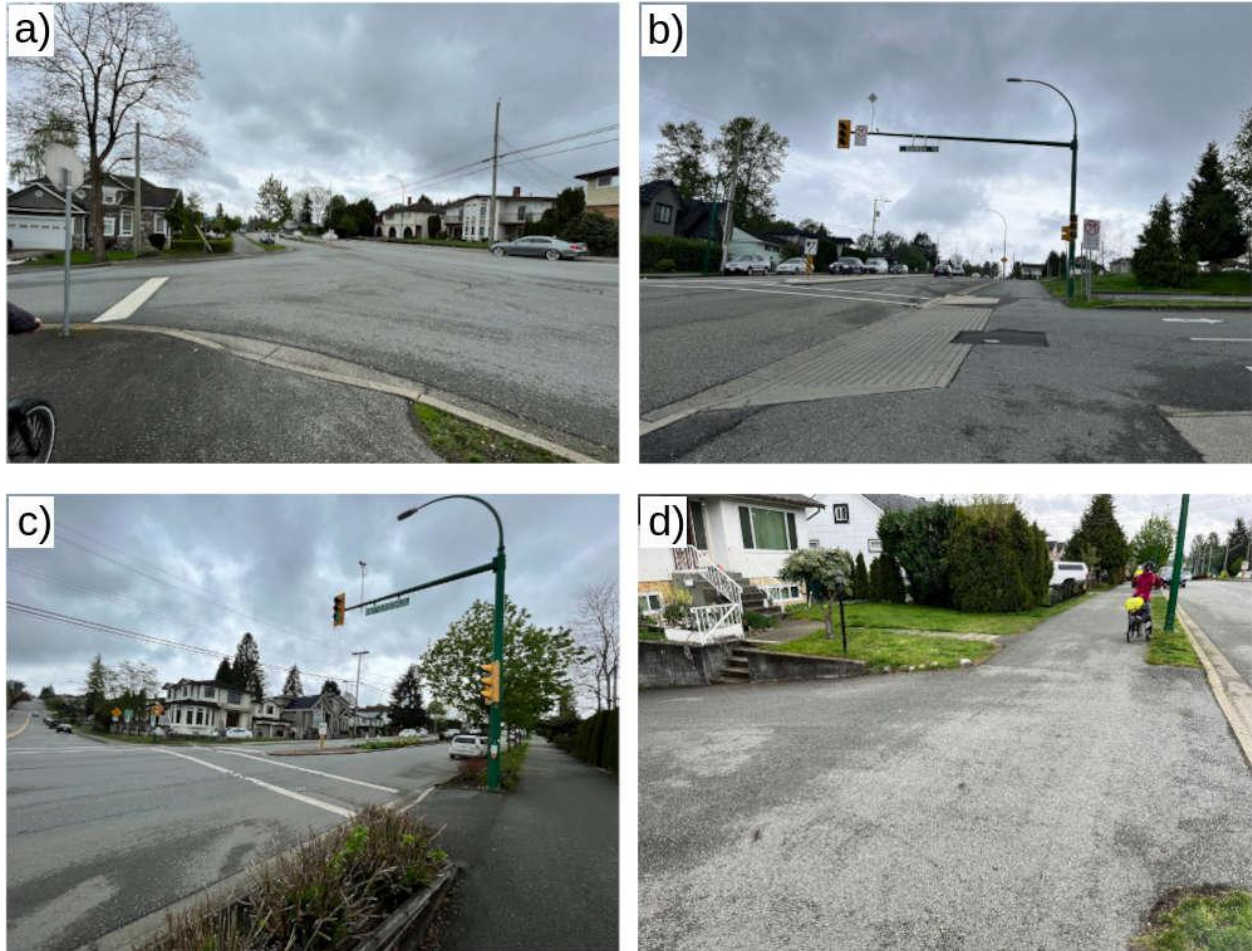
Riding along the Midtown Bikeway, the assessment team noticed fourteen crossings with missing road markings such as green conflict paint or elephant's feet (dashed line). Examples are provided in Figure 1. Approaching such intersections or driveways, the assessment team often felt:

**Figure 1.** a) Intersection at Moscrop and Inman with no elephant's feet or green conflict paint. b) Crossing at Moscrop Secondary School driveway without green conflict paint. c) Crossing at Patterson and Moscrop connecting two segments of the Sea to River Bikeway does not have elephant's feet or green conflict paint. d) Residential driveway without green conflict paint or other markings.

Notwithstanding City of Burnaby's current standard limiting use of green conflict paint to bike-only paths, the assessment team suggests that paint be used to highlight conflict zones at crossings and driveways on official bike paths and multi-use pathways (MUPs). This is how paint is used in other municipalities, with effect (Figure 2).

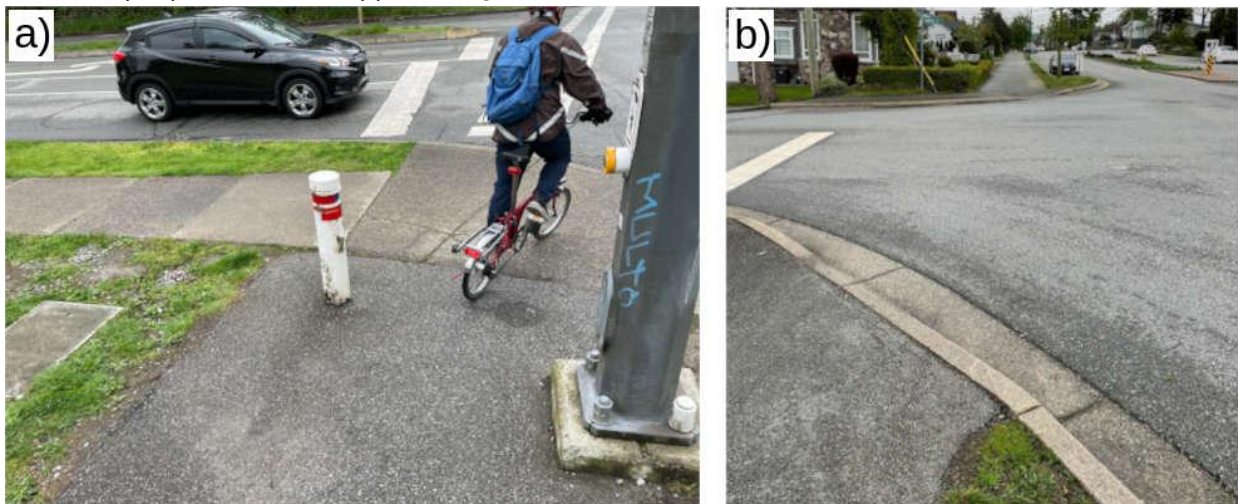
Along Moscrop St between Boundary Rd and Willingdon Ave, all road crossings have curb drops that are angled diagonally out towards the center of the intersection and are too narrow. There is also an angled curb drop at the Deer Lake Ave and Waybourne Dr intersection.

These angled, narrow curb drops are not wide enough to accommodate bidirectional traffic. This can result in conflicts between people riding bicycles traveling in opposite directions, as well as with people walking or using other mobility devices like wheelchairs. They also impose unnecessary bike maneuvering when a bike rider's attention should be focused on looking for people walking, sharing the MUP, and people in vehicles approaching to cross the intersection.

**Figure 3.** a) Angled curb drop at Deer Lake Ave and Waybourne Dr. Note that the bollard and light pole add to the

navigating difficulty to reach the angled drop. b) Example of angled curb drop on Moscrop St.

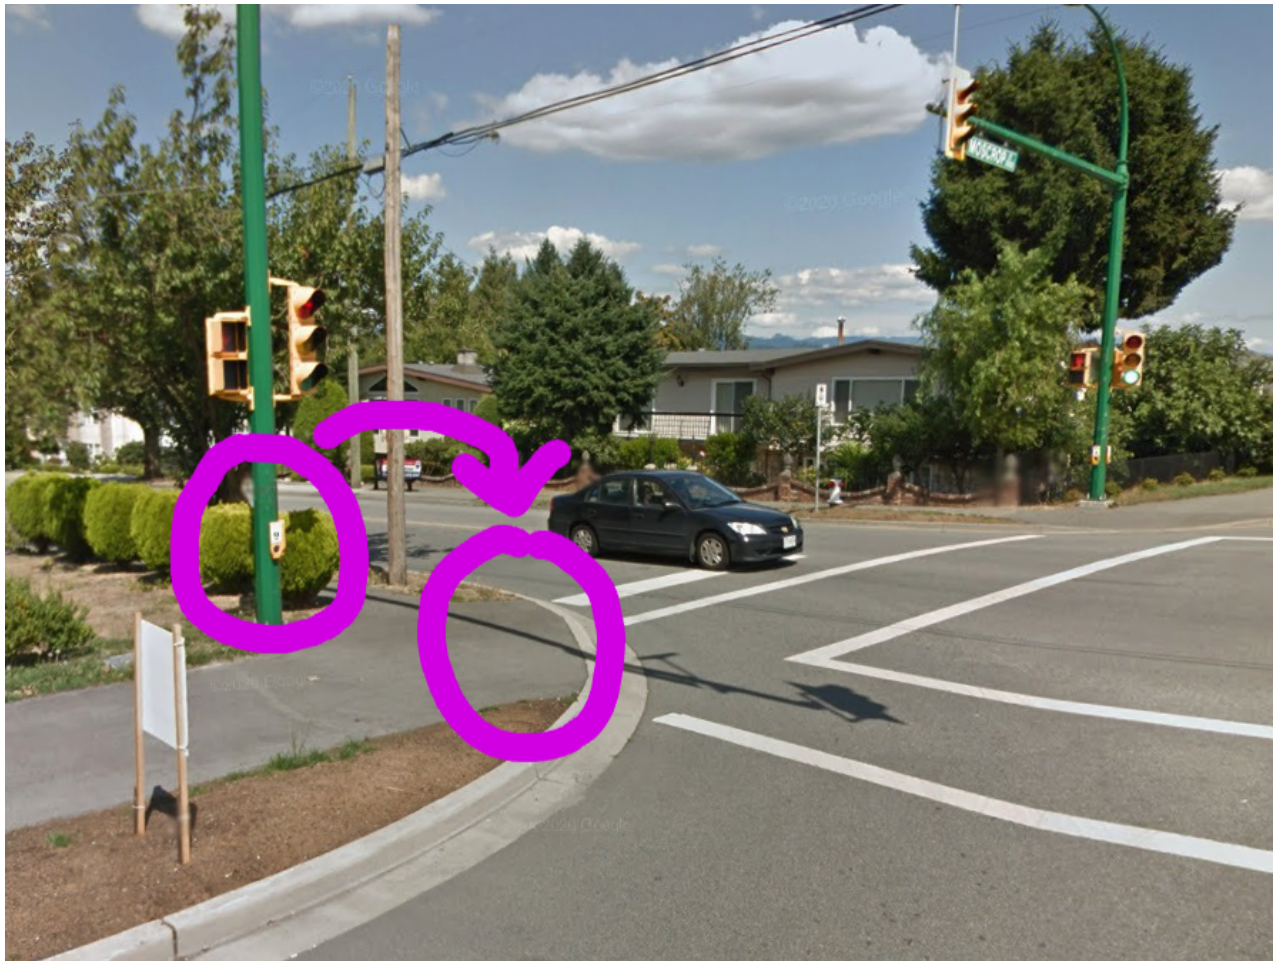
There are a number of intersections along the route where people on bikes have to cross into oncoming people walking on the sidewalk or on wheelchairs to press the call button. This increases the risk of conflict with people walking, people using wheelchairs, and other people on bikes or other modalities of travel. Having a call button on each side of the MUP would reduce the risk of collisions around intersections.

**Figure 4.** MUP on the Northwest corner of Moscrop St and Smith Ave. Purple arrows show the suggested location for the call button.

People riding bikes and people walking as well as using wheelchairs could enjoy better and safer travels if, instead of using call buttons, a crossing phase was built into every cycle. The City can also consider using ground-activated call buttons like what is used in New Westminster (Eighth St and 8th Ave intersection), Victoria, Calgary, and Edmonton. Figure 5 shows a case study of this system.

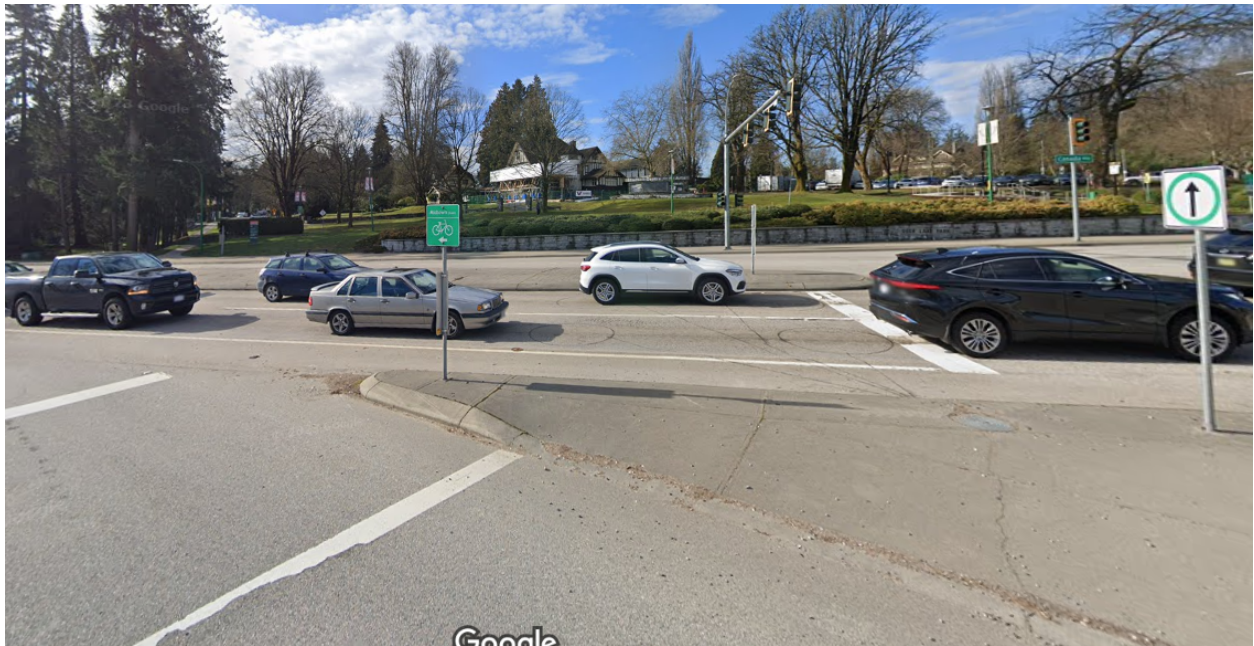
When crossing Canada Way eastbound, the assessment team first saw the "Do Not Enter" signs at Gilpin St and only later noticed the much less prominent bike route sign. One Midtown Bikeway arrow sign at the Canada Way intersection points in the wrong direction (Figure 7).

**Figure 7.** The Midtown Bikeway sign points to the left, which is towards oncoming Canada Way traffic.

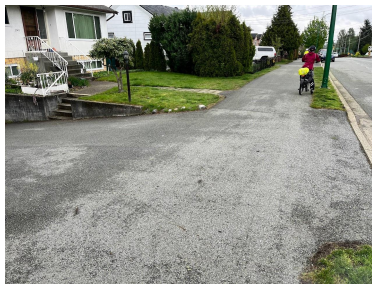
Issue code	Issue description	Photo	Location	Safety/ Comfort Level Impact (High, Medium, Low)
<b>SEGMENT 1 - BOUNDARY RD. TO WILLINGDON AVE.</b>				
1.1	Residential alley with no pavement markings.

Along Moscrop St.	Low

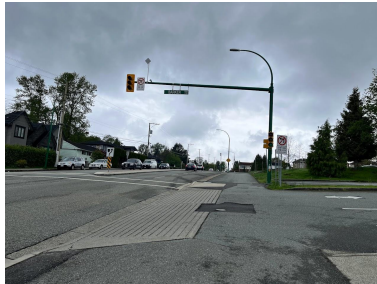
Issue code	Issue description	Photo	Location	Safety/ Comfort Level Impact (High, Medium, Low)
1.2	No elephant's feet markings.

All crossings along Moscrop St. MUP with side streets between Boundary Rd. and Willingdon Ave.  Moscrop St. MUP beside Moscrop Secondary	Medium
1.3	Pothole indent in the ground

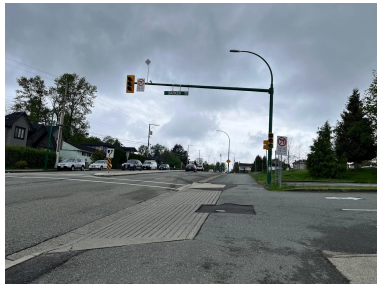
Moscrop St. MUP beside Moscrop Secondary	Medium
1.4	No directional signage to let people cycling southbound on Carleton Ave. know to use the MUP along Moscrop St. to continue down along Patterson Ave.

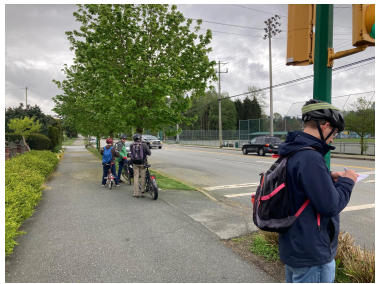
Moscrop St. and Patterson Ave./Carleton St.	Medium

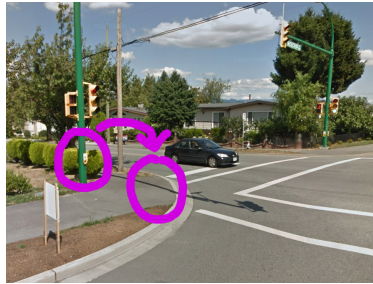
Issue code	Issue description	Photo	Location	Safety/ Comfort Level Impact (High, Medium, Low)
1.5	Add a call button to the South side of MUP, replace call buttons with pre-timed crossing signals, or consider ground-activated call buttons.

Eastbound Moscrop at Smith	Low

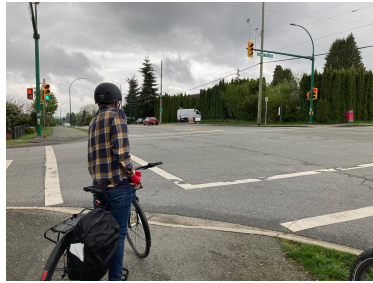
1.6	Curb cuts at crossings are angled and do not allow people cycling to easily go straight along the MUP at intersections.

All crossings along Moscrop St. MUP with side streets between Boundary Rd. and Willingdon Ave.	High

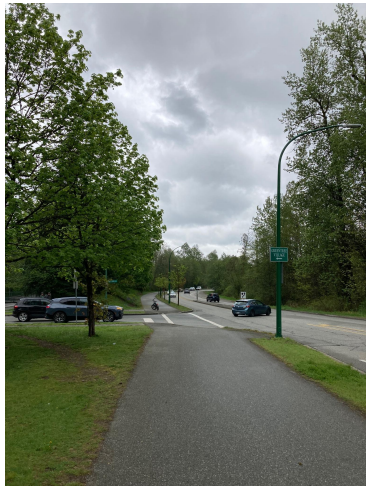
Deer Lake Ave. and Waybourne Dr.	High
<b>SEGMENT 3A - GARDEN GROVE DR. TO DEER LAKE AVE. VIA MOSCROP &amp; GILPIN ST.</b>				
3a.1	No pavement markings or signs indicating bike crossing.

Moscrop St. at Garden Grove Dr.	Medium

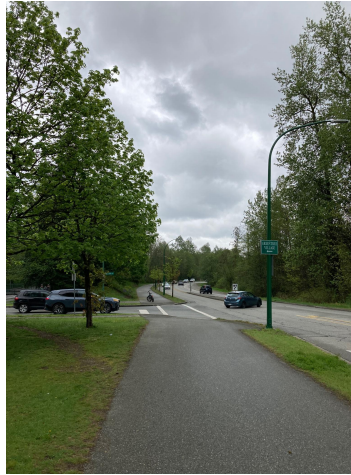
Issue code	Issue description	Photo	Location	Safety/ Comfort Level Impact (High, Medium, Low)
3a.2	No directional signs indicating the option for the turn-off onto Garden Grove Dr to access Moscrop St/Midtown Bikeway, or continuation along Deer Lake Pkwy. A bypass sign might be appropriate to allow people cycling to choose an AAA route (Deer Lake Pkwy) over Gilpin St.

<p>Looking east from Deer Lake Pkwy.</p>	Deer Lake Pkwy at Garden Grove Dr.	High
3a.3	No directional signs to indicate bike route, for both eastbound and westbound directions of the bikeway.

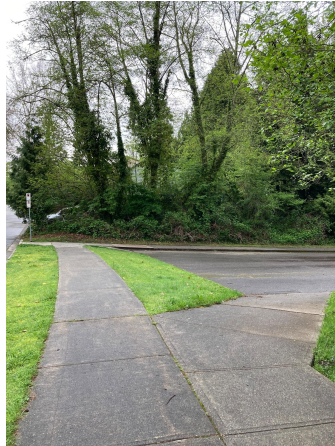
<p>Looking north from Garden Grove Dr.</p>	Garden Grove Dr. at Moscrop St.	High

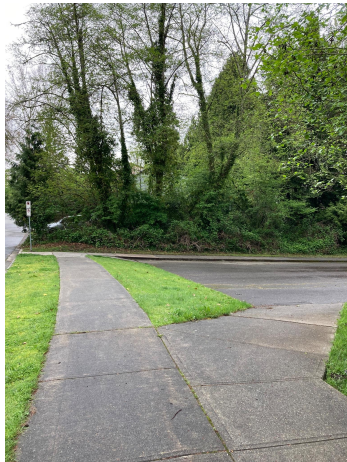
Issue code	Issue description	Photo	Location	Safety/ Comfort Level Impact (High, Medium, Low)
3a.4	No shared pathway signs or bike accommodations; people cycling are forced to ride on the sidewalk to access the bike route on Moscrop St.

<p>Looking north from Garden Grove Dr.</p>	Garden Grove Dr. at Moscrop St	Medium
3a.5	No pavement markings.

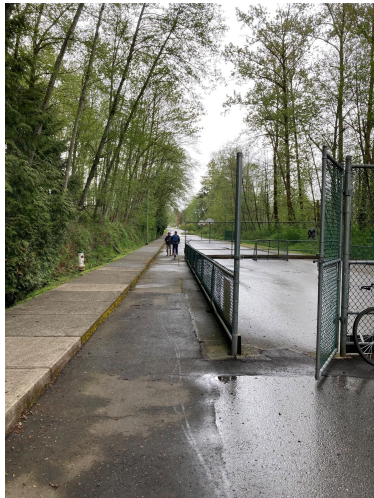
<p>Looking east along Moscrop St.</p>	4900 block of Moscrop St.	Low

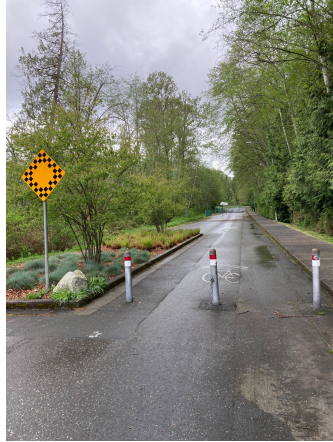
Issue code	Issue description	Photo	Location	Safety/ Comfort Level Impact (High, Medium, Low)
3a.6	Sharrow pavement marking is outdated and unidirectional.

4900 block of Moscrop St.	Low
3a.7	No bike infrastructure along Gilpin St. Road can be busy during rush hour and school time. Parked cars force people on bikes into traffic. 30 km/h speed limit from 7am to 10pm Monday to Friday, but no other speed control implementations (e.g. speed humps, road narrowing, protected bike lanes).

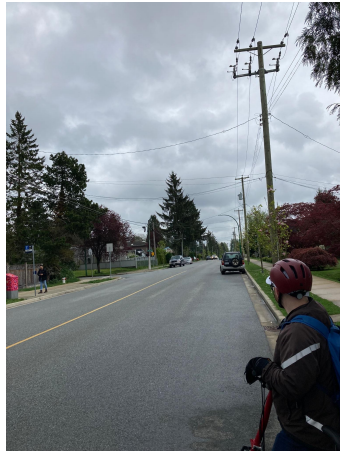
Looking east along Gilpin St.	Gilpin St. between Royal Oak Ave. and Deer Lake Pkwy.	Medium

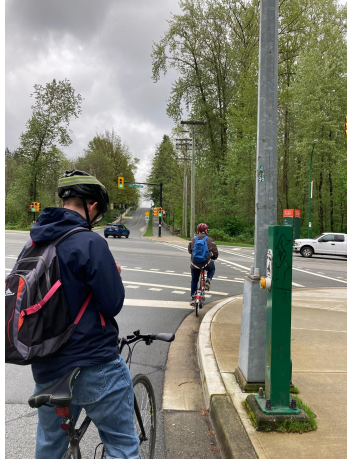
Issue code	Issue description	Photo	Location	Safety/ Comfort Level Impact (High, Medium, Low)
3a.8	<p>No directional sign or pavement markings directing people cycling from Gilpin St. to proceed onto the MUP on the west side of Deer Lake Pkwy.</p> <p>Well-placed bicycle call button.</p>

<p>Looking east on Gilpin St.</p>	Gilpin St. at Deer Lake Pkwy.	Low
<b>SEGMENT 3B - GARDEN GROVE DR. TO DEER LAKE AVE. VIA DEER LAKE PKWY.</b>				
3b.1	<p>Dangerous blind spot at the slip lane. People cycling can not see cars coming southbound on Royal Oak Ave. and turning right along the slip lane onto Deer Lake Pkwy. westbound. Drivers also can not see people cycling around the blind corner.</p>

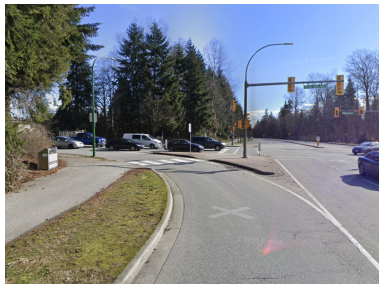
Deer Lake Pkwy. at Royal Oak Ave.	High

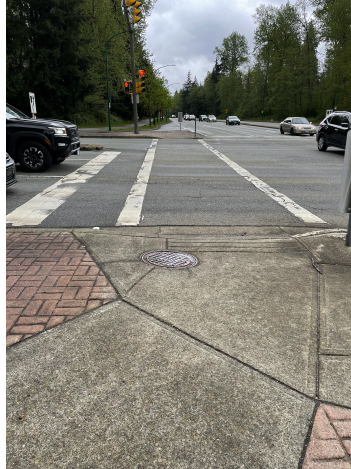
Issue code	Issue description	Photo	Location	Safety/ Comfort Level Impact (High, Medium, Low)
3b.2	No elephant's feet at the busy intersection and the two slip lanes on both the west and east sides.

Deer Lake Pkwy. at Royal Oak Ave.	High
3b.3	Lack of lighting

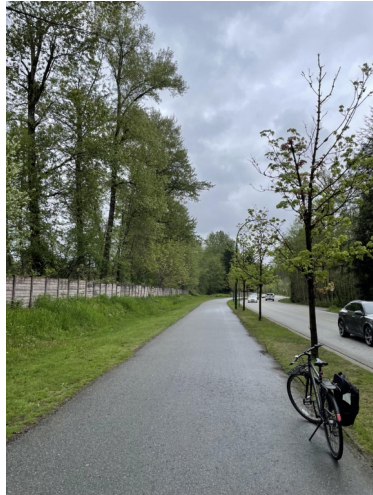
Deer Lake Pkwy, East of Royal Oak Ave	High
3b.4	Add a call button to the East side of MUP, to activate both Northbound and Eastbound pedestrian/bike signals, replace call buttons with pre-timed crossing signals, or consider ground-activated call buttons.

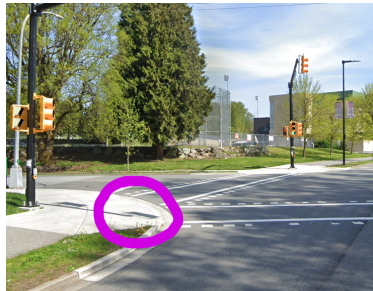
Eastbound and Northbound MUP at Deer Lake Pkwy, Deer Lake Ave, and Gilpin	Medium

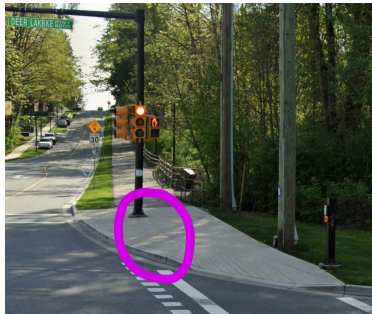
Issue code	Issue description	Photo	Location	Safety/ Comfort Level Impact (High, Medium, Low)
3b.5	Add a call button to the North side of MUP, to activate Westbound ped/bike signal, replace call buttons with pre-timed crossing signals, or consider ground-activated call buttons.

Westbound MUP on Deer Lake Ave/Gilpin, at Deer Lake	Medium
<b>SEGMENT 4 - DEER LAKE AVE. TO CANADA WAY</b>				
4.1	MUP narrows between bus stop and flower bed

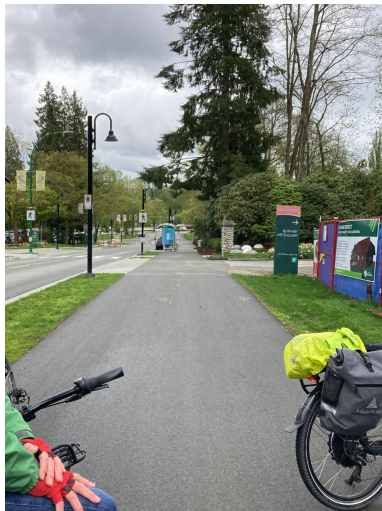
Bus stop Rowan Ave, south side of Deer Lake Ave.	Medium

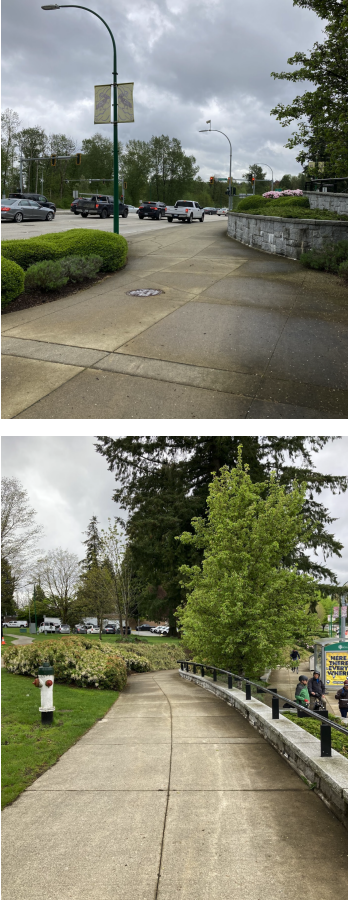
Issue code	Issue description	Photo	Location	Safety/ Comfort Level Impact (High, Medium, Low)
4.4	No pavement markings indicating people cycling can bike on the path.

Near Canada Way and Kensington Ave.	Medium

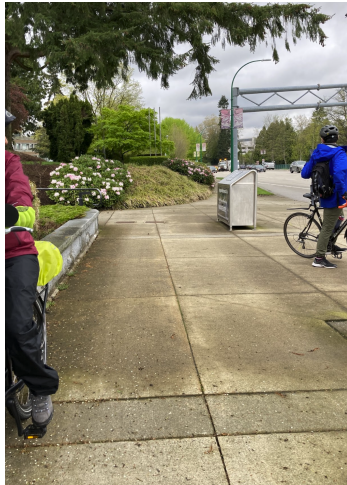
Issue code	Issue description	Photo	Location	Safety/ Comfort Level Impact (High, Medium, Low)
4.5	Narrow sidewalk and sharp corner. Potential conflict between people cycling, and also between people cycling and pedestrians.

Near Canada Way and Kensington Ave.	Medium
4.6	Add a call button to the East side of MUP, or replace call buttons with pre-timed crossing signals.

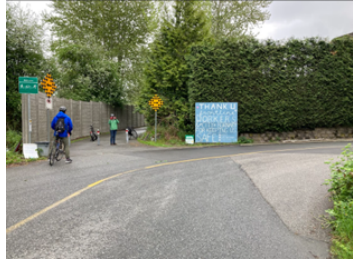
Issue code	Issue description	Photo	Location	Safety/ Comfort Level Impact (High, Medium, Low)
5.2	Blind corner at Claude and Wilton when traveling West and no sightlines for people cycling traveling East on Midtown and entering Claude Ave.

Corner of Claude and Wilton.	High
5.3	No directional signs to indicate bike route when exiting MUP. No pavement marking.

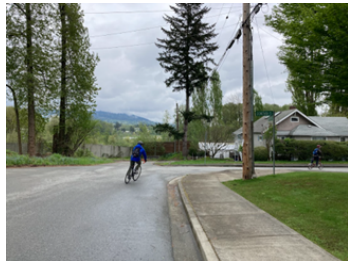
Corner of Claude Ave and Rayside St.	Medium
5.5	No directional signs to indicate bike route. No pavement marking.

Corner of Rayside St. and Donovan Ave.	Medium

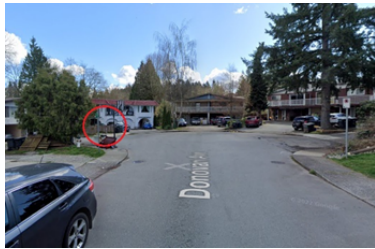
Issue code	Issue description	Photo	Location	Safety/ Comfort Level Impact (High, Medium, Low)
5.6	Entrance to MUP well hidden at the end of the cul-de-sac. More prominent marking recommended.

5600 Block Donovan Ave.	Medium
5.7	Midtown Sign for Eastbound travelers, but no wayfinding or directional signage for Westbound Travelers. Travelers unsure of whether the gravel path on the left of the road is appropriate or if they are to continue on the road. No pavement marking.

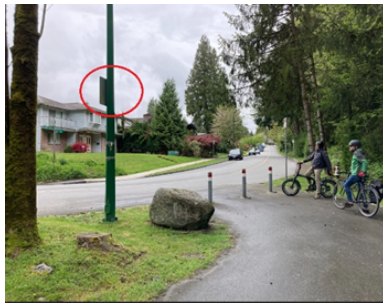
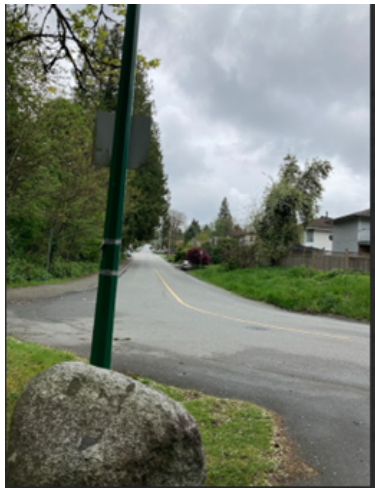
6th Street and Burris St.	High

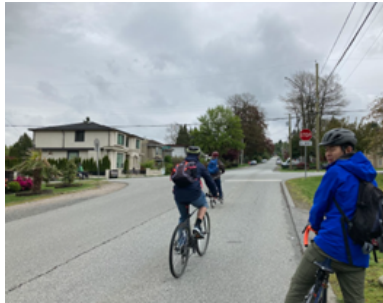
Issue code	Issue description	Photo	Location	Safety/ Comfort Level Impact (High, Medium, Low)
5.8	No directional sign or pavement markings directing bikes from 6th St. to Nursery in either direction.

6th St. and Nursery Ave.	Medium
5.9	No directional signs or pavement markings at Nursery St and Lakefield Dr		Nursery St and Lakefield Dr.	Medium
5.10	No pavement markings from Lakefield Dr to 4th St. Add sharrows		Lakefield Dr between Nursery St and 4th St	Medium
5.11	Elwell is inaccessible to people cycling but marked an alternate cycling route with pavement markings.

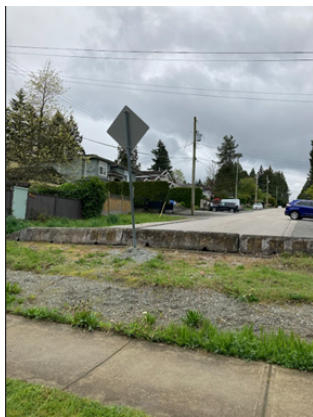
4th St. and Elwell St.	High

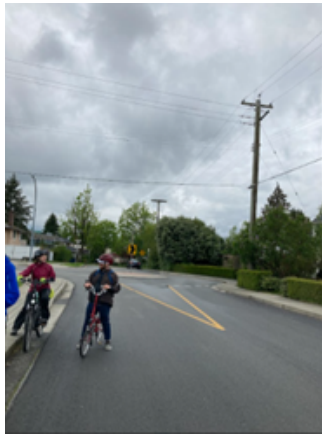
Issue code	Issue description	Photo	Location	Safety/ Comfort Level Impact (High, Medium, Low)
5.12	No wayfinding at 4th St. and Edmonds St. No pavement markings.

4th St. and Edmonds St.	Medium
<b>SEGMENT 6 - ROBERT BURNABY PARK TO 13TH AVE.</b>				
6.1	No wayfinding signage along this section.		Entire section	Medium
6.2	No pavement markings indicating this is a bike route. Add sharrows		Entire section	High
6.3	No directional signage indicating the continuation of the Midtown Bikeway, both from 13th Ave. (going southeast) and from 4th St. (going southwest)

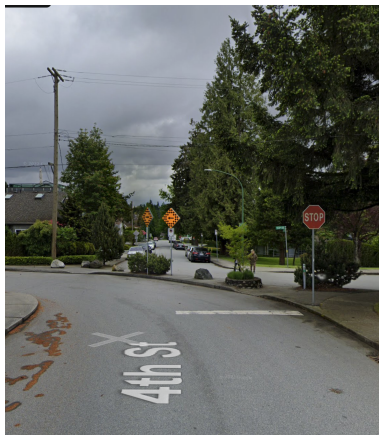
4th St. and 13th Ave.	Medium
