Inspection Ride Report for the 47a Avenue/River Road West Cycling Route by Kathy Bossort, February 21, 2015

Introduction

This report describes inspection rides for 47a Avenue and River Road West, the east-west connector from Ladner to Delta Municipality's western border at Roberts Bank. (See Map 1 for outline of route marked in red)

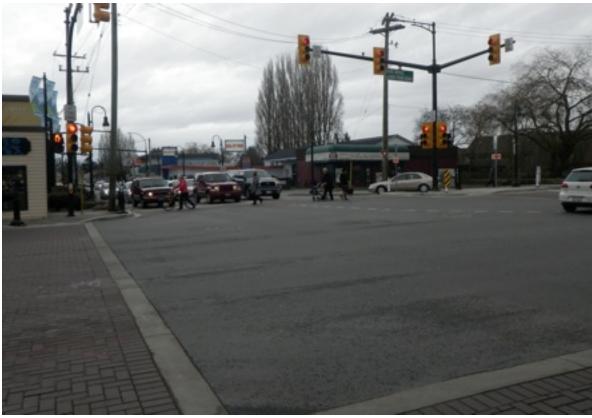
Photo 1: Intersection at Ladner Trunk Road and 47a Avenue, looking north up Elliott Street; 47a Avenue on left, bridge on right (not in picture). Note dismounted cyclist using crosswalk, and lack of markings and symbols for bike lanes.

•The bridge has four motor vehicle lanes and two pedestrian walkways. There are no bike lanes or room on the road for cyclists other than to mix in with vehicle traffic traveling at speed.

•The bridge sidewalk is narrow and cannot be shared by cyclists and pedestrians. Dismounted cyclists and motorized wheelchairs aggravate crowding on the sidewalk. Lack of a barrier between sidewalk and road on the bridge makes crowding not only inconvenient but a danger for falling into traffic.

•The intersection at Ladner Trunk Road and 47a Avenue was upgraded in 2013/14, but provided no specific safety benefits for cyclists. Concerned cyclists dismount and cross as pedestrians.

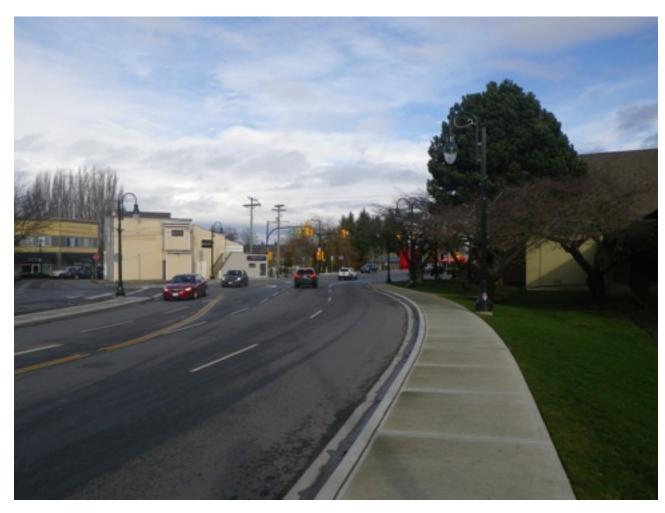
•Between 51st Street and the intersection, the generous two lane width of 47a Street is divided into four narrow lanes to accommodate a right and left turning lane on 47a. In Ladner, the pinching out of cycling space or bike lanes commonly occurs in the block approaching a main intersection in order to create more motor vehicle lanes. (see Photo 2)

Photo 2: 47a Avenue approaching the intersection and bridge at Ladner Trunk Road, looking east on 47a Avenue from 51st Street.

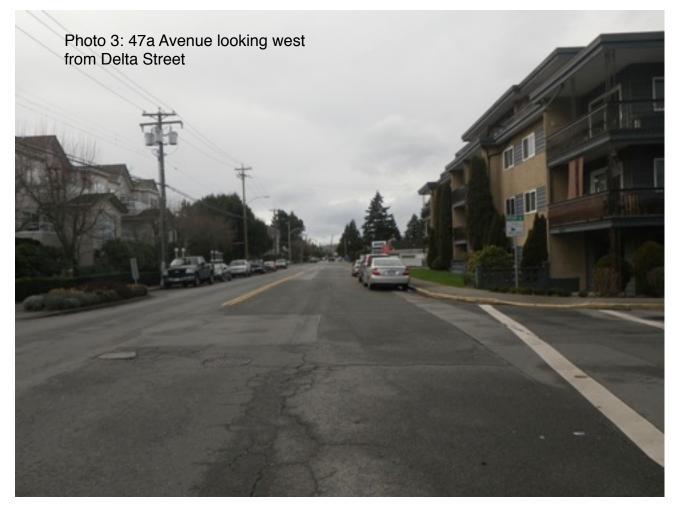
•parking on both sides of avenue, the parking lane denoted by landscaped projections at some intersections. (see photo 3 at the left of the photo)

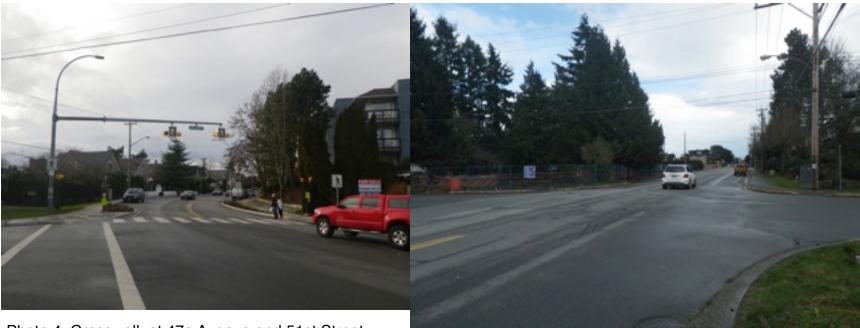
Photo 4: Crosswalk at 47a Avenue and 51st Street intersection, looking west on 47a Avenue

Photo 5: Construction of townhouse developments on the north side of 47a Avenue (looking east on 47a Avenue from 48b Street).

- Two large townhouse developments are being constructed on 47a Avenue in 2015 (See photo 5). The municipality
 often sees development as an opportunity to upgrade public amenities, such as adding trees, sidewalks and bike
 lanes. Densification and accompanying increases in traffic and parking congestion can be balanced by building for
 alternative modes of transportation.

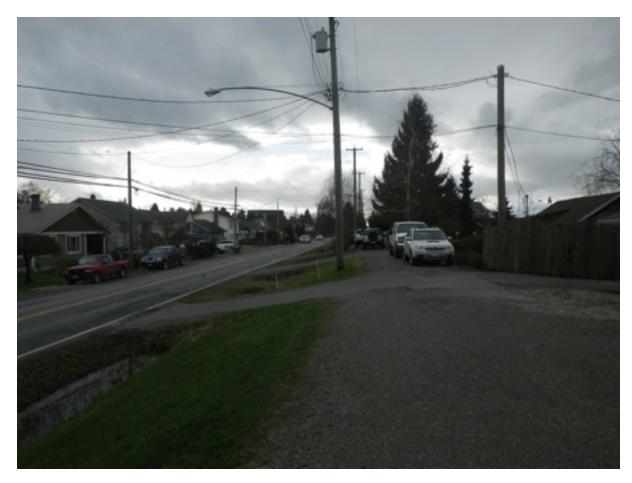
•The road is narrow without shoulders, and is squeezed between the Fraser River dyke and ditch on its north side and residential properties to its south.

•There is no sidewalk bordering the road (except in a short section). Walking this route is generally done off the road on top of the dyke.

•Slow cyclists may also use the dyke trail, but the uneven gravel path is not used by road bikes. The dyke trail is narrow in places and has a variety of obstructions, mainly parked cars, making it a challenge for cyclists and walkers to share.

Photo 6: River Road West in Port Guichon, looking west and showing dyke on right.

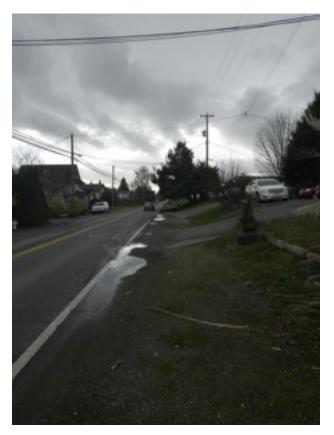
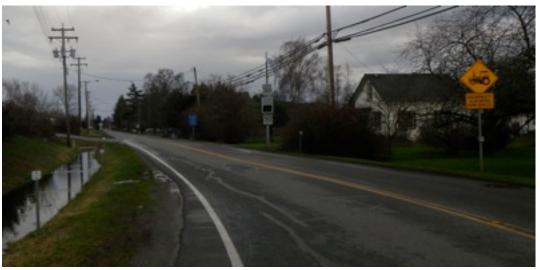
•Speed limit is 50 kph for cars and 30 kph for heavy trucks. Speeding is obviously an issue. (See solar powered speed sign in photo 8 below)

Photos 7 & 8: River Road West, looking west (left) and east (right).

- Traffic is light to moderate and is intermittent, varying with time of day and use by visitors to the area. (These photos were taken on a rainy Sunday.) Commercial trucks use the road to access greenhouses, farms, fish processing plants and other small industries located on the road.
- Road edges are uneven and eroding and are encroached upon by grass, ditch water and dirt debris. To avoid hazards cyclists may seem to motorists to maneuver erratically.
- The straight road gives good sight lines. As motor vehicles must cross into the oncoming lane as they overtake cyclists, it is helpful to see ahead.

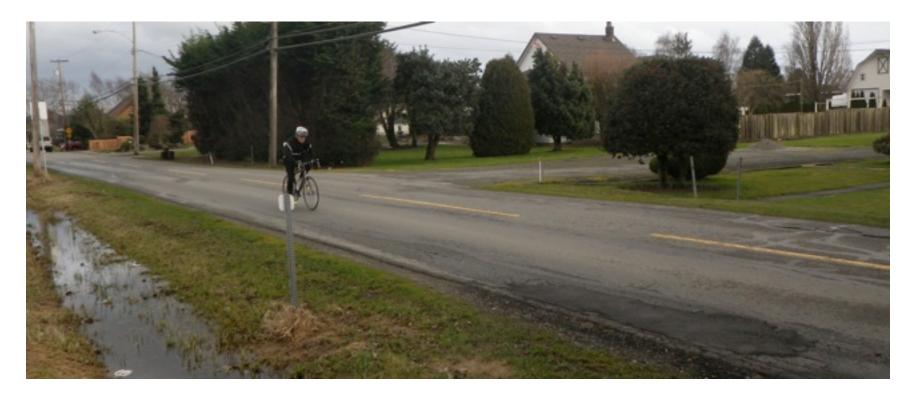
Photo 9: Cyclist on River Road West between 41b and 40th Streets, looking east. Note that cyclist is riding on the best part of the pavement and not at the deteriorating edge.

- Repair potholes and deteriorating pavement edges, followed by ongoing frequent maintenance to keep margins free of debris and encroaching grass.
- Provide signage warning motorists about cyclists and to caution cyclists.
- Provide or create attractive alternative routes where possible in the short term. As noted alternatives are limited. Improving public use of the dyke top by removing fence barriers and obstacles is one doable option. Building a path around the barrier created by S.M. Products is a priority as noted above.
- Monitoring traffic and conflicts between cyclists and motorists, as noted above.

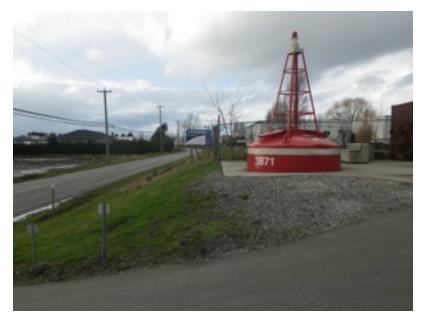
Photo 10: The dyke path ends here. The fence at S.M. Products blocks the public from using the top of the dyke to access Wellington Point Park.

Photo is taken from the west end of Mike's Marina, and looks west on River Road West towards Wellington Point.

- Ideally an extension of public access on the dyke top is the solution. S.M. Products may be able to move its
 fence and trailers back from the dyke top to allow the public to use the dyke trail from Mike's Marina to
 Wellington Point Park. It is understood that public access to dykes is not a given. However Lion's Gate
 Fisheries and Mike's Marina, as well as other residents on the dyke, accommodate walkers and cyclists.

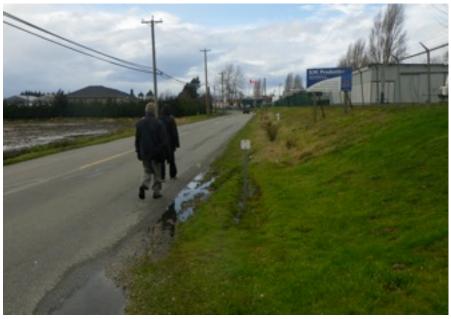
Photo 11: Two walkers decide to "run the gauntlet" to reach their goal, Wellington Point Park.

Note that there is little option but to walk on the paved road in the narrow vehicle lane. Further on the walkers moved to the other side of the road to face traffic. However, the margin is very narrow between the paved road and the steep ditch on that side, again forcing the walkers into the road.

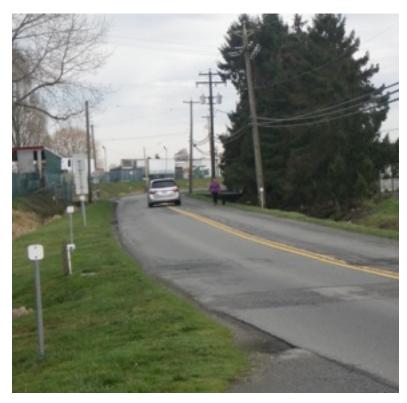
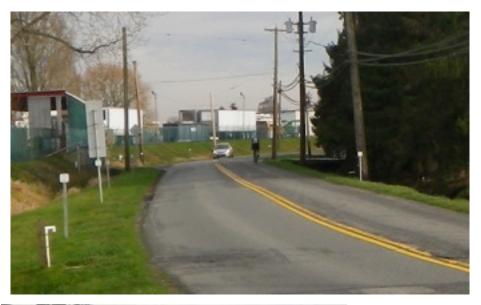
Photos 12 & 13a: Walker (left) and cyclist (right above) on River Road West at curve near Wellington Point Park. Note how motor vehicle moves into oncoming lane as it overtakes pedestrian. Pedestrians on the road are hazards for both motor vehicles and cyclists.

Above photos are looking east on River Road West from Wellington Point Park with S.M. Products' fence and buildings in the background. Note that curve in road obstructs line of sight. The speed limit is reduced to 40 kph to compensate.

- If the above option is not an option then it may be possible to build a boardwalk (with nonslip surface), or a
 paved path, between the road and the dyke shoulder, and over the shallow drainage ditch at the dyke's
 base. The narrow grass margin, which is often wet and muddy, widens towards the park, making this a more
 doable option. (see photos on p. 13 and photo 13b)

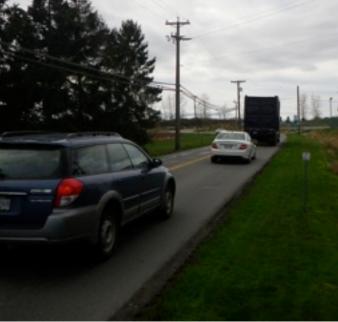
Photo 13b (left): Traffic in Wellington Point corner, looking northwest towards park.

Note grass margin & shallow ditch on right where a proposed boardwalk or paved path could be built (see p. 24 in summary)

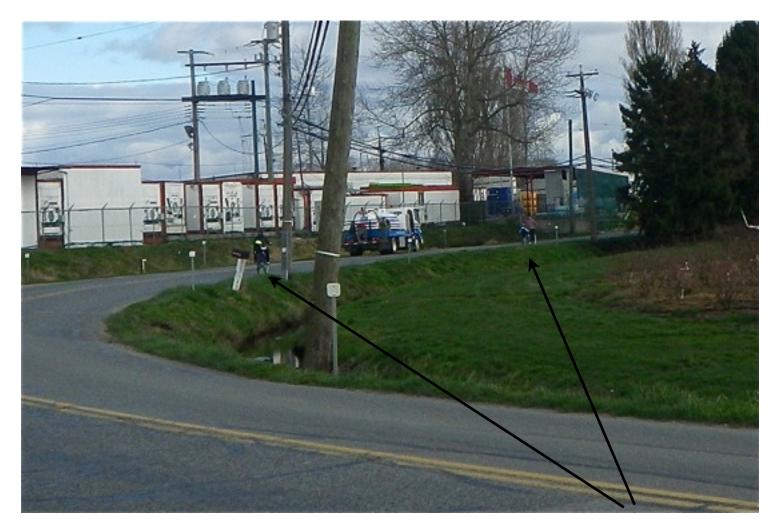
Photo 14: This is the most scary situation I observed and photographed (so far). Two cyclists, each with a child on the back, have cycled around the corner. (The truck has pulled into the oncoming lane to pass them.) Just prior to this scene, I had approached the corner from the east (Ladner) in my car, noting oncoming traffic and the cyclists. A car overtaking both cyclists (the first cyclist being in the corner then) did not pause and wait behind the cyclists but moved into my lane, causing me to brake and veer onto the grass margin. I quickly stopped at the park entrance to take the photo. The cyclists have stayed the course, but one assumes with white knuckles, unless they are entirely unaware of the risk just taken or hazard created.

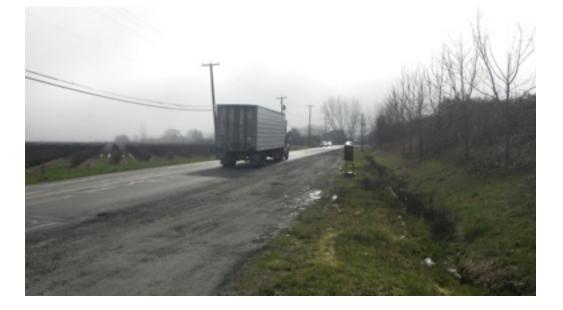
Photo 17: Truck traveling west on River Road West, just past Wellington Point Park's entrance.

The wide gravel margin is not used by road bikes, but may give respite to slow cyclists on bikes with fat tires going west. The other side of the road falls steeply away to a ditch.

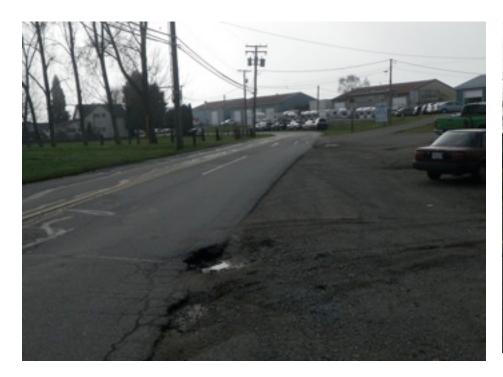
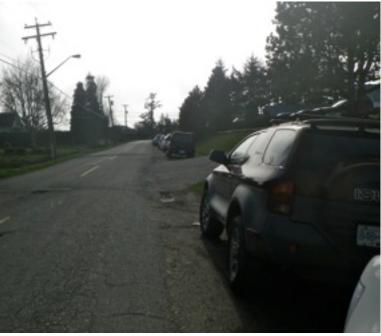
Photo 18: River Road West in S curve. Businesses and small industries line the road from Wellington Point Park to Westham Island Road and the Canoe Pass Marina and houseboat community.

Cyclists need to be aware of vehicles emerging from the many driveways on River Road West, and motor vehicles of cyclists on road.

The eroding road edges and potholes pose serious hazards for cyclists.

Photo 19: Cars parked along River Road West at Canoe Pass Marina crowd the road and passing traffic. "Dooring" is an added hazard for cyclists.

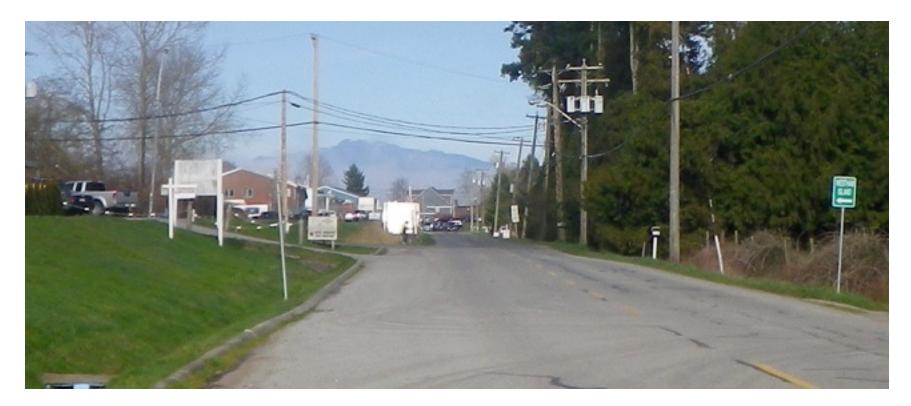
Photo 20: Westham Island Road intersects River Road West on the left of the photo, between the driveway going over the dyke and the back of the large white sign. (Photo is looking east on River Road West from Canoe Pass Marina.)

The intersection is somewhat obscured by dyke shoulders and the large sign on its east side. Note the cyclist inching out into River Road to turn left across traffic.

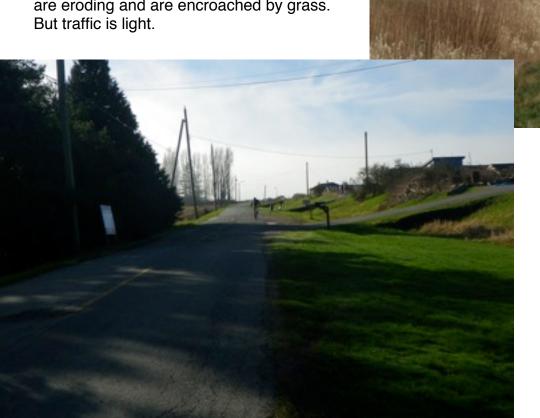
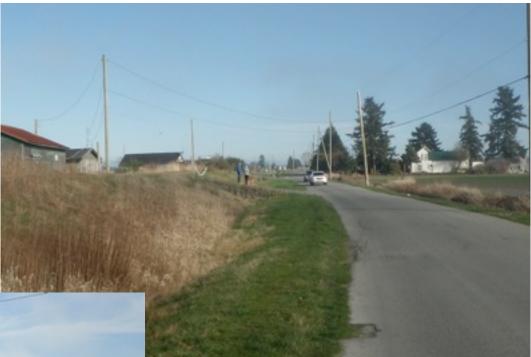
River Road West is narrower (yellow lane divider has been abandoned). Road edges are eroding and are encroached by grass. But traffic is light.

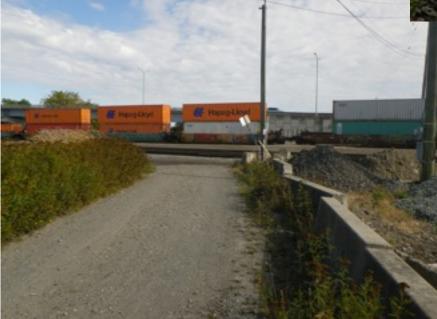
Photo 29 (left): The dyke trail ends at the railway tracks at Deltaport causeway. Posted no trespassing signs, if not prudence, should discourage cyclists from attempting to cross here or at 27b Street. The 2004 Delta Routes map does show the trail crossing the tracks - perhaps a less busy time for the port.
