**SOUTHWEST MARINE DRIVE
(GRANVILLE STREET TO MACDONALD STREET)
IN-SERVICE ROAD SAFETY REVIEW - FALL 2016**

PREPARED FOR
CITY OF VANCOUVER

URBAN
systems

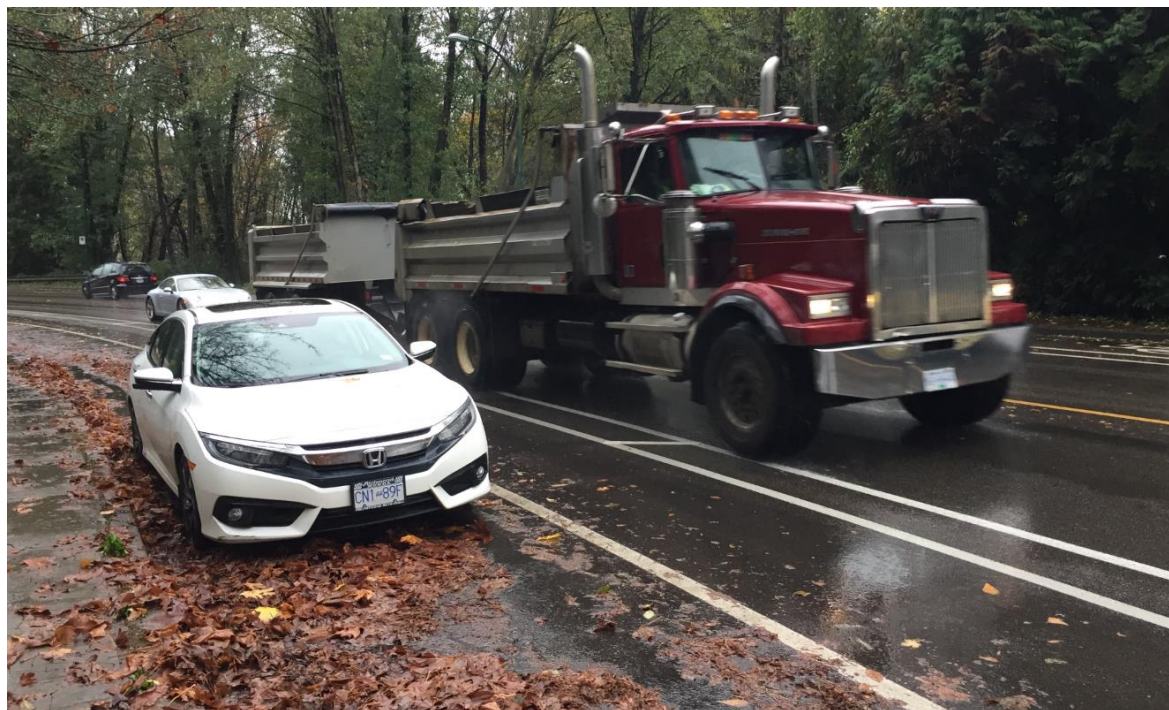
As noted previously, curbside on-street parking is permitted in the westbound direction (north side) of Southwest Marine Drive between Barnard Street and Angus Drive. Between Wiltshire Street and Angus Drive, the bicycle lane is 1.5 metres with a 0.6 metre buffer between the bicycle lane and the motor vehicle travel lane. The width of on-street parking is 2.3 metres, with no buffer between parked cars and the bicycle lane. At these locations, people cycling in the bicycle lanes are travelling in the 'door zone'. Where the road curves, motor vehicles were observed to be encroaching into the bicycle lane buffer and motor vehicles were not parking directly against the curb, likely due to the leaves and debris in the parking lane, as seen in **Figure 7**. This scenario creates a potential dooring safety issue for people cycling.

Figure 7: Curbside Parking creates a Dooring Safety Issue

Some potential mitigation measures for the safety issues associated with doorings include:

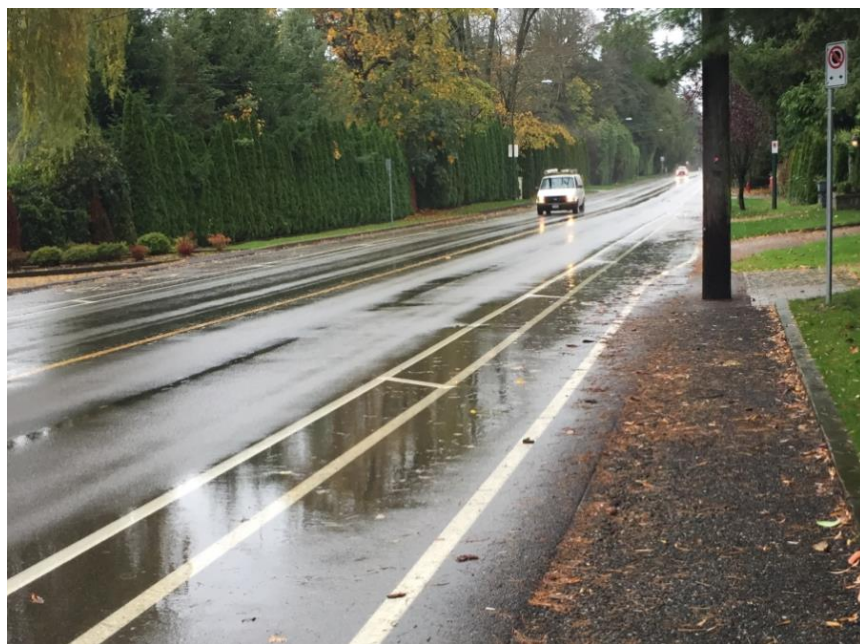
The 100% design drawings provided by the City indicate that as part of the typical cross section, 0.3 metres of space should generally be provided between the centre of the painted white line closest to the edge of the asphalt and the edge of the asphalt itself. Along the corridor, however, the width of this space varies and in some locations, it appears to be less than 0.3 metres and in others it appears wider, which in some cases results in the narrowing of the bicycle lane (**Figure 8**).

Figure 8: Example of a Location Where the Width of The Bicycle Lane is Below 1.5 Metres

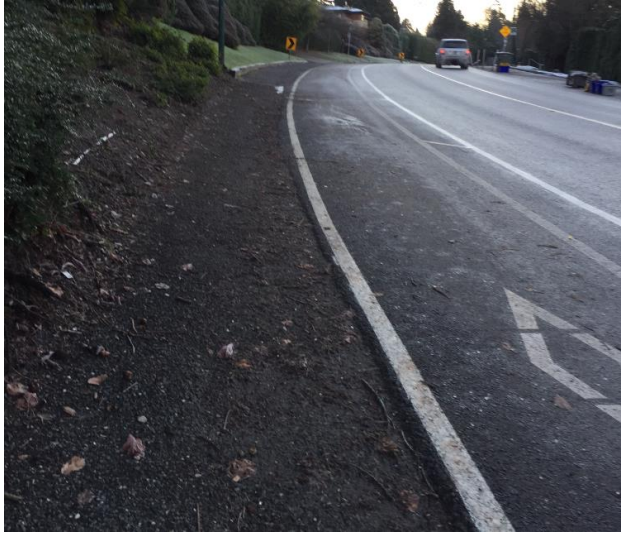
- In the westbound direction between Angus Drive and 64th Avenue where there is no curb separation (in front of 1955 and 1925 Southwest Marine Drive).
- In the westbound direction between 57th Avenue and 54th Avenue

Figure 10: Example of White Lane Line Adjacent to the Edge of the Asphalt

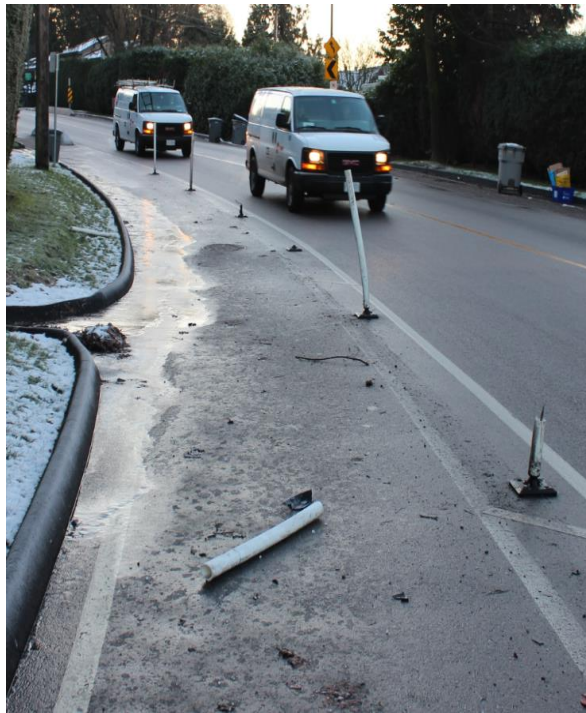
- **Broken and knocked over plastic bollards.** Plastic bollards had been knocked over or broken at several locations along the corridor as seen in **Figure 12**, including around the curve near Maple Grove Park and east of Macdonald Street. The damage to the plastic bollards was most significant between West 57th Avenue and Macdonald Street. It is important to note that most of the bollards are located along this segment of the corridor.

Figure 12: Damage to Plastic Bollards

- The City can continue to work to ensure the roadway and bicycle lanes are clear of debris including damaged plastic bollards (see recommendations specific to maintenance identified in **Issue 10**). See also **Issue 4** regarding motor vehicle lane widths and vehicle encroachment.

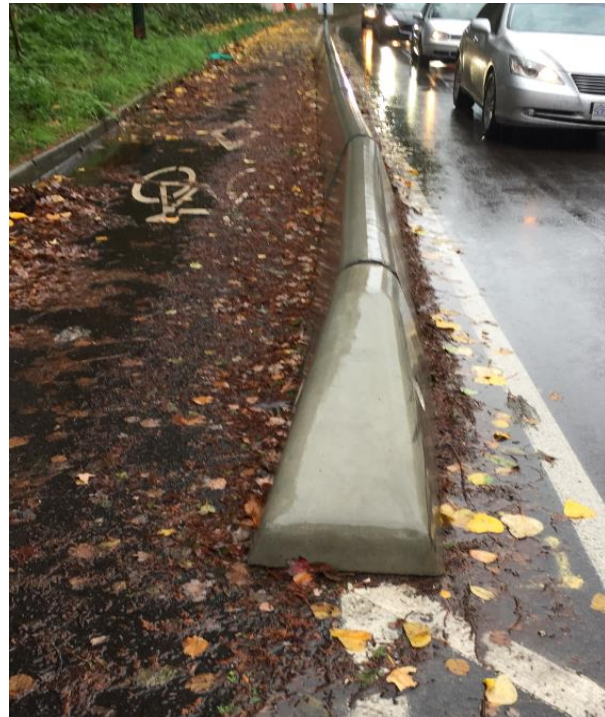
- **Shifted concrete barriers.** The concrete barriers that have been used on Southwest Marine Drive were observed to have shifted at some locations into the bicycle lane (**Figure 11**). They were also seen to have cracked and broken apart. The following safety issues were identified:

Figure 11: Shifting Concrete Barriers

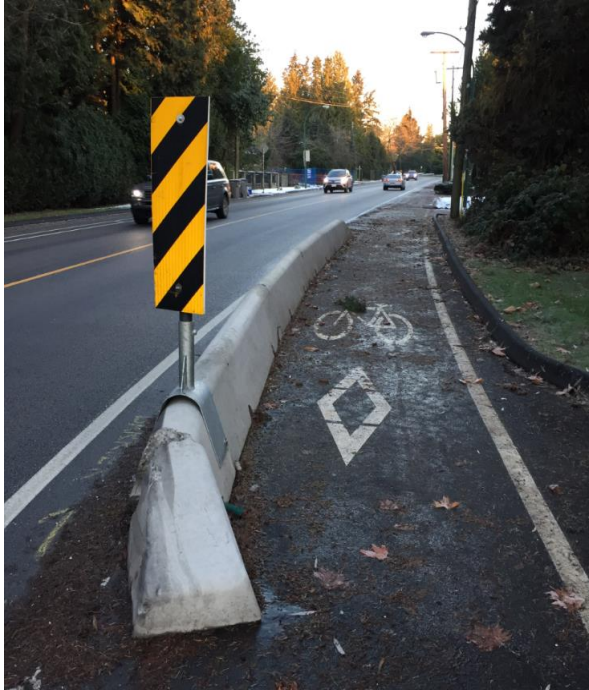
- The shifting, broken and cracked concrete barriers create debris and a tripping hazard in the bicycle lane.
 - The marks and damage to the concrete barriers indicate that motor vehicles have collided with the barriers (**Figure 13**). This could be an indication the barriers are not visible.

Figure 13: Broken and Scuffed Concrete Barriers

- Consider enhancing the visibility of the concrete barriers along the corridor. Some suggestions to enhance visibility include:
 - Paint the bullnose of the barrier with yellow paint such as the treatment used on the cement diverter at Southwest Marine Drive and Cornish Street (**Figure 15**).

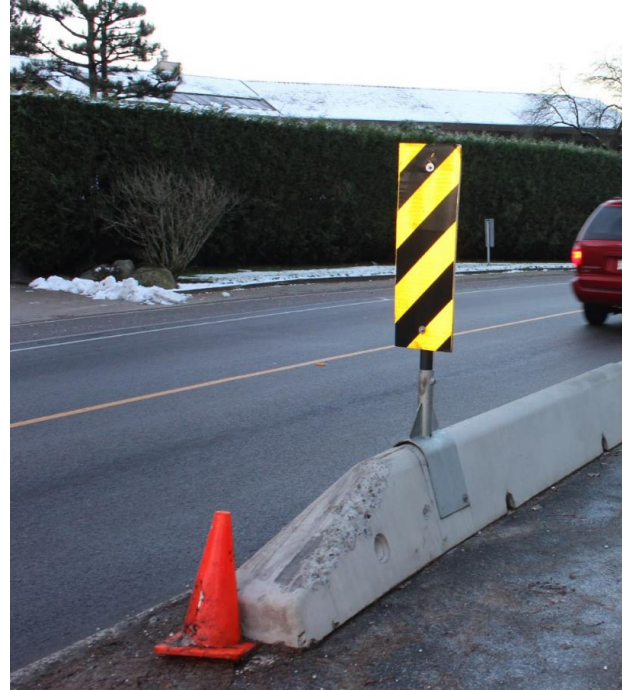
Figure 14: Example of a Traffic Cone Added in Front of Barrier to Increase Barrier Visibility

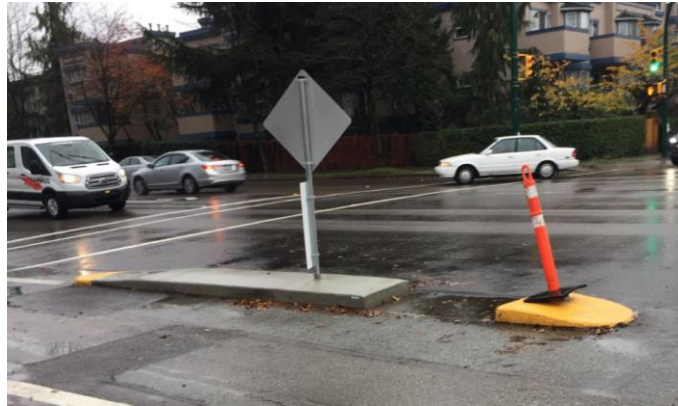
Figure 15: Example of Yellow Paint Used to Enhance Visibility

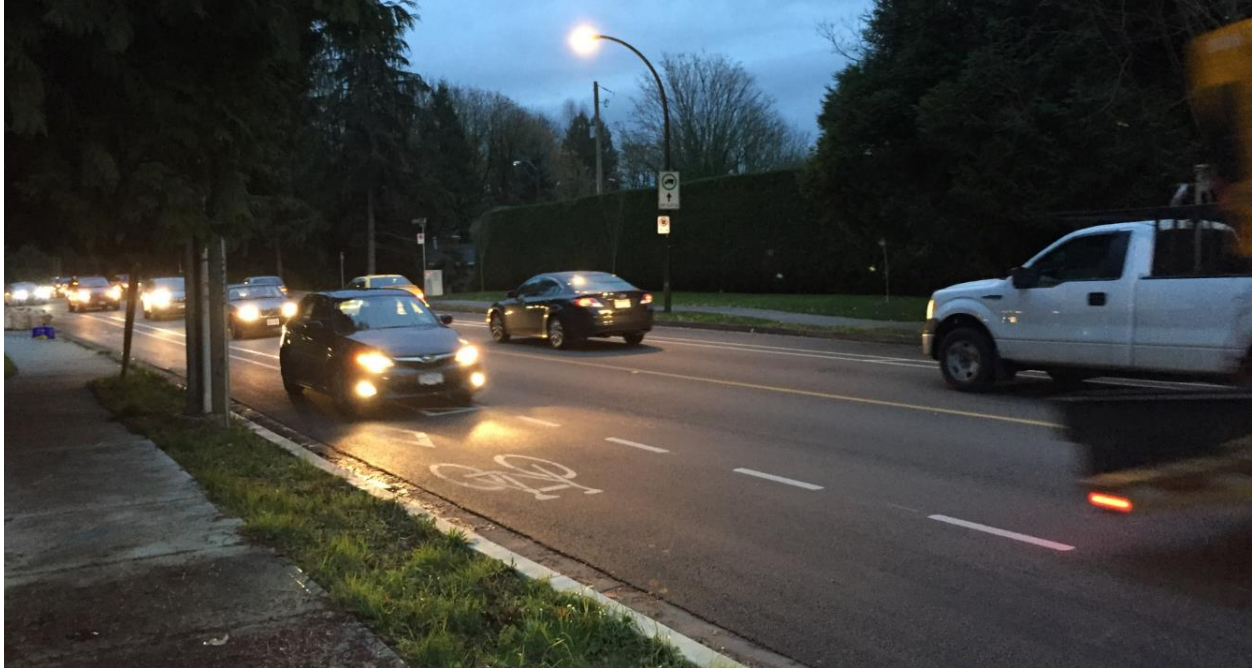
- At Southwest Marine Drive and Angus Drive, the ISRSR Team observed motor vehicles crossing the buffered bicycle lane prior to the dashed line to enter the right turn lane early and avoid waiting behind other stopped vehicles, as seen in **Figure 16**.

Figure 16: Vehicle Encroaching into the Bicycle Lane (Southwest Marine Drive and Angus Drive)

- The City may consider installing a Turning Vehicle Yield to Bicycles Sign (RB-37) to advise motor vehicle drivers they are crossing and travelling in a designated bicycle lane.

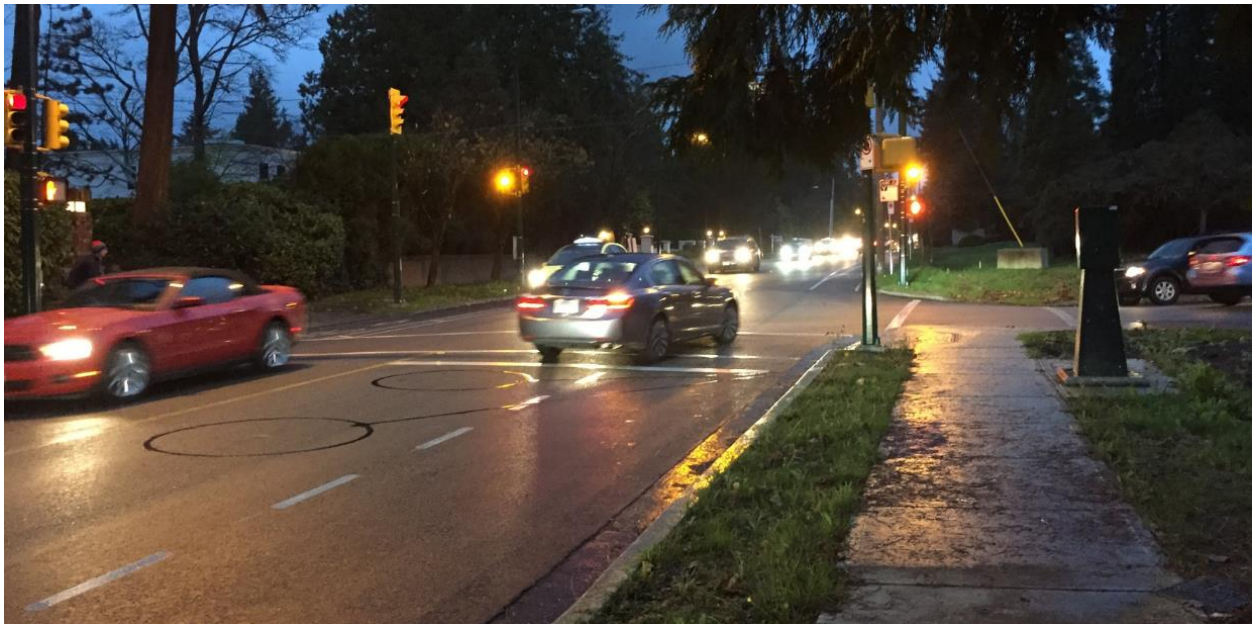
- At both signalized and non-signalized intersections when there was no congestion, vehicles were observed to be making right turns from the through lane (**Figure 17**). Because the shared right turn lanes are not being used consistently, this results in unpredictable behaviour as

people cycling and driving may be unaware that the vehicle is preparing to make a turning movement particularly if motor vehicle drivers are not using their vehicle turn signal.

Figure 17: Vehicle not using the Mixing Zone to Make Right Turn Movement (Southwest Marine Drive and Angus Drive)

- The City can continue to review the volume of right turn motor vehicle movements at intersections along the corridor. At intersections where right turn volumes are low, the City can consider eliminating the shared right turn lane. It was observed by the team that at intersection locations where there was no congestion, motor vehicle drivers were making right turn movements from the through lane.

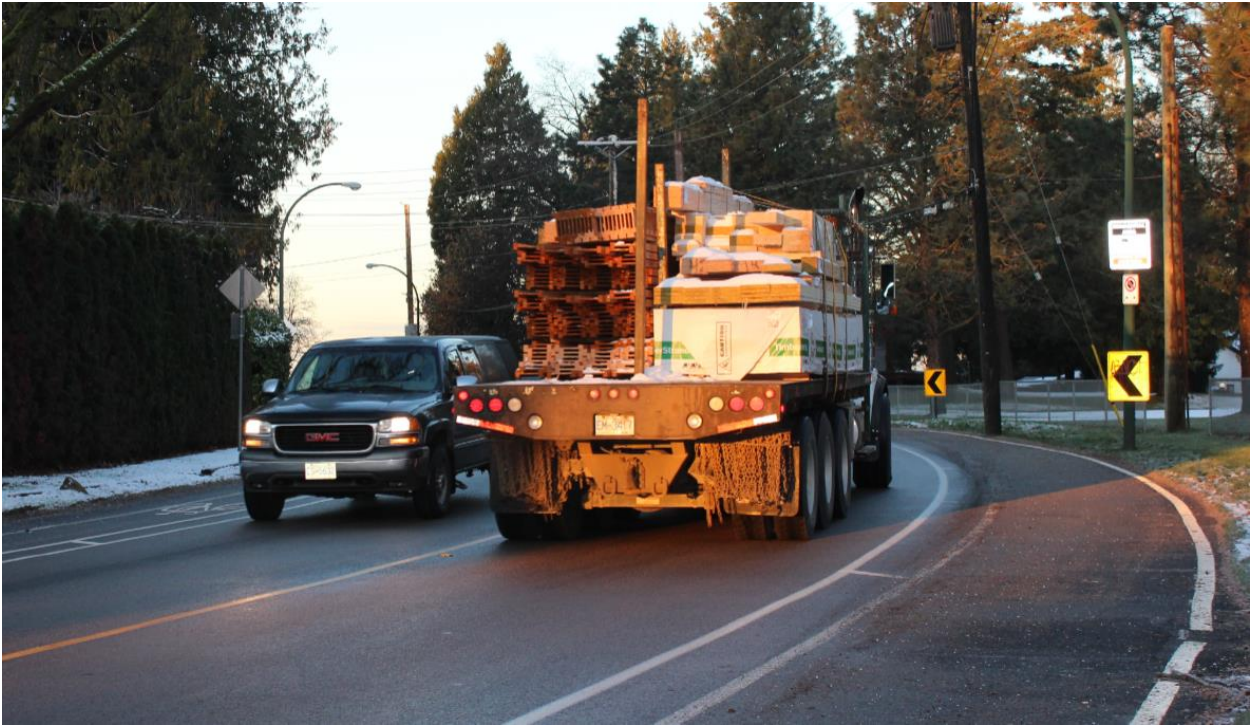
Between East of West 54th Avenue and Macdonald Street, there are several horizontal curves in the road, which are often compounded with vertical curves that impact sightlines. Based on the 100% design drawings provided by the City, the motor vehicle lane widths in this section range between 3.3 metres to 3.9 metres. As noted, lane widths are the widest at locations where there are vertical and horizontal curves. However, there are several locations along this portion of the corridor as observed by ISRSR Team where the lane widths felt narrow particularly when passing a larger vehicle and at locations where there were physical barriers separating the bicycle lane. Images below show incidents of vehicles encroaching into the centre line and the bicycle lane buffer while driving along Southwest Marine Drive (**Figure 18**, **Figure 19** and **Figure 20**). While **Figure 19** and **Figure 20** illustrate that motor vehicle drivers are encroaching into the bicycle lane and into the cement barrier, they also show that at these specific locations there is sufficient lane width. Motor vehicle drivers may be encroaching into the bicycle lane because they just passed a larger vehicle encroaching on the centre, they are travelling at higher speeds, and the road geometry.

Figure 18: Vehicle Encroaching onto the Centre Line While Navigating a Curve in the Road

The following suggestions have been provided to address vehicles encroaching out of their designated lane between East of West 54th Avenue to Macdonald Street:

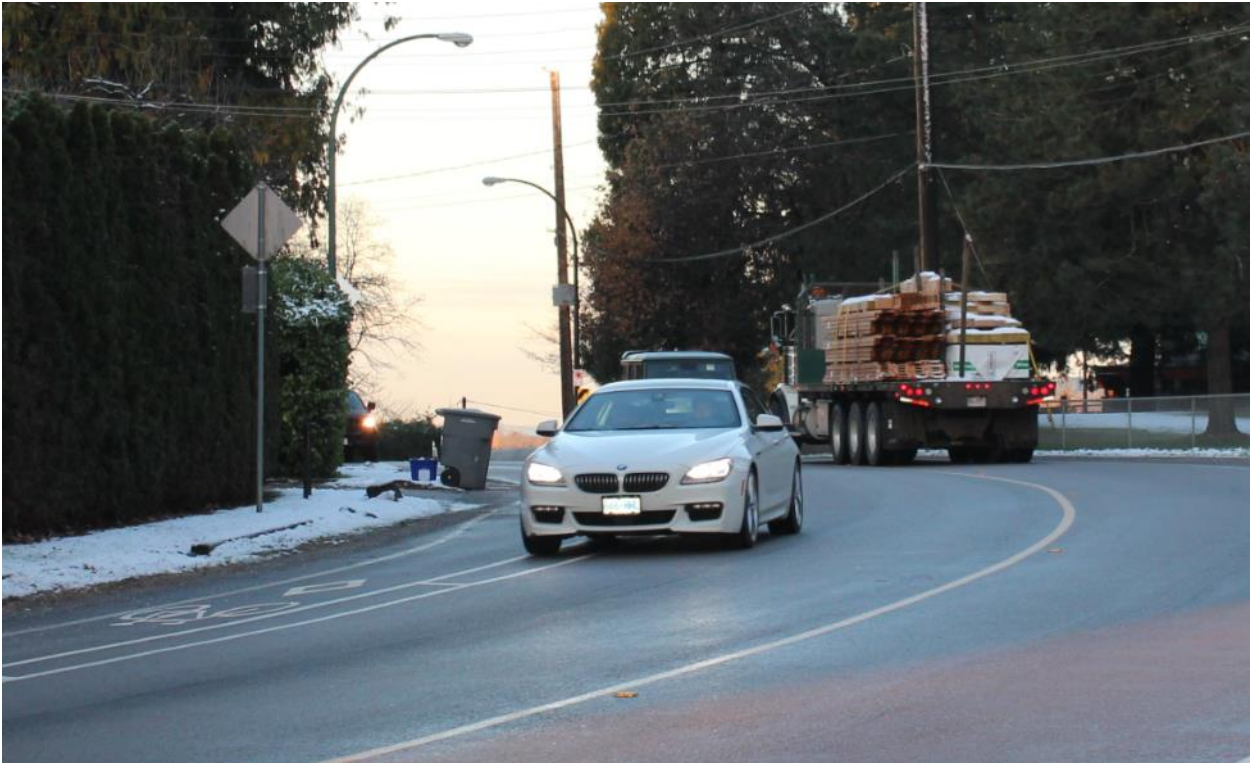
Figure 19: Vehicle Encroaching into the Bicycle Lane While Navigating a Curve in the Road

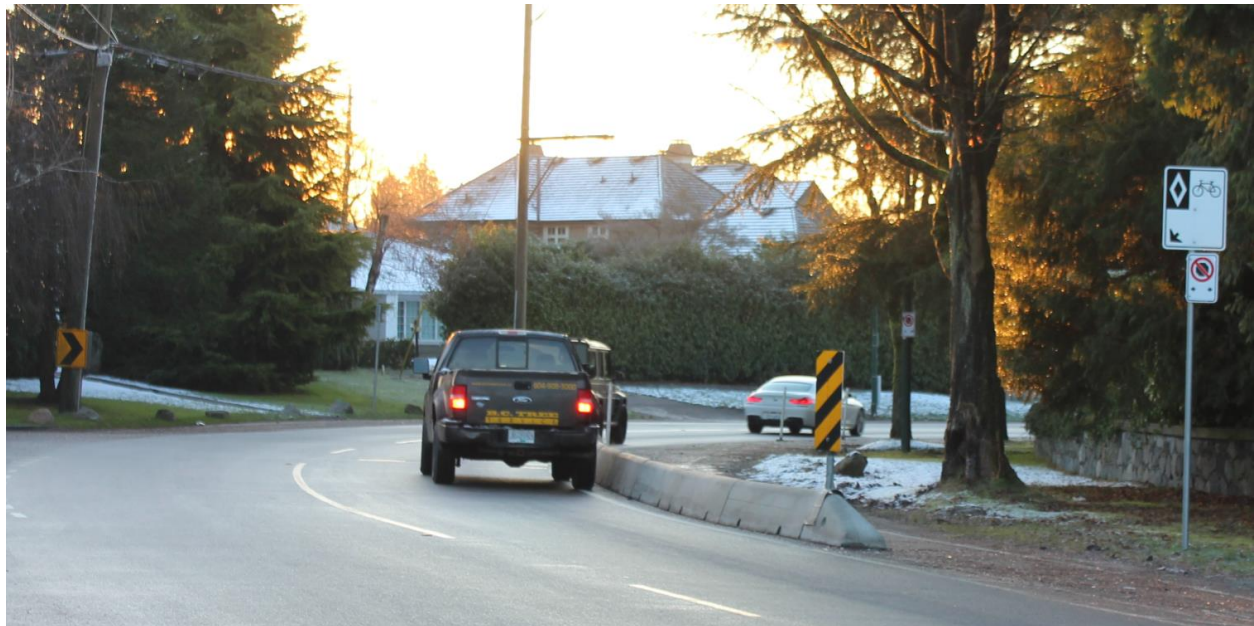
Observed damage to the plastic bollards and concrete barriers along this portion of the corridor also indicates that current motor vehicle lane widths may be constrained in some locations in relation to the vertical and horizontal curves in the road and the speed motor vehicles are travelling.

Figure 20: Vehicle Encroaching into the Concrete Barrier While Navigating a Curve in the Road

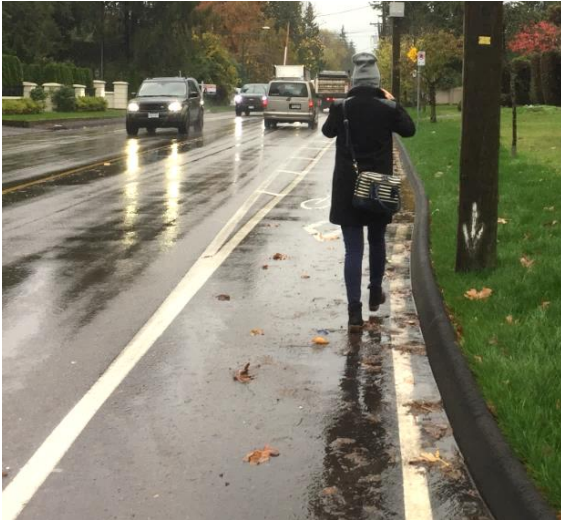
Figure 21: Lack of Walking Facilities Resulting in People Walking in Bicycle Lane

- **Lack of walking facilities.** Consider opportunities to provide a continuous concrete or gravel pathway on at least one side of the street consistently throughout the corridor. Based on current conditions, the north side of the street is recommended as there are already walking facilities or space for walking facilities along much of that side of the street. Continuous paved or gravel walking facilities would enhance the accessibility of the corridor and provide a designated space for people to walk would help to reduce potential conflicts between people walking and cycling. Grass is not considered a suitable facility for people walking, particularly when considering walking

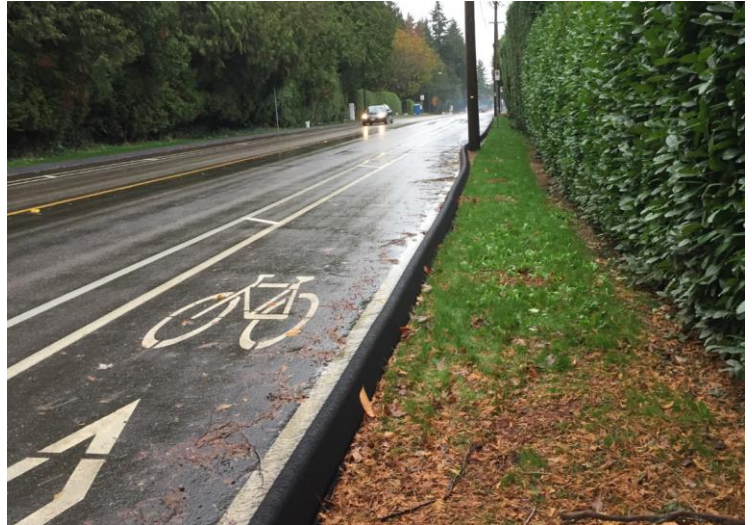
Figure 22: Grass Walking Space

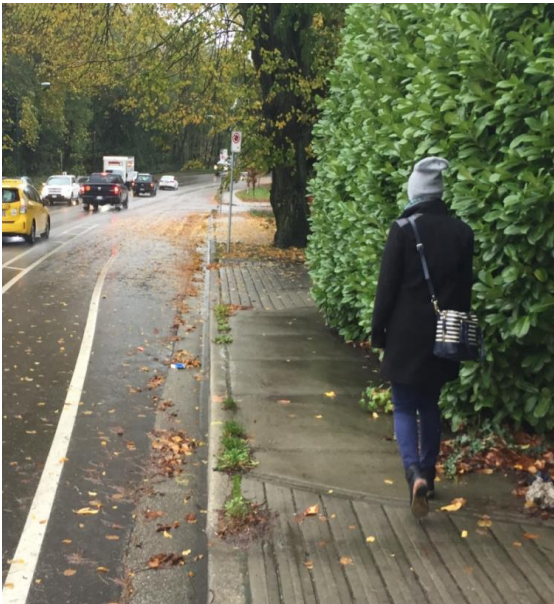
- **Overgrown vegetation.** There were several locations where there was a concrete sidewalk or designated place for people to walk along the corridor, but where overgrown vegetation and hedges reduced the width of the walkway, while also reducing sightlines from the driveway and potentially creating some potential CPTED concerns (**Figure 23**).
- **Limited designated crossing locations.** Designated crossing locations are limited for people walking along this corridor. Crossing Southwest Marine Drive can be challenging due to high vehicle volumes, speeds and the vertical and horizontal curves in the road. The lack of designated crossings can result in an increased number of incidents of people jaywalking and was outlined in the previous reports to Council.

Figure 23: Overgrown Vegetation Adjacent to Sidewalk

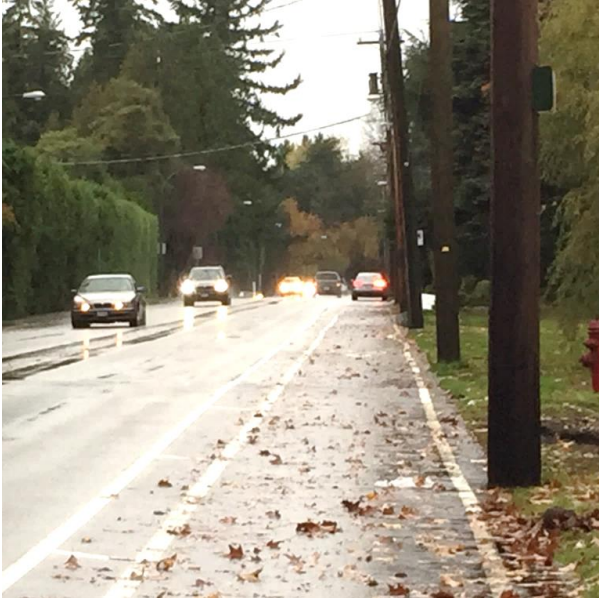
of the roadway, this is not consistently the case along the length of the corridor. This can create a potential safety issue when there are obstructions within proximity of the bicycle lane.

Figure 24: Example of Object within 30cm of Bicycle Lane

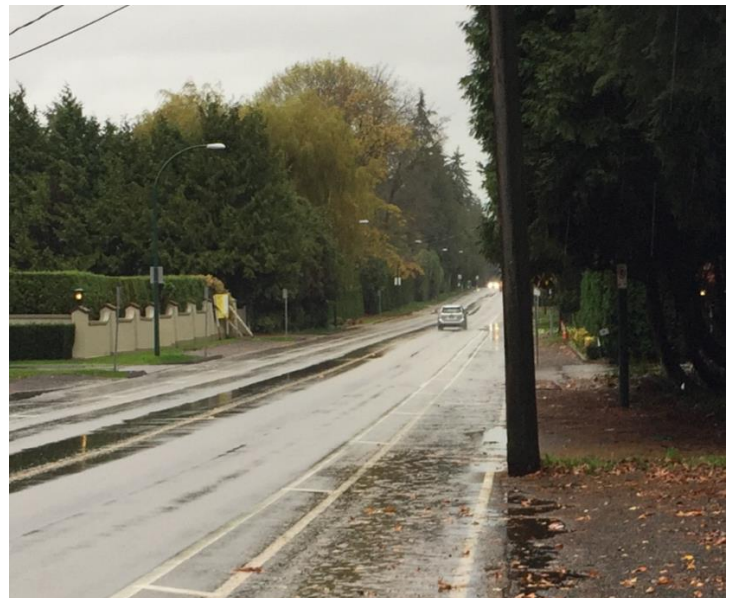
Figure 25: Example of Object within 30cm Bicycle Lane

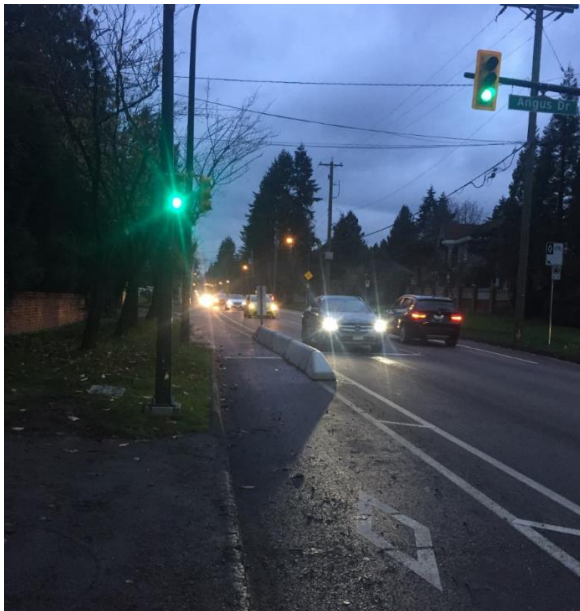
It was also noted during the site visit that at dusk, prior to the overhead lights being activated, visibility can be challenging along the corridor and this is exacerbated in poor weather conditions (**Figure 26**). Due to the unexpected location of some of the barriers (as discussed in **Issue 2**) and the limited visibility the presence of bollards and concrete barriers can present a potential safety issue.

Figure 26: Lighting Along Southwest Marine Drive at Dusk

- Enhance visibility of concrete barriers and bollards based on the recommendations provided to address **Issue 2**.
- Consider installing additional overhead lighting where feasible to ensure the visibility of bollards, concrete barriers and people walking and cycling at the locations noted above, particularly at intersections and where there are horizontal and vertical curves in the road geometry.

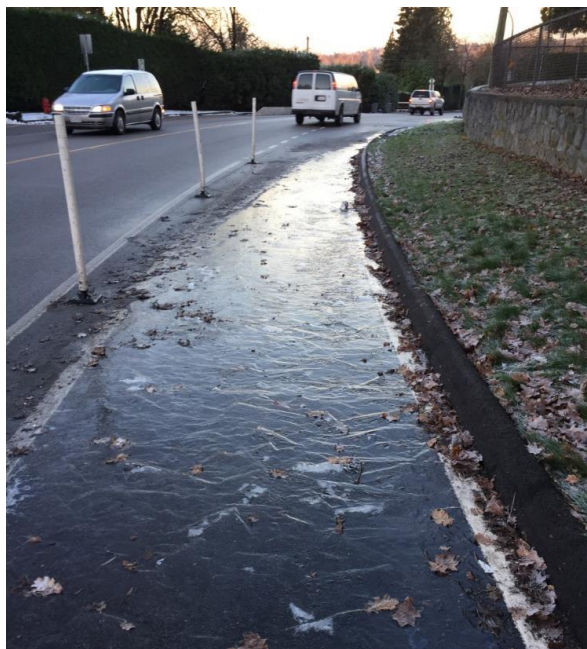
- Drainage and the presence of water and ice within the bicycle lane as seen in **Figure 27**, creates a slippery surface and a potential hazard for people walking and cycling.
- Leaves and other vegetation accumulating in the bicycle lane creates an uneven slick surface, as seen in **Figure 28**.
- Overgrown vegetation creates a vertical obstruction in the bicycle lane, as seen in **Figure 29**.
- Other debris including knocked over signage, bollards and debris from vehicles, as seen in **Figure 30**.
- The ISRSR team visited the corridor on a Tuesday where garbage collection occurred and witnessed garbage and recycling bins left in the bicycle lane creating obstructions along the route, as seen in **Figure 31**.

These maintenance related issues create potential tripping and slipping hazards for people walking and cycling along the corridor.

Figure 27: Bicycle Lane Covered by Ice

- **Ensure that the pathways are a smoothly paved surface and kept free of debris.** It is suggested that the City continue to coordinate bicycle facility maintenance with other road operations and maintenance activities including sweeping, salting and debris removal as well as repairs. Sweeping should occur multiple times though the year particularly in the fall and the spring to clear the accumulated debris collected over these months.
- The City could also consider reminding residents and garbage collectors not to obstruct the bicycle lane with garbage and recycling bins and provide information that outlines where bins should be placed out of the way of the bicycle lane.

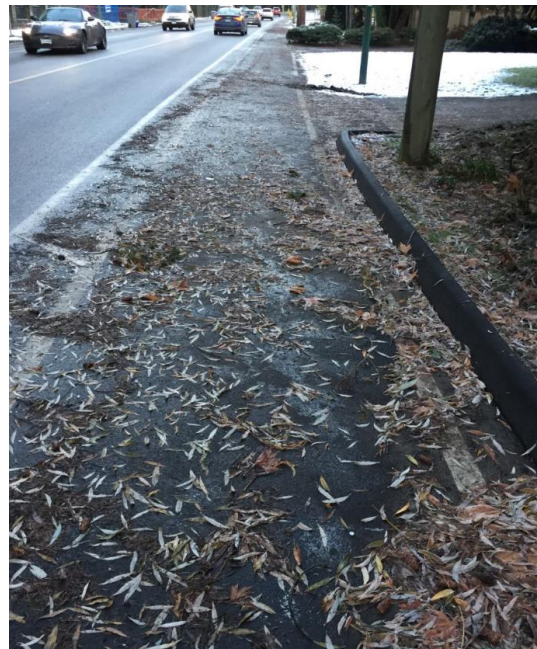
Figure 28 : Bicycle Lane Covered by Leaves and Vegetation

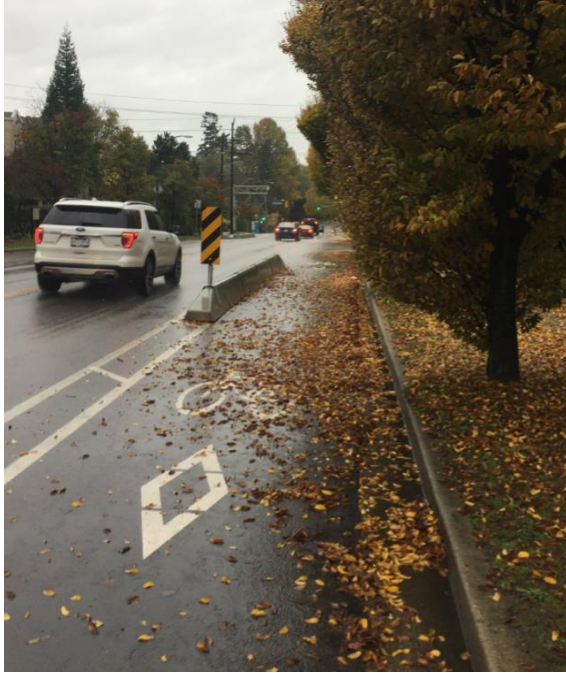
Figure 29: Trees Obstructing the Bicycle Lane

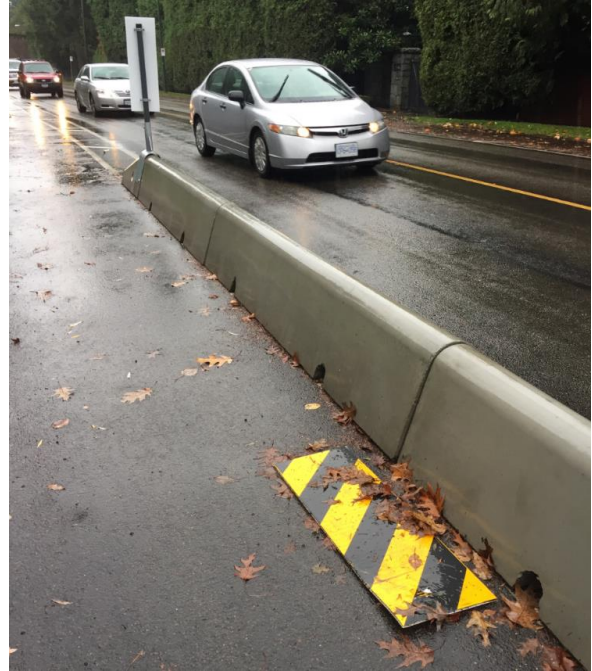
Figure 30: Signs and Other Debris in the Bicycle Lane Overgrown

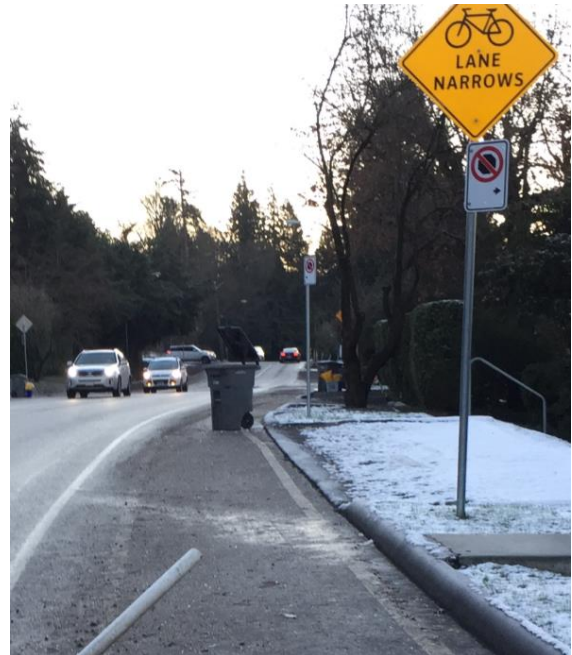
Figure 31: Garbage Bin Obstructing Bicycle Lane
