August 21, 2016

Dale Bracewell, Manager of Transportation Planning, City of Vancouver

Re: Recent Improvements to King Edward Avenue Cycling Infrastructure

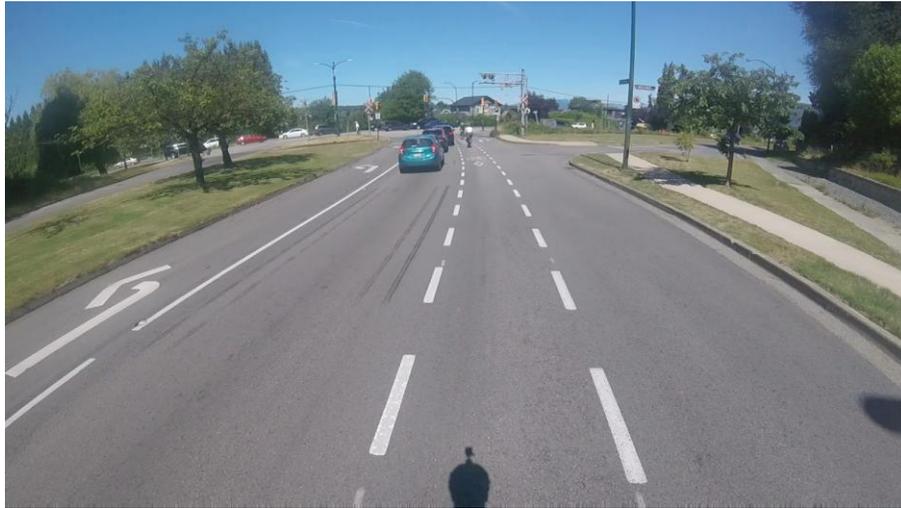
Figure 1 - King Edward Westbound at Arbutus

Approaching Arbutus there is an additional left turn lane, a straight through lane, the bicycle lane (permeable and with no buffer zones) and then a right turn lane, as shown in Figure 1.

Additionally, the Arbutus greenway crosses immediately before Arbutus, and there is an additional right turn possible into East Blvd, on the east side of the rail ROW. All of this creates a wide expanse of pavement, with multiple potential vehicle turning movements. It is not a comfortable cycling location for any but the bravest cyclists. Because right turns are permitted on a red light, at the light there is constant motor vehicle traffic passing on the right side of people stopped on bikes, and these vehicles are often moving quickly.

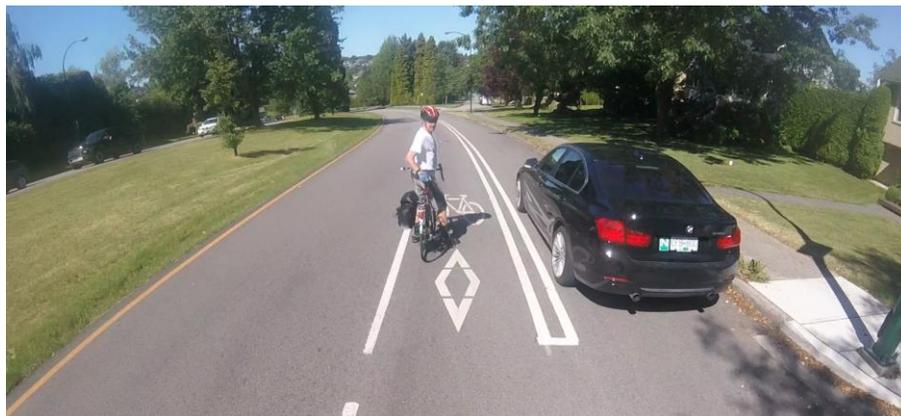
Figure 2 – Bicycle lane positioning to avoid the door zone

The lane widths were measured just after this point, and were found to be 2.2 m (parking lane), 0.3 m (buffer), then the bike lane, then the motor vehicle travel lane (3.0 m). The door width of a parked compact vehicle was measured, and the safe riding distance (1.5 m from

the vehicle) was measured out. This is shown in Figure 2, above. Note the required bicycle position for safety from opening doors, as it relates to overtaking motor vehicle traffic.

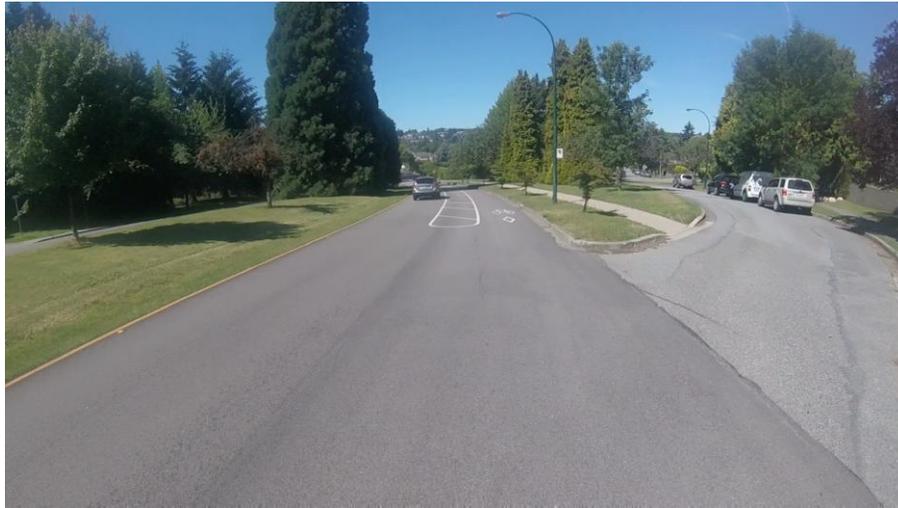
Figure 3 - A better riding experience with an increased buffer

West of 23rd Ave, there is no parking permitted until Yew, as residents have 23rd for parking. Here the bike lane is positioned next to the curb, and there is a wide painted buffer zone between the bike lane and the motor vehicle travel lane, as shown in Figure 3. The difference is noticed immediately when riding, as vehicles are further away from people on bikes. This short stretch illustrates what could be accomplished with reductions in parking.

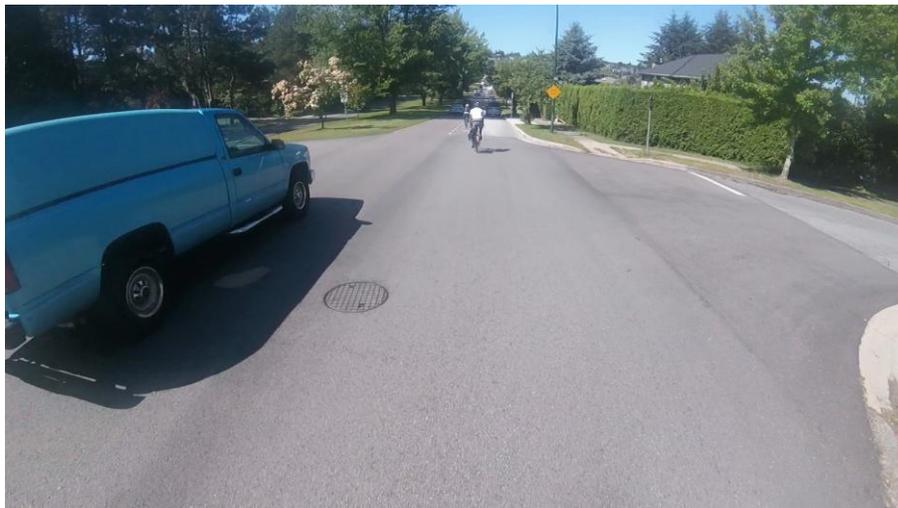
Figure 4 – Bicycle lane transition through the intersection at Yew

Immediately after Yew, the bike lane transitions back to being on the travel lane side of parked vehicles. There is a danger zone here, shown in Figure 4, as overtaking motor vehicles have no cues to advise them to expect bicycles to come out from the curb. We recommend that lane markings be added here to alert drivers to people on bikes.

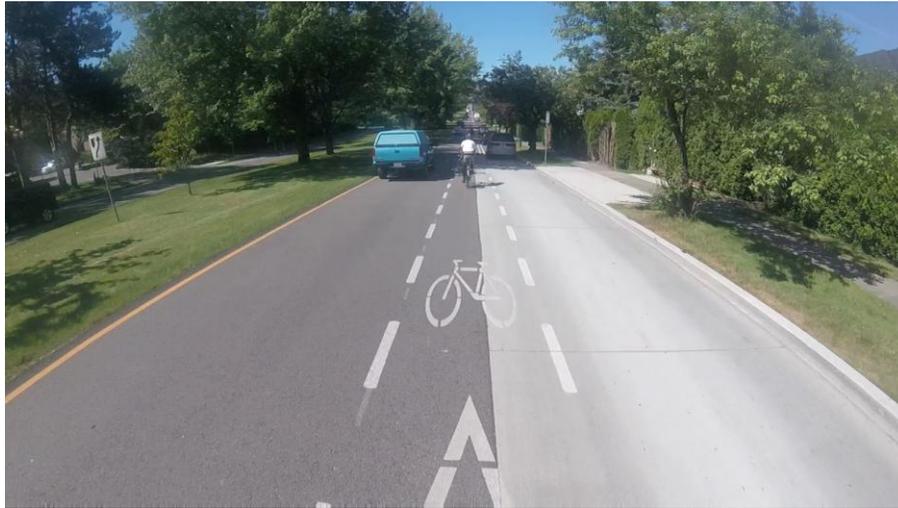
Figure 5 - Bus pad creates a dangerous pavement seam

Additionally, this transition happens at a transit stop, and there is a poured concrete pad for the buses instead of the standard pavement. The risk here is because the pad has been extended out to halfway through the painted bike lane, creating a seam down the centre of the bike lane that can catch tires, as shown in Figure 5. The concrete pad should be ended at either the inner edge of the bike lane, or the outer edge. We recommend that this detail be considered on future projects.

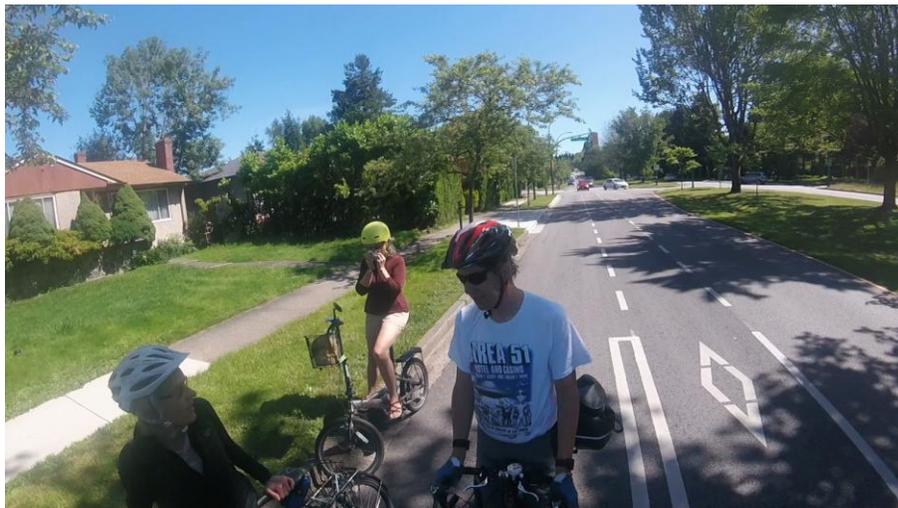
Figure 6 - Vehicles overtaking on the right in the bike lane

This stretch is flat, and higher motor vehicle speeds were observed. At Valley, motor vehicles travelling westbound were observed overtaking on the right, in the bike lane, as shown in Figure 6.

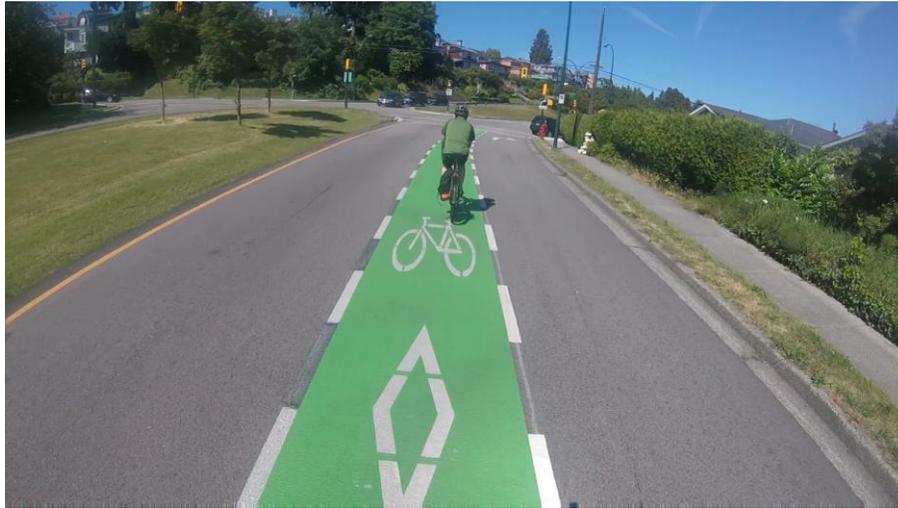
Figure 7 - King Edward westbound approaching MacDonald

Approaching MacDonald, there is a right turn lane, and green paint has been applied to the bicycle lane, as shown in Figure 7. We recommend that this same treatment be applied at Arbutus, and other key intersections along King Edward.

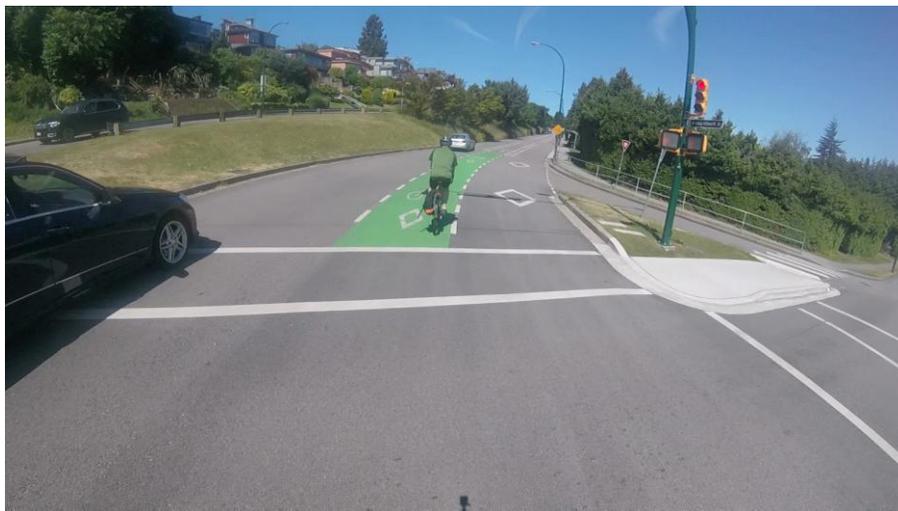
Figure 8 - King Edward westbound after MacDonald

Immediately after MacDonald, the curb lane is marked with a diamond, then the bike lane is painted green, and to the left is the motor vehicle travel lane, as shown in Figure 8. There is also a slip road for vehicles southbound on MacDonald to turn right (westward) onto King Edward. Those vehicles must cross the curb lane, then the bike lane, to get to the travel lane, as they accelerate up the hill. Vehicles were observed travelling in the curb lane (diamond marking) for some distance. Road lane width reductions and channelization here would help by narrowing the lanes and clarifying where motor vehicles should be positioned. The diamond marking on the curb lane is presumably for the transit stop part way up the hill, but the buses could pull into the transit stop when necessary, without travelling up the hill in the curb lane on the inside of the bicycle lane. Normalizing the intersection could include removing the slip lane, as the wide radius results in motor vehicles taking the corner at

higher speeds and without a full view of the traffic on King Edward. The turn is less than 90 degrees, but could be managed with a standard intersection. The risk of the slip lane here is very similar to that at the slip lanes currently being removed from the Burrard/Pacific intersection. Moving the transit stop to the left of the bike lane could also be considered.

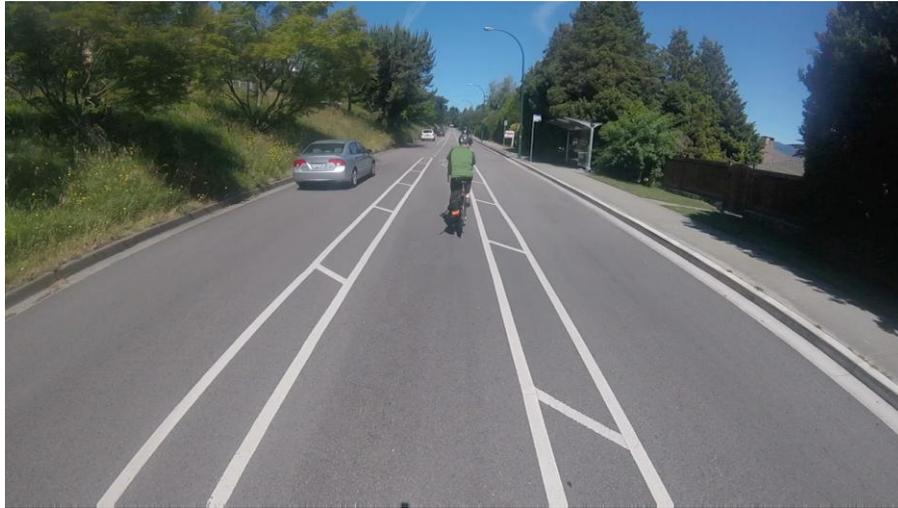
Figure 9 - King Edward westbound after MacDonald

After the transit stop, there is a curb lane for parking, then a painted buffer, then the bicycle lane, then another painted buffer, then the motor vehicle travel lane, as shown in Figure 9. The additional buffer spacing along this block results in much greater comfort and a sense of security for people on bikes, at least at times when no vehicles are treating the bike lane as a travel lane, as shown in Figure 10.

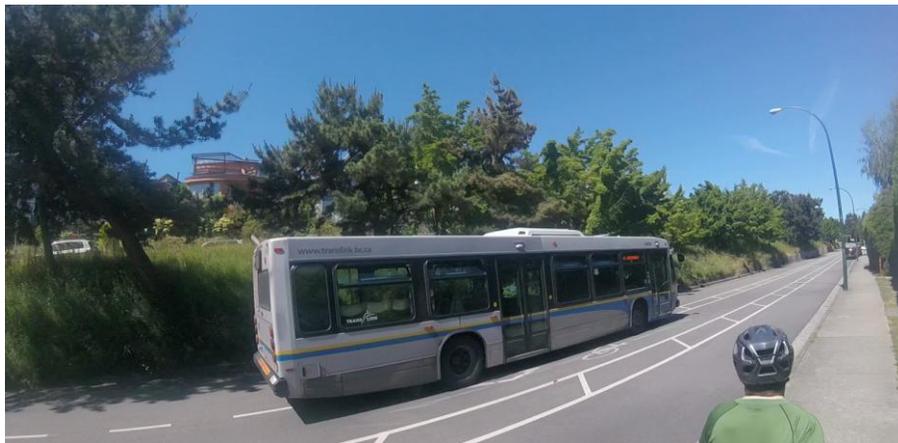
Figure 10 - King Edward westbound after MacDonald

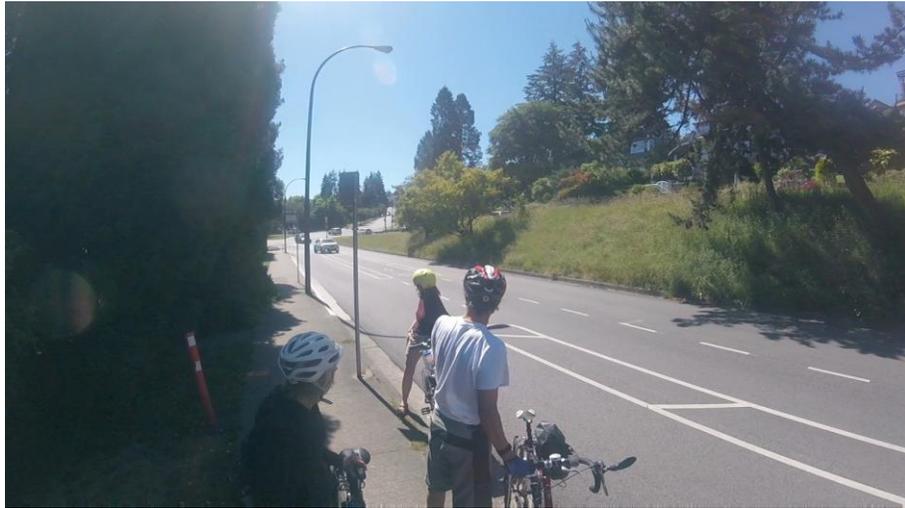
Figure 11 - King Edward westbound after MacDonald

Vehicles were observed driving in the bicycle lane up the hill, especially when they had turned westward on King Edward from the slip lane, as shown in Figure 11.

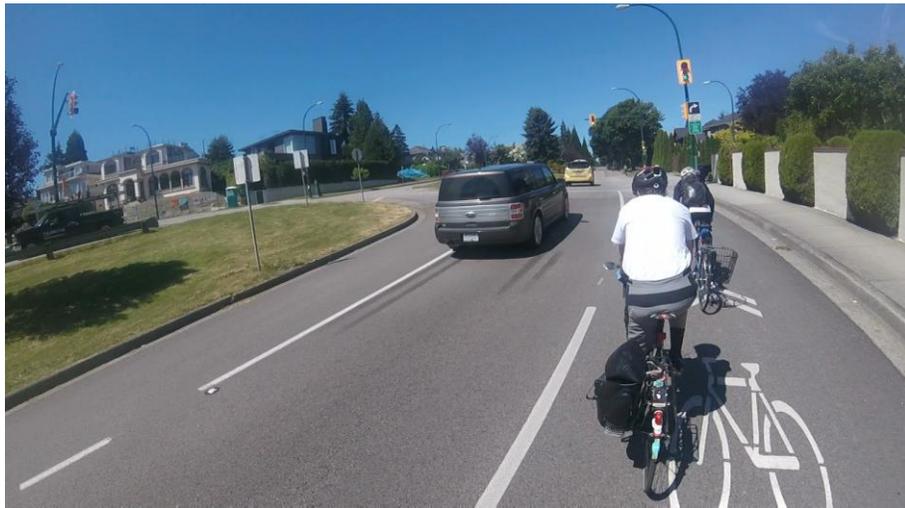
Figure 12 - King Edward westbound approaching Quesnel

Approaching Quesnel, which has a traffic light, there is a left turn lane, a straight through travel lane, and a right turn lane. The painted bike lane disappears at this point, with sharrows painted in the right turn lane, as shown in Figure 12. Ride participants advised that the right turn lane was added in with the repaving work, as there were formerly two lanes (left turn and straight) and room for a painted bike lane. It is disappointing to see the elimination of a bike lane, even a painted one, simply to allow additional motor vehicle lanes. Vehicles were observed moving quickly at the right turn onto Quesnel, which is posted with a 30 km/hr limit, as the turn is not at ninety degrees due to the road geometry. This results in vehicles moving quickly in the shared lane zone on King Edward.

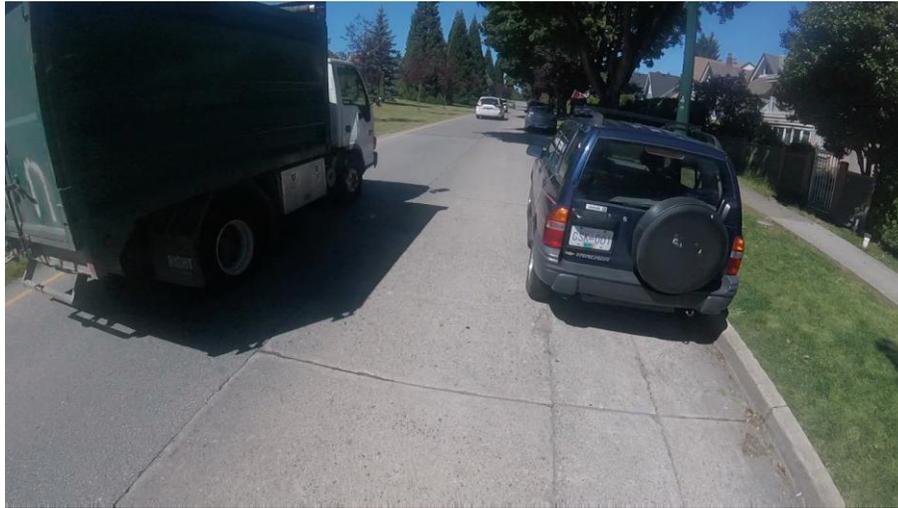
Figure 13 - King Edward westbound after Quesnel

After Quesnel, the painted bike lanes disappear and there are no road markings. There are two lanes of width, with parked vehicles and a travel lane, as shown in Figure 13. Extending the bike lanes three blocks westward to reach Balaclava and Dunbar (both of which are north/south bike routes) would provide significant network connectivity enhancements.

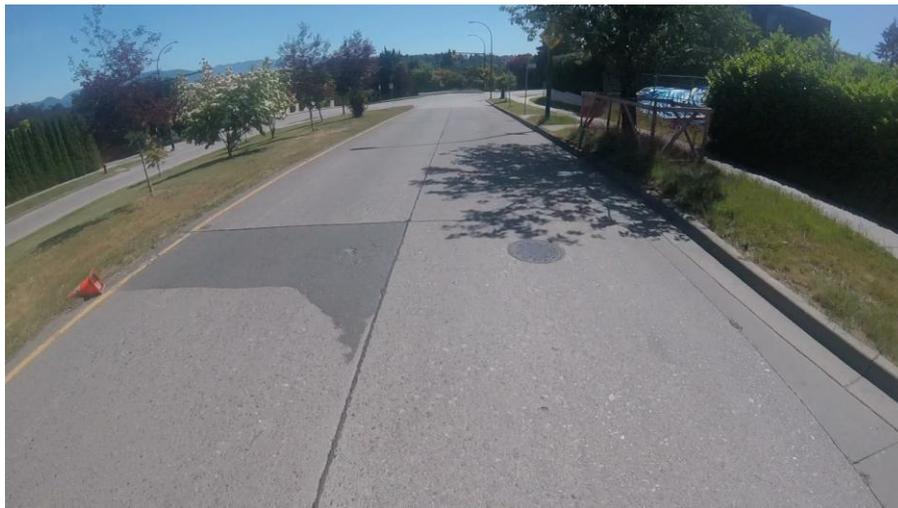
Figure 14 - King Edward westbound after Balaclava

There are no pavement markings for a bicycle lane on this stretch, as shown in Figure 14. The roadway is two lanes wide, with parked vehicles. Because the road descends, and is straight, vehicles were observed to be travelling at higher speeds. The pavement is not in good condition, creating the risk of a bicycle tire catching a groove. Approaching the Ridgeway bikeway on Quesnel, there are two apparent travel lanes, with a transit stop, although without lane markings. There is a caution sign indicating a bicycle crossing, but it is hidden in the trees and not visible. We recommend that this be addressed.

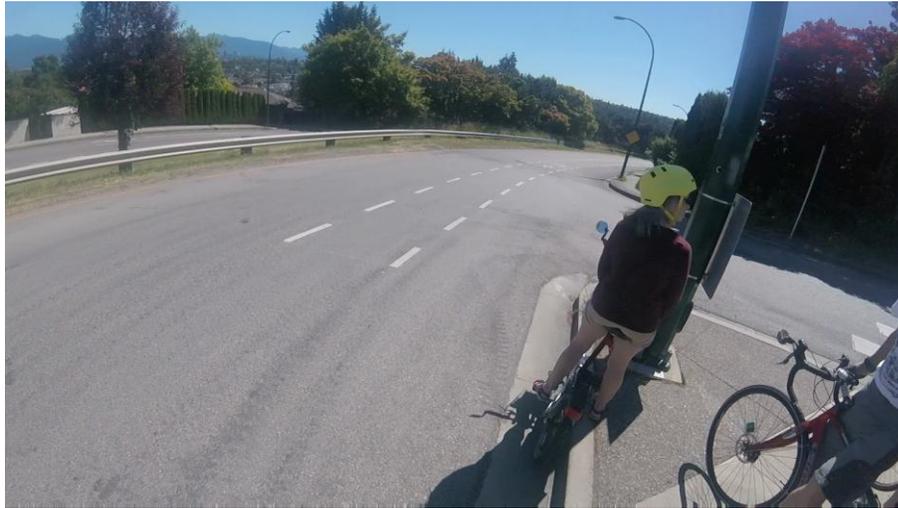
Figure 15 - King Edward eastbound at Quesnel

At Quesnel, there is a slip lane for northbound motor vehicles turning right (eastbound) onto King Edward. A permeable painted bicycle lane restarts just east of Quesnel, with the curb lane for parking, then a painted bike lane, then the motor vehicle travel lane, as shown in Figure 15. Additional risks are created as the curb lane appears to carry through the intersection, causing vehicles to drive in the painted bike lanes while they merge. We recommend that eastbound on King Edward from Quesnel, there be a single painted motor vehicle lane, and a painted bike lane with a buffer, to encourage motor vehicles to use the travel lane. Where the slip road crosses the bike lane, there should be green paint to indicate the conflict zone. Vehicles were observed using the slip lane without slowing sufficiently or yielding to parallel traffic in the bike lane or motor vehicle travel lane, despite the presence of two yield signs.

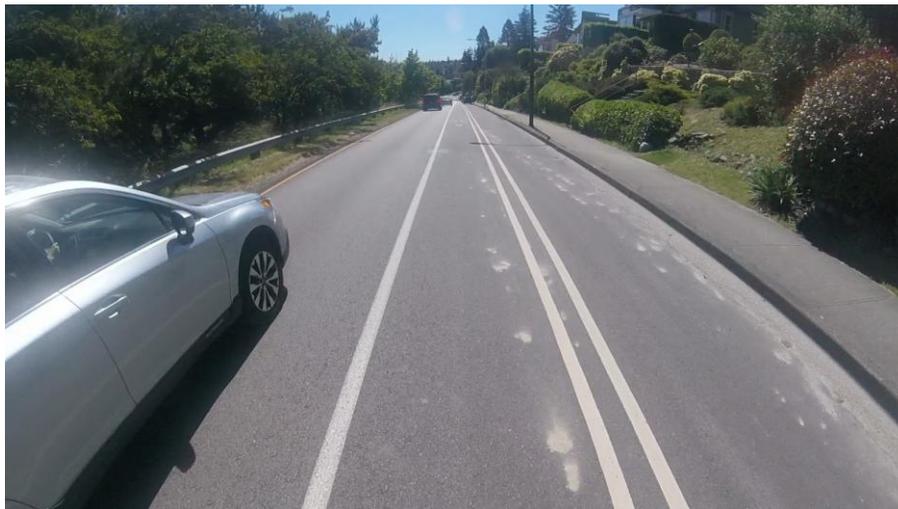
Figure 16 - King Edward eastbound after Quesnel

After Quesnel, the bike lane restarts on the travel lane side of parked vehicles, as shown in Figure 16. Vehicles were observed to be travelling at higher speeds on this downhill section.

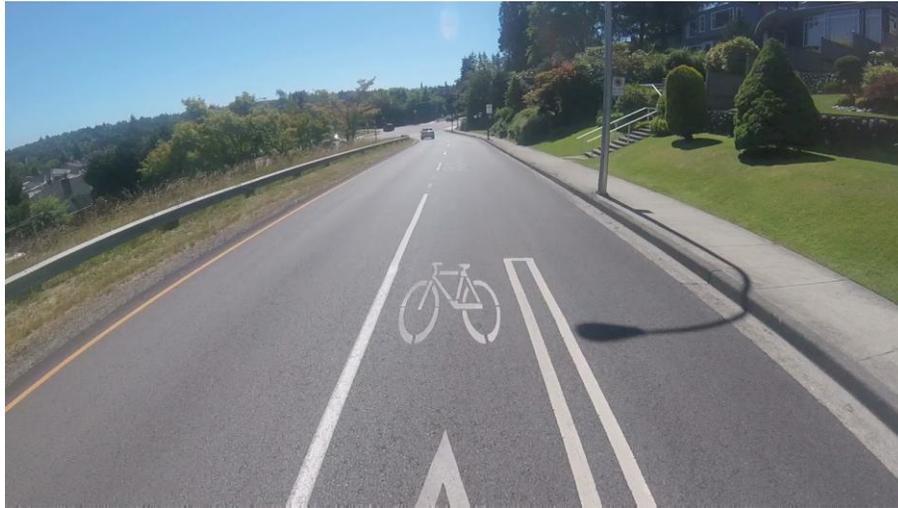
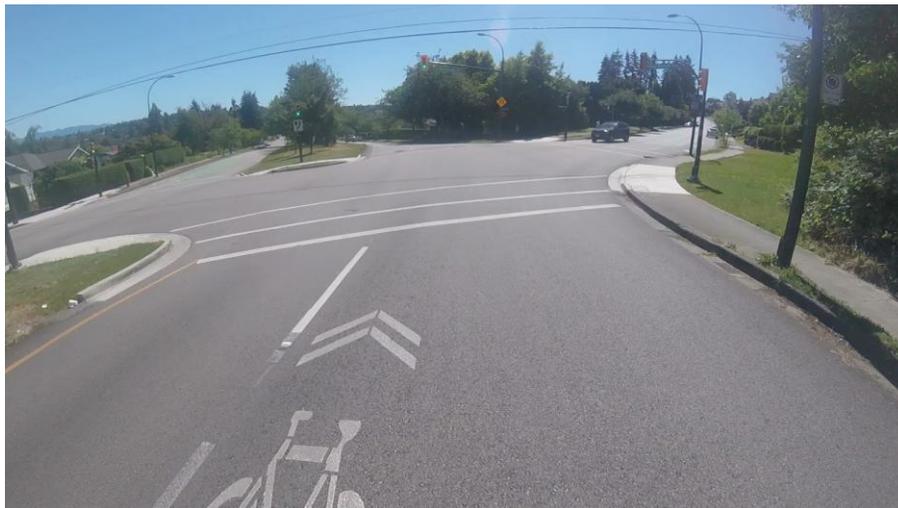
Figure 17 - King Edward eastbound approaching MacDonald

Nearing MacDonald, the bike lane ends and there are two travel lanes, with sharrow in the curb lane, as shown in Figures 17 and 18. This continues through the intersection.

Figure 18 - King Edward eastbound at MacDonald

A significant number of eastbound vehicles were observed turning left on Macdonald, making the curb lane with sharrow the effective through lane for vehicles. As drivers noticed vehicles signalling to turn left, they merged to the right into the shared line, seemingly not aware of people on bicycles. Beyond the competition for road space here, an additional risk is that these vehicles need to move back to the left (travel) lane on the far side of the intersection.

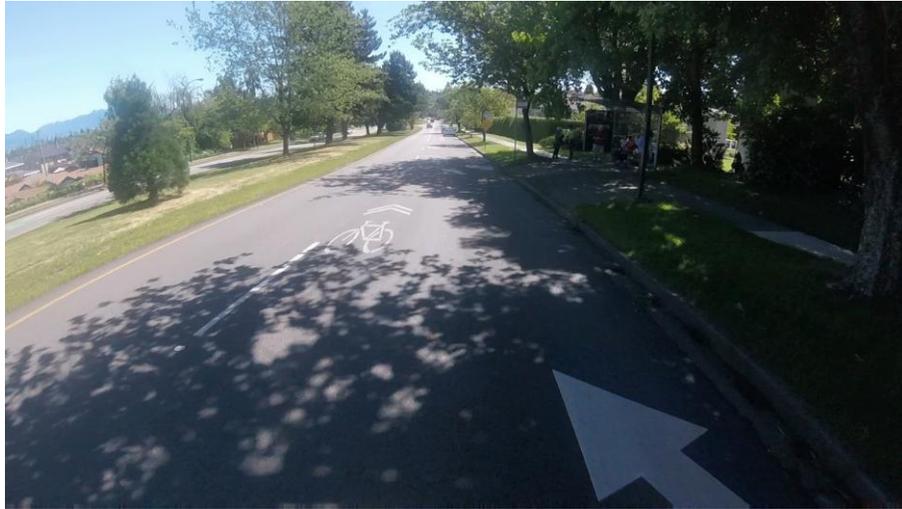
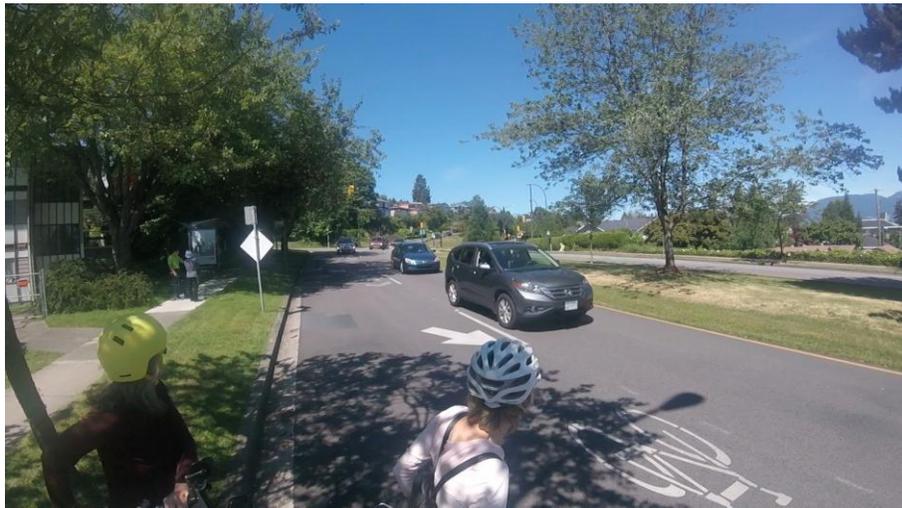
Figure 19 - King Edward eastbound after MacDonald

Immediately after MacDonald, there is a transit stop, with the curb lane having sharrows. This continues until the painted bike lane and parking resume after the transit stop, as shown in Figures 19 and 20. This creates a danger zone as there are vehicles carrying through the intersection in the curb lane, and vehicles turning right off MacDonald northbound onto King Edward, as well as buses, all competing for space with people on bicycles.

Figure 20 - King Edward eastbound after MacDonald

Vehicles were observed driving in the painted bike lane after the transit stop, merging gradually back into the travel lane. It would be safer if eastbound vehicles merged before the intersection, and not in the conflict zone after the intersection. This could be accomplished by painting a left turn lane onto MacDonald northbound from King Edward, with through traffic being directed into the centre lane, and a painted bicycle lane at the curb.

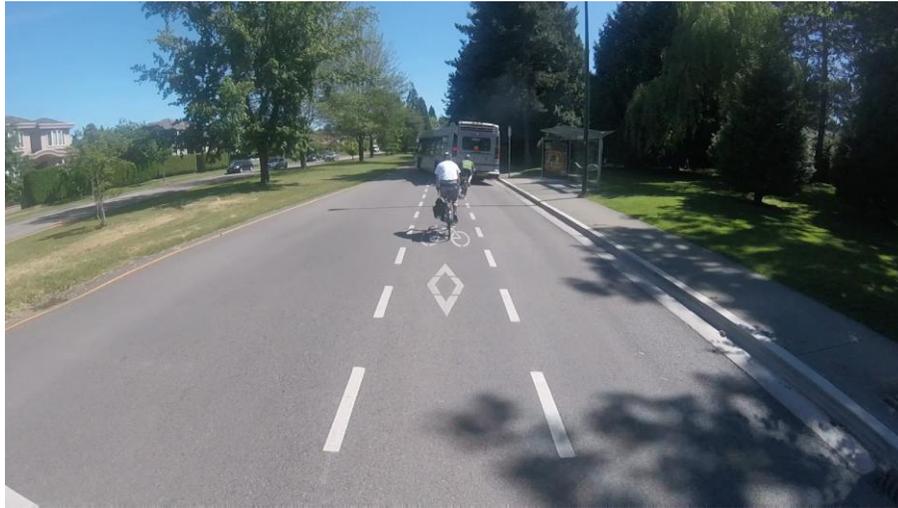
Figure 21 - Conflicts at transit stops

All along the route, there are transit stops. Buses were observed pulling out immediately in front of people on bicycles in the bicycle lane, as shown in Figure 21. It was suggested by ride participants that many vehicle operators appear to not expect people on bicycles along this route, likely due to the low number of bikes encountered. These few users result in the opposite of ‘safety in numbers’ and could be a reflection of whether people on bikes feel safe using this route.

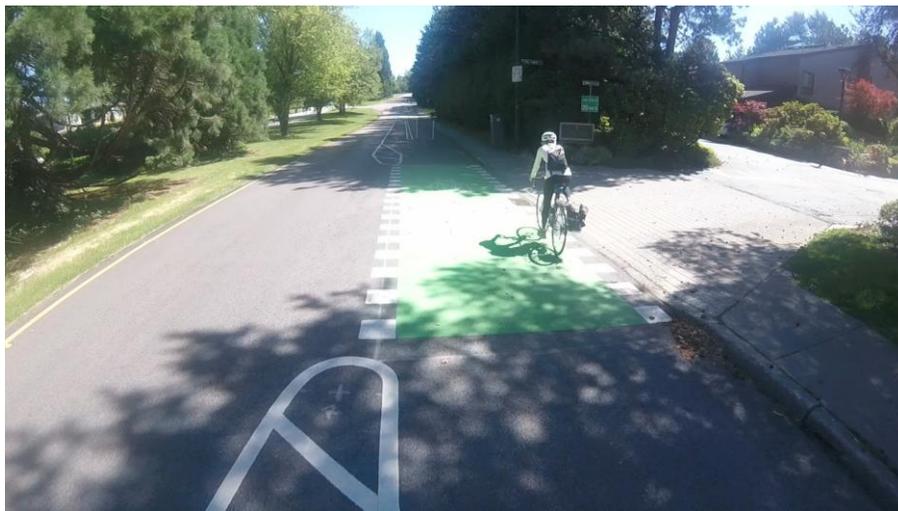
Figure 22 - Bike lane jogs at driveways

Near Yew, there are strata developments on the south side, with driveway entrances. These entrances have green paint applied, and the bike lanes jog towards the curb for the duration of the driveway entrance. This creates a wider turning space for vehicles entering or leaving the developments, but also creates a slalom for people on bicycles.

While not observed, it was reported by local residents that people on bikes coming from Arbutus Village avoid the intersection at King Edward by cutting through the park, and then salmoming westbound down the eastbound bike lane near the strata developments. This has reportedly caused conflicts at these intersections as drivers exiting the developments do not expect westbound bikes.

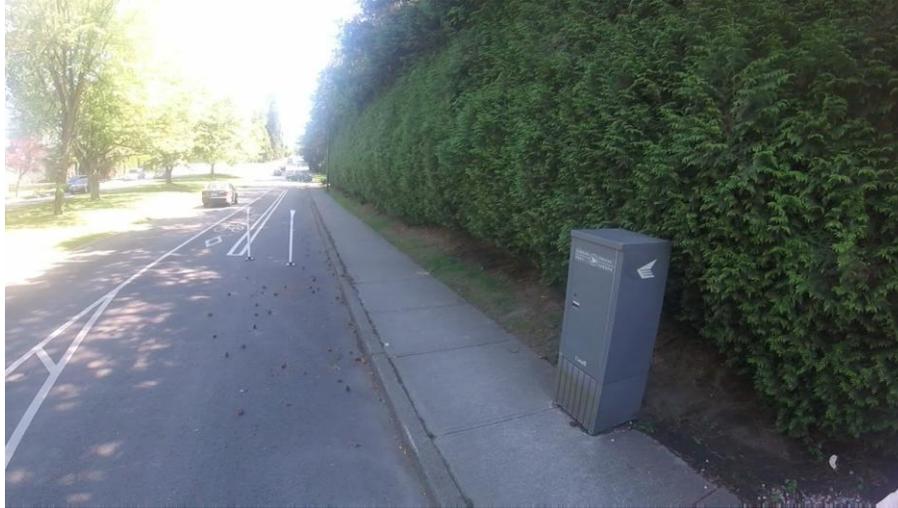
Figure 23 - Bike lane narrows

Both the curb (parking) lane and the painted bike lane are noticeably narrower at this point, as shown in Figure 23, likely due to the existing roadway width. This makes it more likely for parked vehicles to be partially obstructing the bike lanes. Also, plastic pylons have been erected, presumably to stop drivers from using the curb lane to jump ahead of the lineup at the Arbutus light.

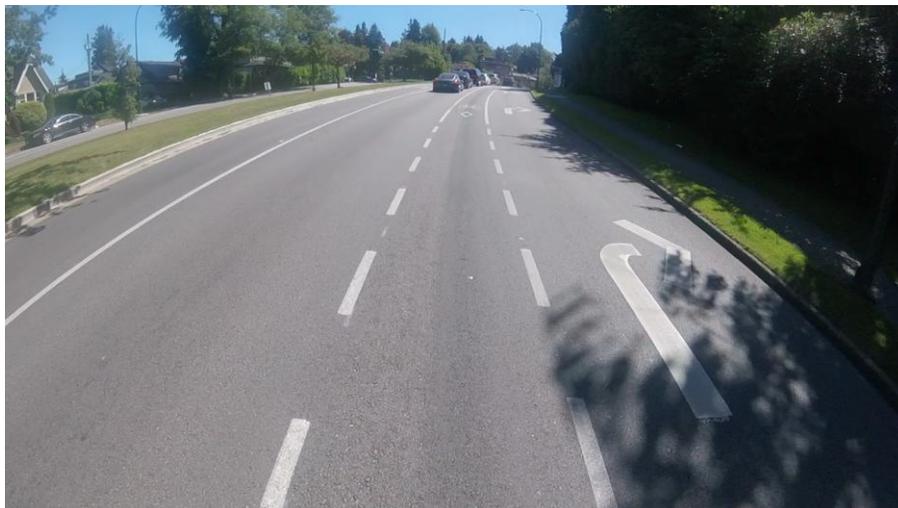
Figure 24 - King Edward eastbound approaching Arbutus

Climbing the hill to Arbutus, there is a transit stop, then a right turn lane, as shown in Figure 24. This results in motor vehicles moving into the right turn lane early, and overtaking people on bikes on the hill where there is not sufficient width. This was found to be very uncomfortable for people on bikes. There are no painted buffer zones here.

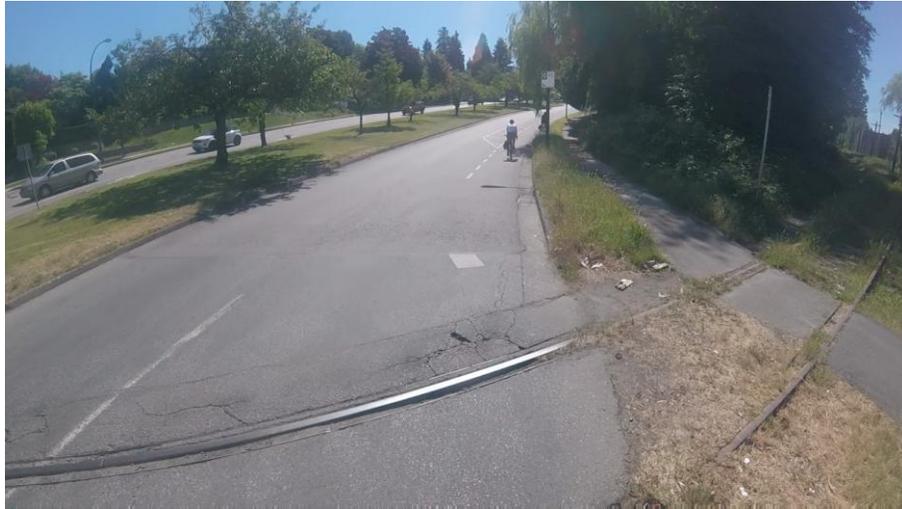
Figure 25 - King Edward eastbound after Arbutus

This block has a painted bike lane, with painted buffer zone, from Arbutus to Maple. However, the painted bike lane does not begin right at Arbutus, but some distance later, after King Edward crosses the new Arbutus Greenway. This encourages right turning vehicles from Arbutus to use the curb lane to merge into traffic. This will require improvement with construction of the future greenway paths. The intersection could be protected with northbound right turning vehicles on Arbutus having to turn into the main travel lane instead of the curb lane where the bike lane is. The eastbound bike lane on the west side of Arbutus could then continue through the intersection to this point, with green paint applied.

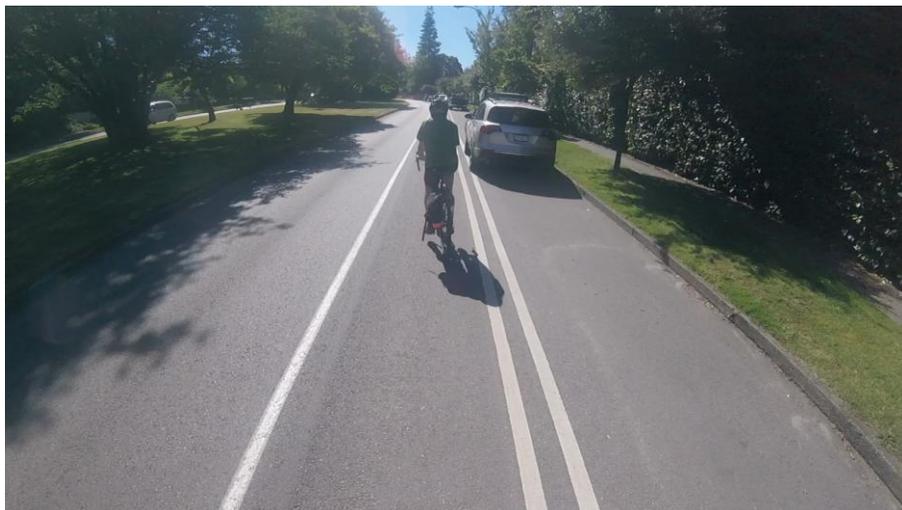
Figure 26 - King Edward eastbound after Maple

After Maple, parking is permitted, and the painted bike lane is positioned on the travel lane side of the parked cars, with no buffer zone for the first part, and then an approximate 12" buffer zone for the remainder. Vehicles were observed parking over the line into this zone. The decision here, as in other sections, comes down to whether the buffer zone is adequate, and whether a trade off should be considered with vehicle parking space. Note that all of these residences have rear lane access.
