## Proposal for Improvements to the Midtown and Ridgeway Bikeways

**March 5, 2019**

**Vancouver-UBC Local Committee**

**HUB Cycling**

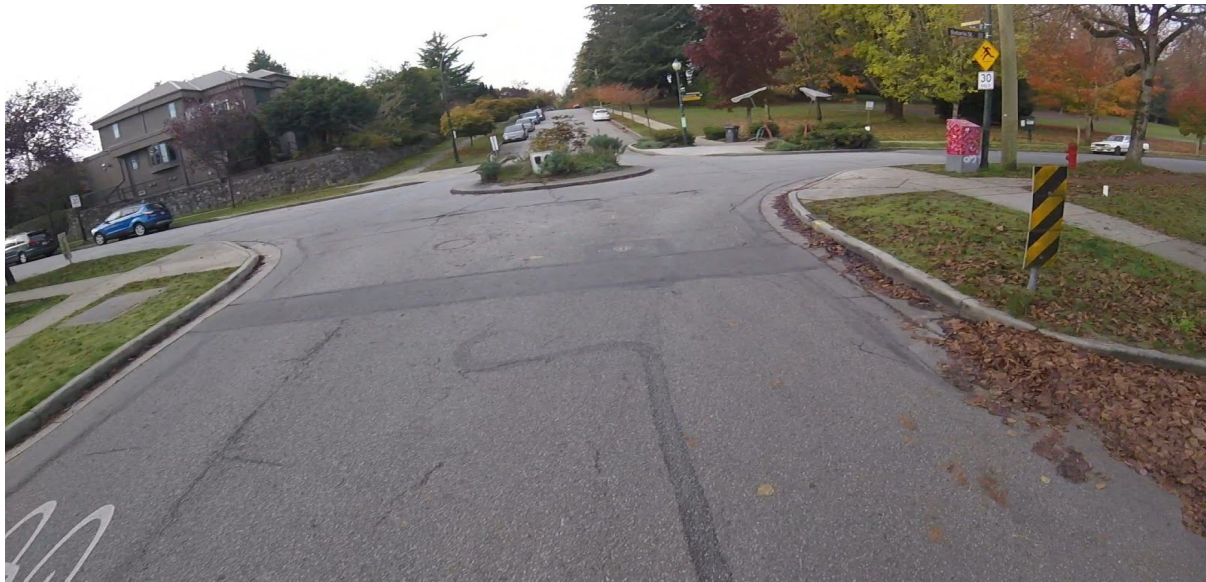
HUB Cycling has received public feedback on dangers and near misses at the Ontario and 37th traffic circle (figure 2). ICBC reports 6 crashes involving motor vehicles at this intersection, which is a crossing of two busy bikeways. There are two downhill slopes to the traffic circle, resulting in some users travelling quickly into the roundabout, both in vehicles and on bicycles. Signs warning of a bike route crossing, posted uphill of the intersection on both routes, may help. The traffic island has the lowered Keep Right signs, to help improve visibility through the intersection, but the vegetation has not been trimmed to maintain that visibility. Given the volumes of users at this crossing, a raised crosswalk instead of the traffic circle should be considered. A relatively higher volume of vehicle traffic was observed along this stretch of 37th. The pending Little Mountain residential development from Ontario to Main is expected to bring more local traffic to

Figure 2 - 37th and Ontario traffic circle looking west

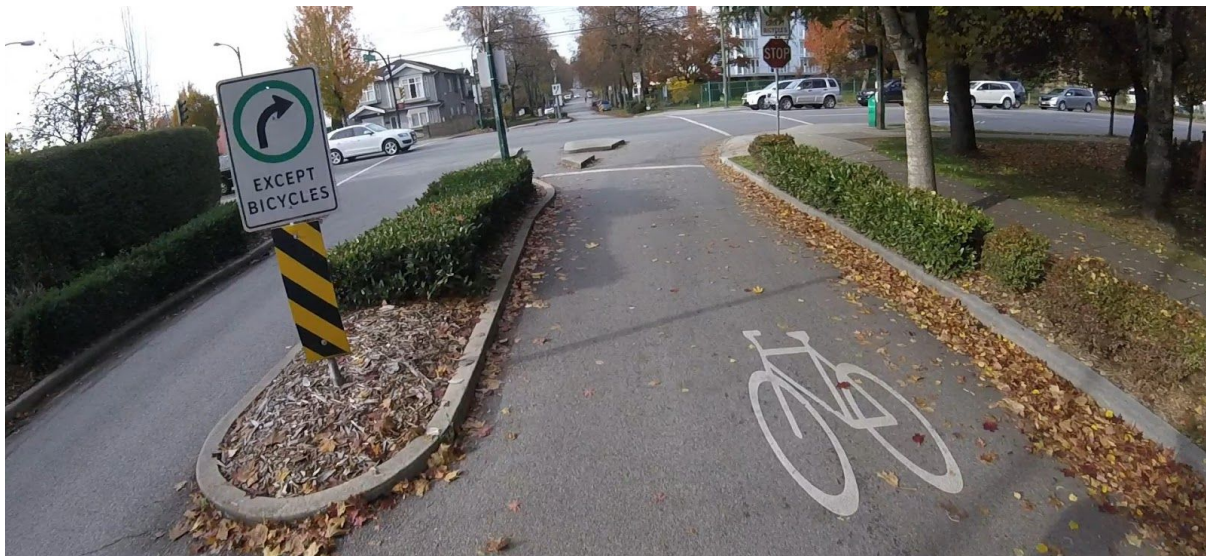
this neighbourhood. At Main St a push button for people on bikes crossing Main St is placed in the centre island along 37th (figure 3). Traffic islands are marked to prevent vehicles from travelling straight through on 37th, with only right turns out of 37th, and right and left turns in to 37th permitted. Vehicles have been observed travelling straight through on 37th in violation of these signs; a centre island on Main would curtail this, and together with an elimination of left turns in to 37th from Main, would also serve to reduce vehicle traffic on 37th. Painting the islands, or at least the curbs around the islands, would improve their visibility at night

Figure 3 - 37th at Main St looking west

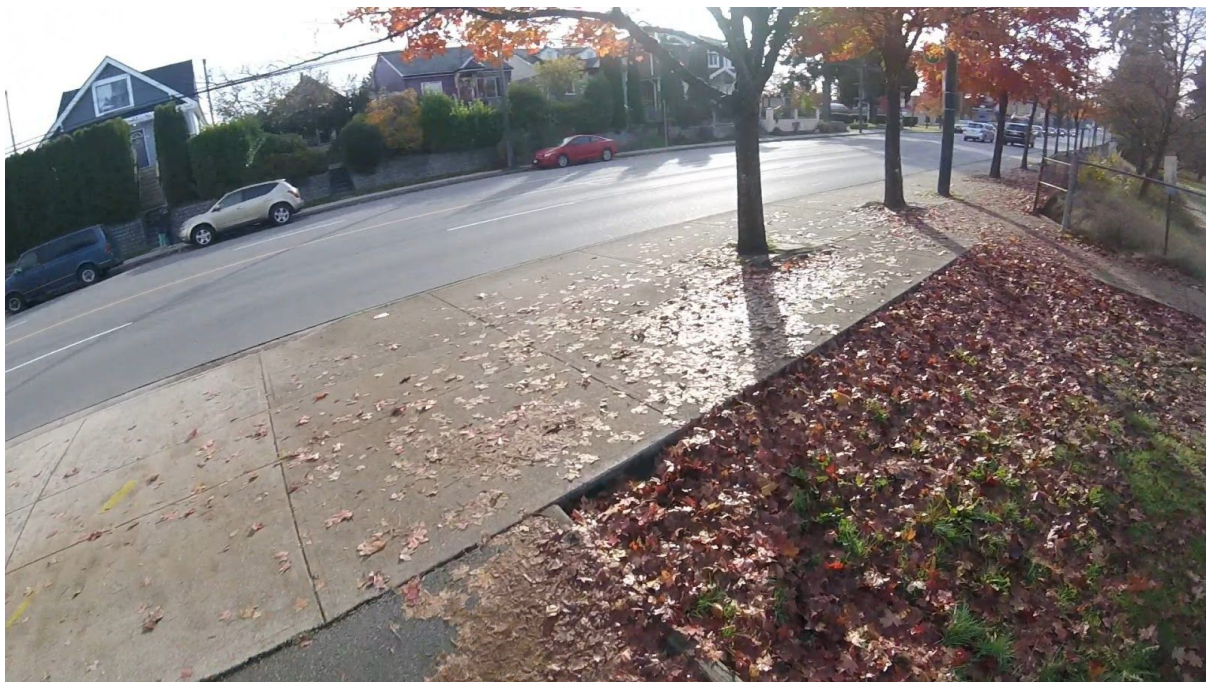
Figure 5 - 37th at Fraser St showing the MUP on the sidewalk. Painted lanes on the MUP along with turn arrow stencils, would improve safety for users of all modes at this corner, as the bike/walk signs are located in the trees along the path, but not at the start of the MUP.

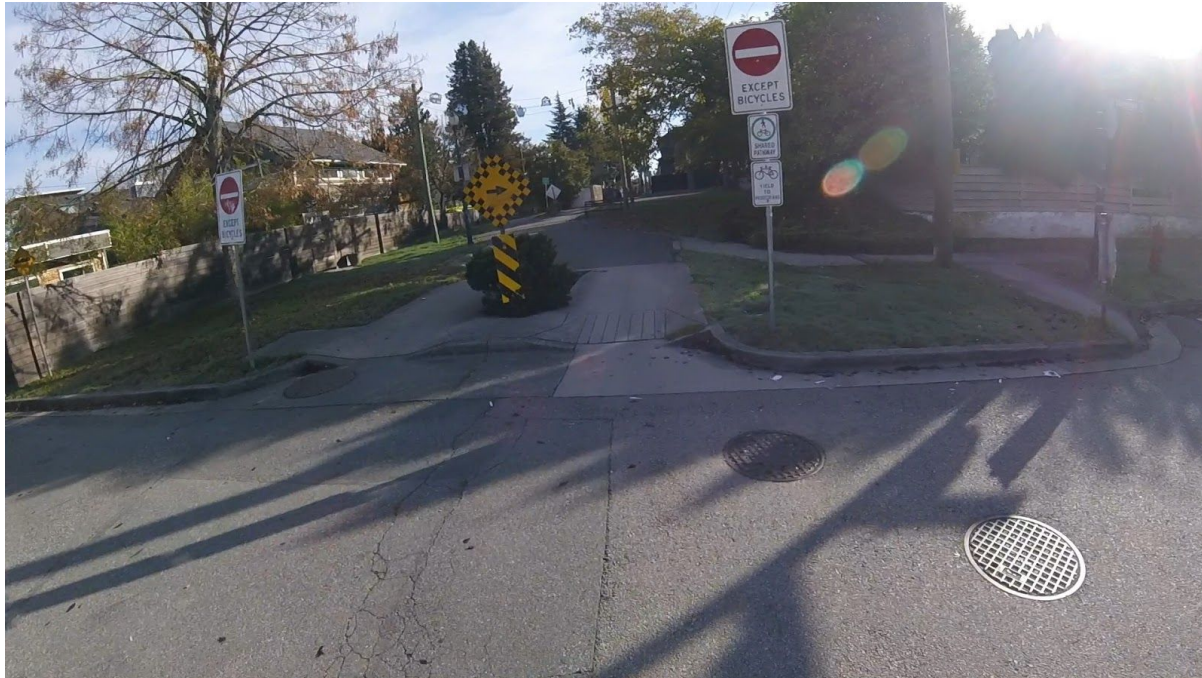
At Inverness, 37th is closed to through motor vehicle traffic with a parklet (figure 6). The multi-use path is marked as at Ross St, and similarly, would benefit from the addition of directional arrows on the pavement at the entry and exit points.

Figure 6 - 37th Ave at Inverness St. showing parklet

people cycling. The paths are generally narrow, with narrow curb cuts, and as user volumes have increased, conflicts between people walking and people on bikes are becoming more frequent. Examples of these paths are shown in Appendix 1, in figures 4, 5, 6, 13, 14. Consideration should be given to marking areas for people walking and people cycling. Where there is insufficient space for mode separation, directional arrows should be added to reduce the likelihood of conflict (figure 6)

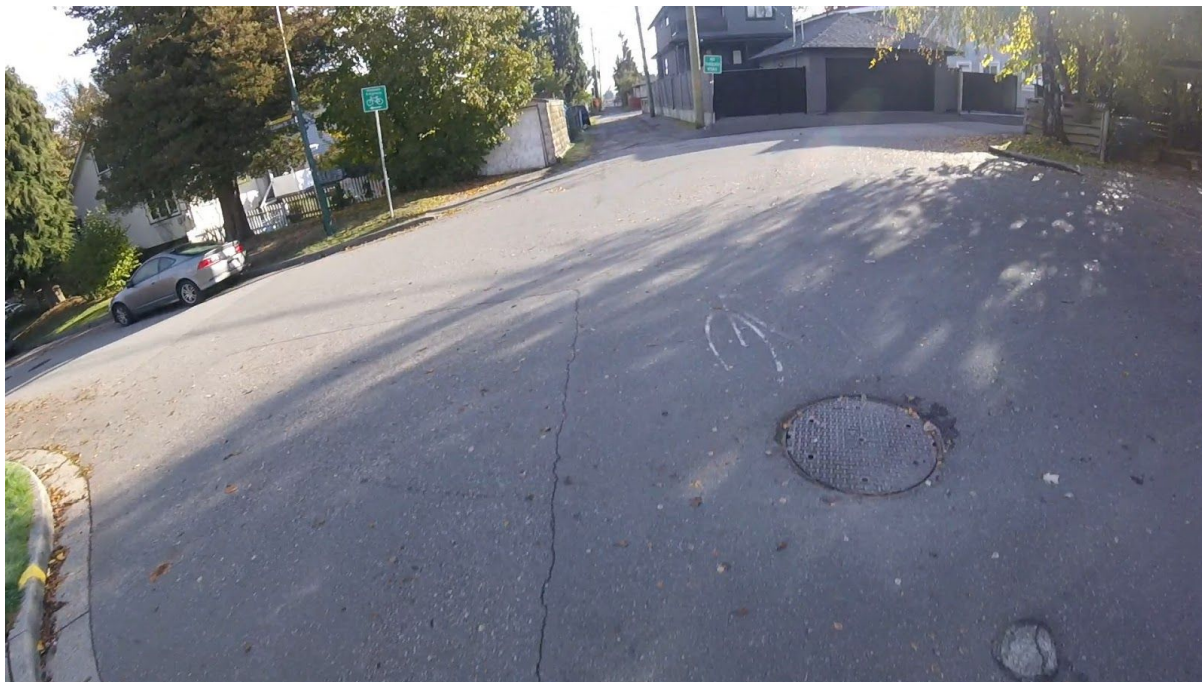
Immediately east of Inverness, at Culloden St, 37th jogs to the north. This happens at a point where two back lanes join the cul-de-sac. It is not readily apparent to people on bikes travelling eastbound that the Ridgeway and Midtown routes turn to the north here. There is a small green bikeway sign on the curb opposite the parklet exit, and a faded bike stencil on the pavement (figure 7). The stencil requires repainting, with a larger arrow, and the green bikeway sign should be reviewed for visibility. This is more of an issue eastbound, as people on bikes westbound come to a T intersection and are less likely to lose the bikeway route. Northbound on Culloden, there are street signs but a bike stencil and arrow would assist with wayfinding for people on bikes.

Figure 7 - 37th Ave at Culloden where the Ridgeway Bikeway jogs to the north. The stencils and arrows require repainting.

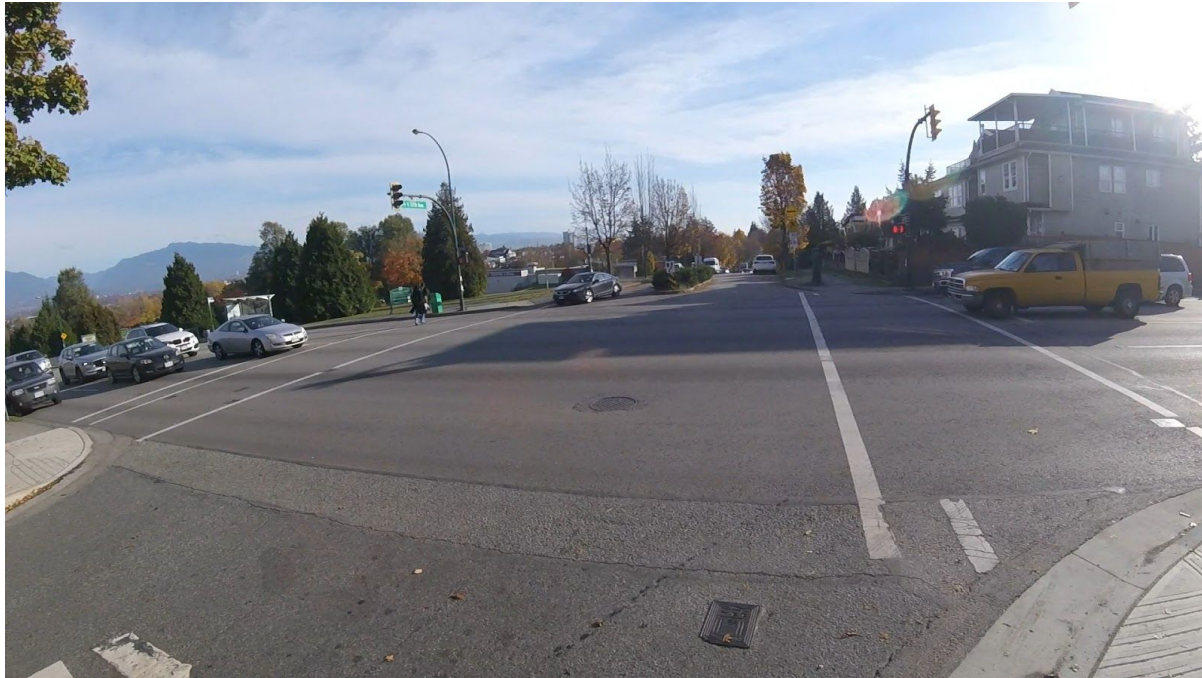
Approaching Knight St, a higher volume of vehicle traffic was observed along the Ridgeway bikeway. There is a push button crossing at Knight St, but there are no vehicle restrictions whether for through traffic on 37th, or turning movements in to or out of 37th St (figure 8). This intersection should be considered for additional traffic diversions to reduce vehicle traffic on 37th, and improve comfort and safety for people on bikes.

Figure 8 - 37th Ave at Knight St. This busy intersection has no traffic diversions to reduce shortcutting along 37th Ave.

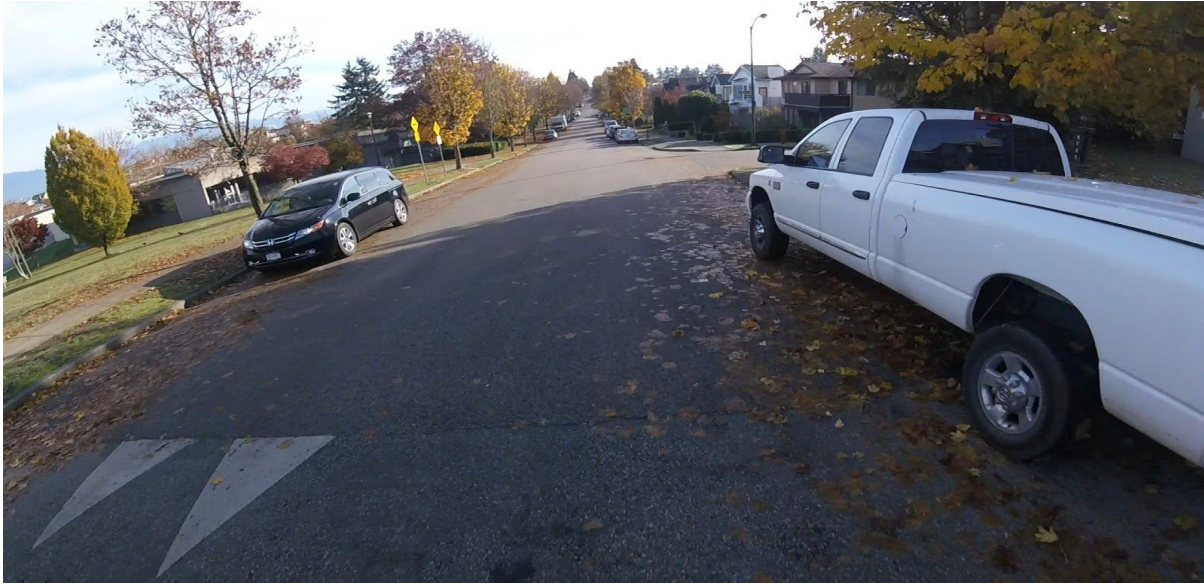
As with 37th west of Knight, a relatively higher volume of vehicle traffic was observed, and potentially due to the wider roadway, people in vehicles were observed travelling at a higher speed (figure 9). This may also relate to the 30 km/hr signs being posted along with playground signs, and not as standard speed limit signs. As playground signs are only in effect from dawn to dusk, this practice provides no benefit for people on bikes travelling outside of these hours.

Figure 9 - 37th east of Knight St. The wider built roadway and lack of traffic diversions at Knight St. result in higher apparent vehicle speeds along this stretch, and more vehicle volume, both combining to make people on bikes less comfortable here.

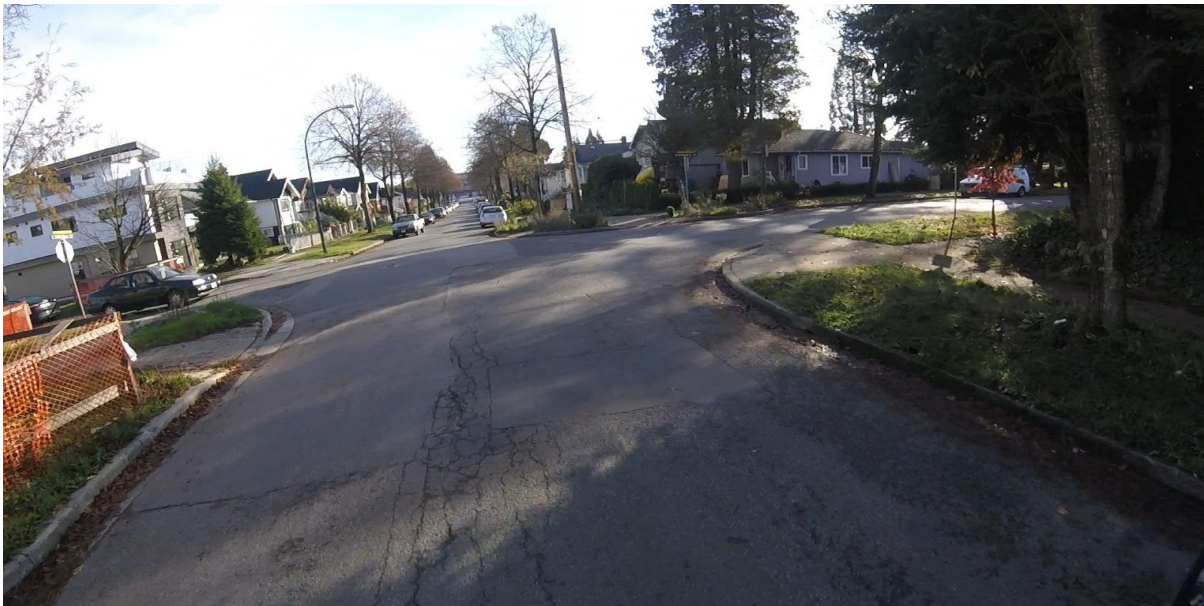
Figure 10 - 37th Ave at Commercial St requires a stencil and arrow to improve wayfinding where the Ridgeway Bikeway jogs to the south.

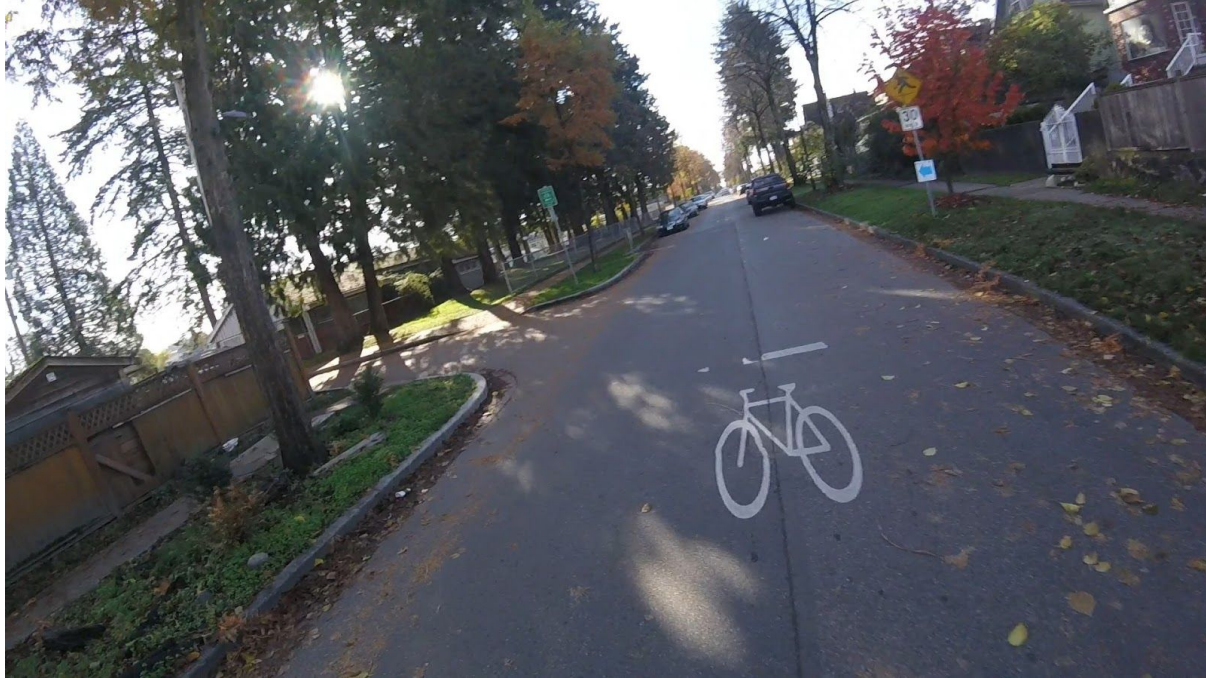
Figure 11 - Commercial St at Jones Park requires a turn into a back lane to connect to the MUP in the park. The stencils and arrows require repainting.

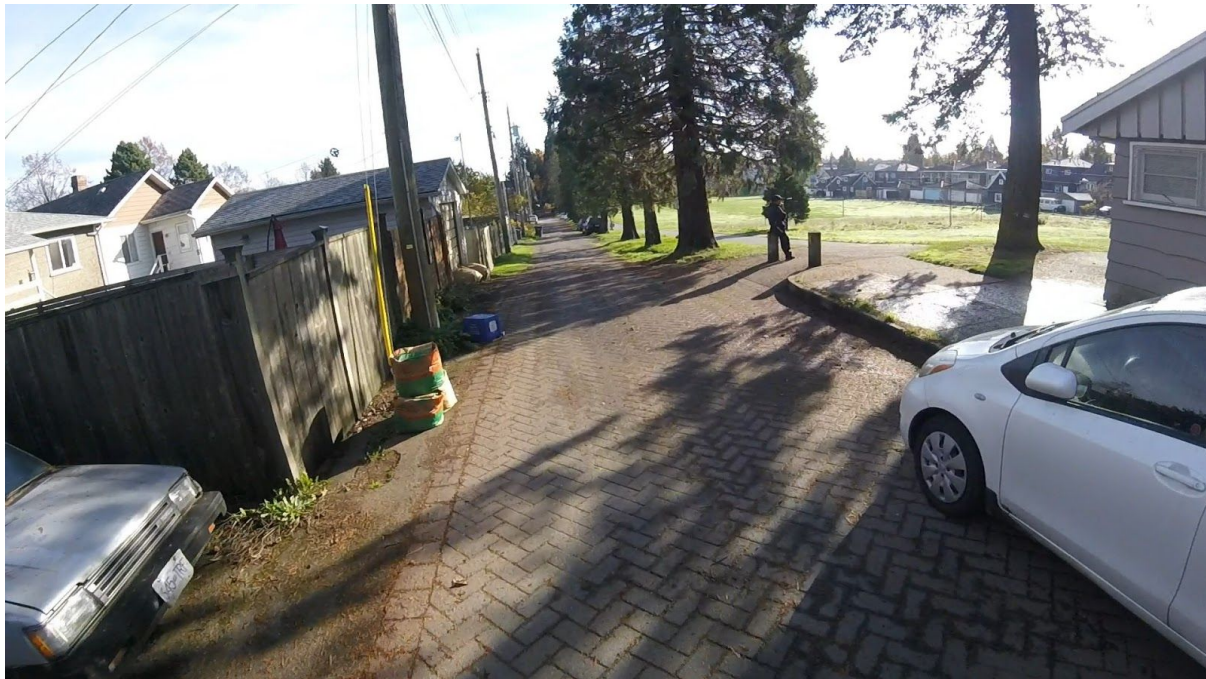
Figure 12 - From the back lane, there is an unsigned jog into Jones Park. This turn requires wayfinding signage, preferably stencils and arrows. The bollards require better reflectors that are visible from the direction of travel.

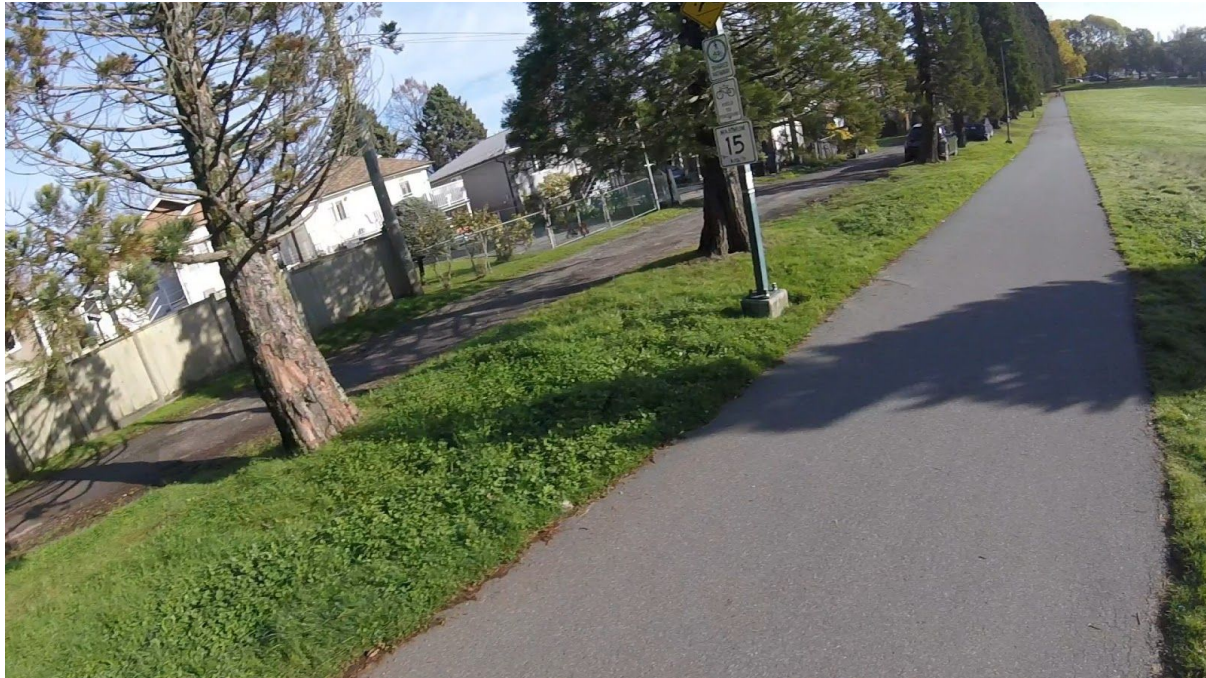
Figure 13 - Along the MUP in Jones Park there are signs for people walking and people on bikes. These signs should be relocated to the start of the path near Commercial St. Stencils should be applied to the pathway.

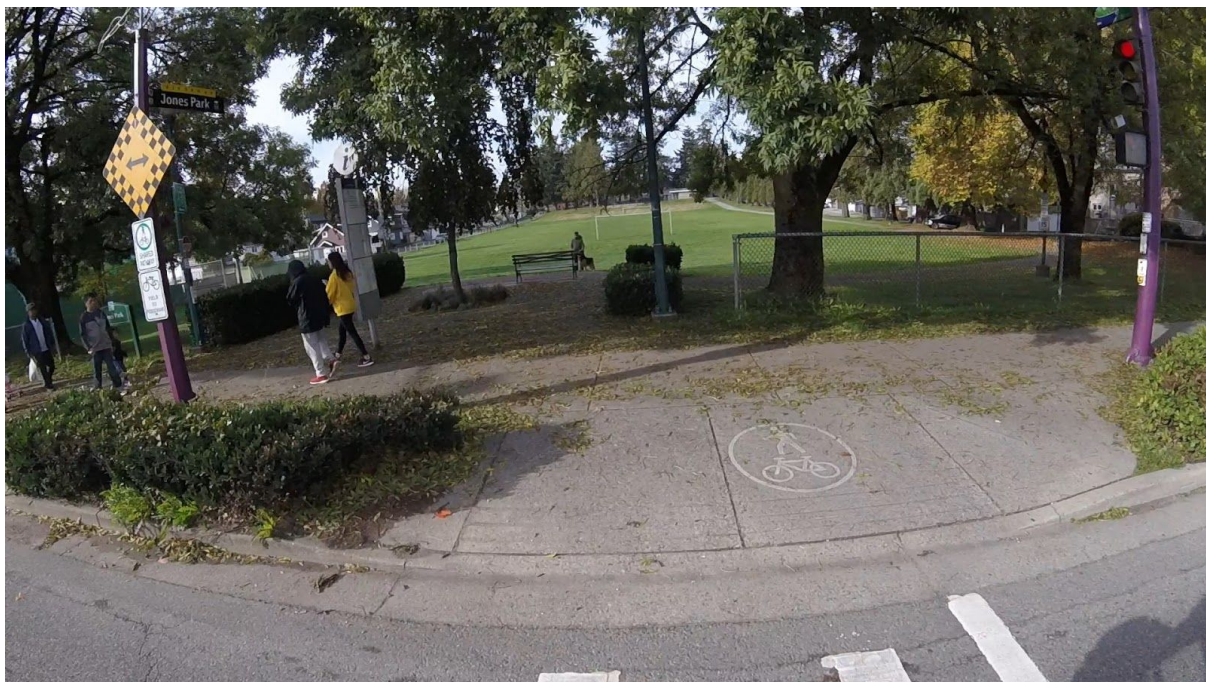
separate sidewalk, and two separate entry/exit points to the cross bikes painted on Victoria Dr (figure 14). These cross bikes are very narrow and should be repainted at a standard width. A review of traffic movements (people walking and people on bikes) should be done by City staff for the plaza, to improve safety and comfort for all users.

Figure 14 - Where the MUP in Jones Park meets Victoria Drive there is a small plaza with people walking, and people on bikes. Traffic flow is confused, and the path through the plaza does not appear to be appropriate for the volume of users along the Ridgeway Bikeway..

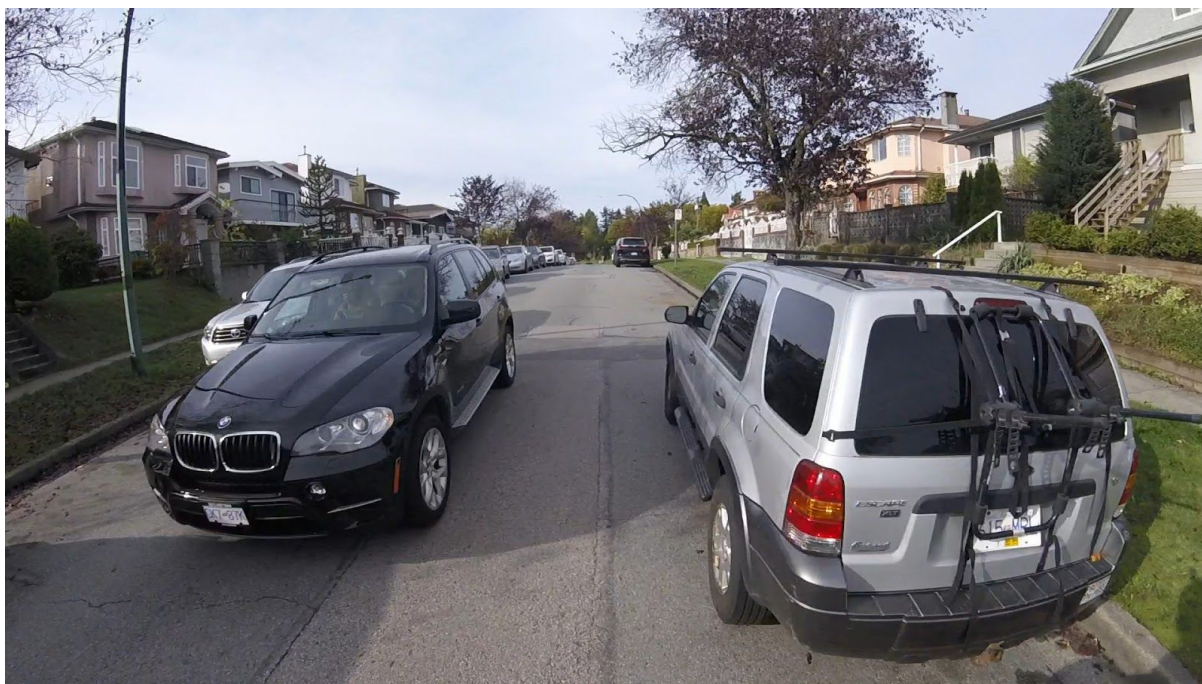
Along this stretch of the Ridgeway and Midtown bikeways, a higher volume of vehicle traffic was observed (figure 15). There are no traffic diversions along this stretch; it extends to Earles St, which connects to Kingsway, thereby providing a shortcut for people in vehicles. Traffic counts should be reviewed along this section, and consideration given to additional diversions to reduce vehicle volumes.

Figure 15 - Along 38th near Victoria Drive, higher volumes of vehicles were observed, and with parking permitted on both sides of 38th space was limited with oncoming and overtaking vehicles.

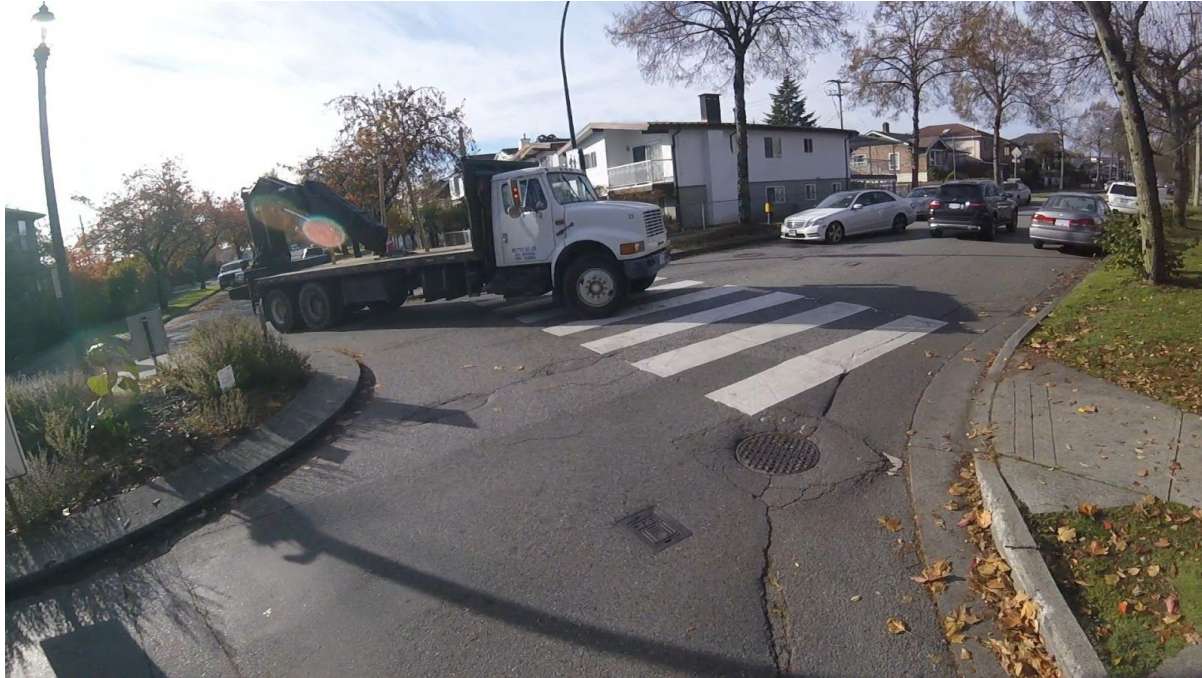
At Nanaimo and 45th there is a relatively small traffic circle situated in a wide roadway. A truck was observed turning left by travelling the wrong way around the traffic circle,

immediately in front of oncoming people on bikes (figure 16). While large trucks may need to make special movements at traffic circles, they should be done after oncoming and intersecting traffic has cleared, or come to a stop.

Figure 16 - Traffic circle at Nanaimo and 45th, with a vehicle travelling in the wrong direction in front of oncoming bicycles.

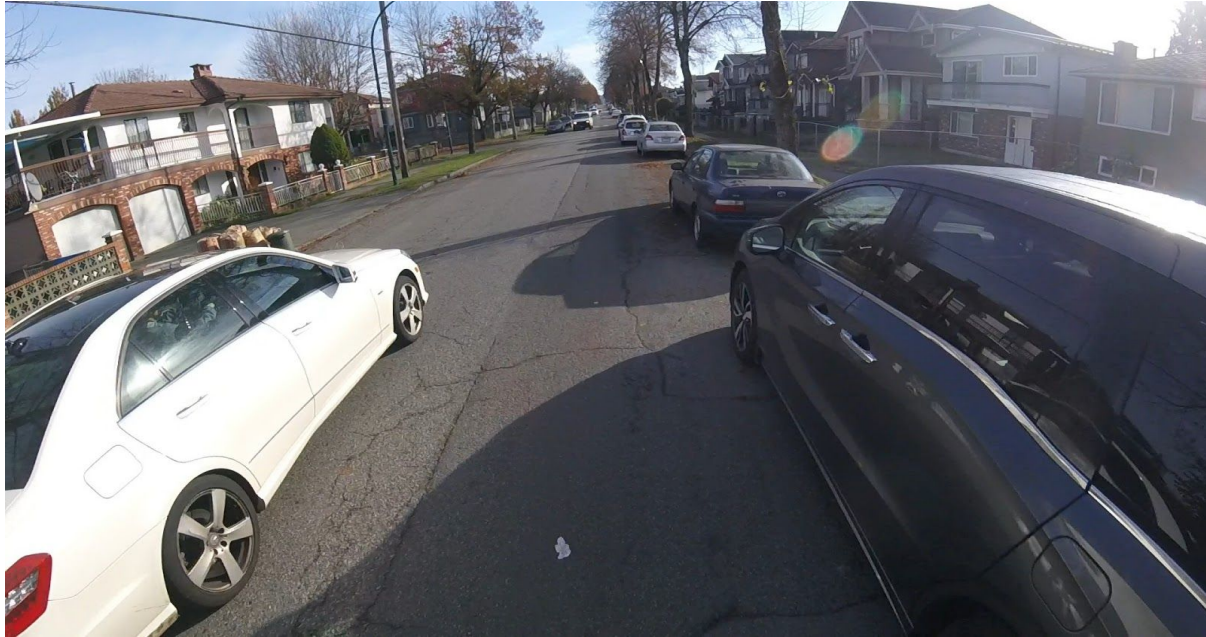
Figure 17 - 45th Ave near Nanaimo showing a vehicle overtaking at high speed

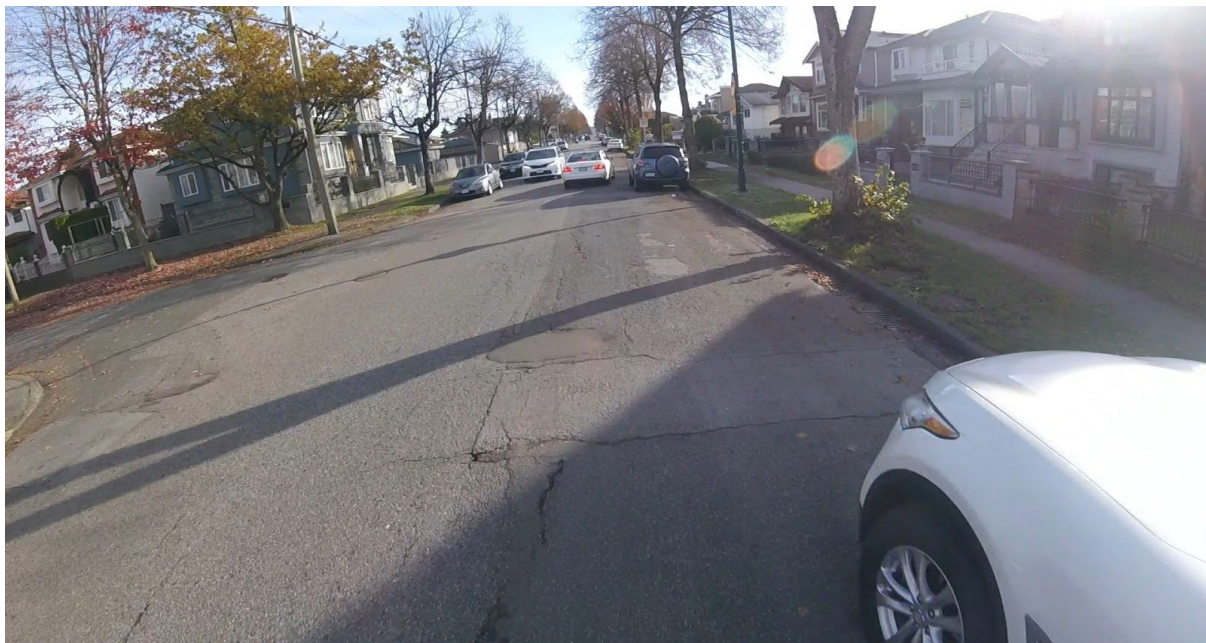
Figure 18 - 45th Ave near Nanaimo showing the overtaking vehicle braking to avoid oncoming vehicle traffic

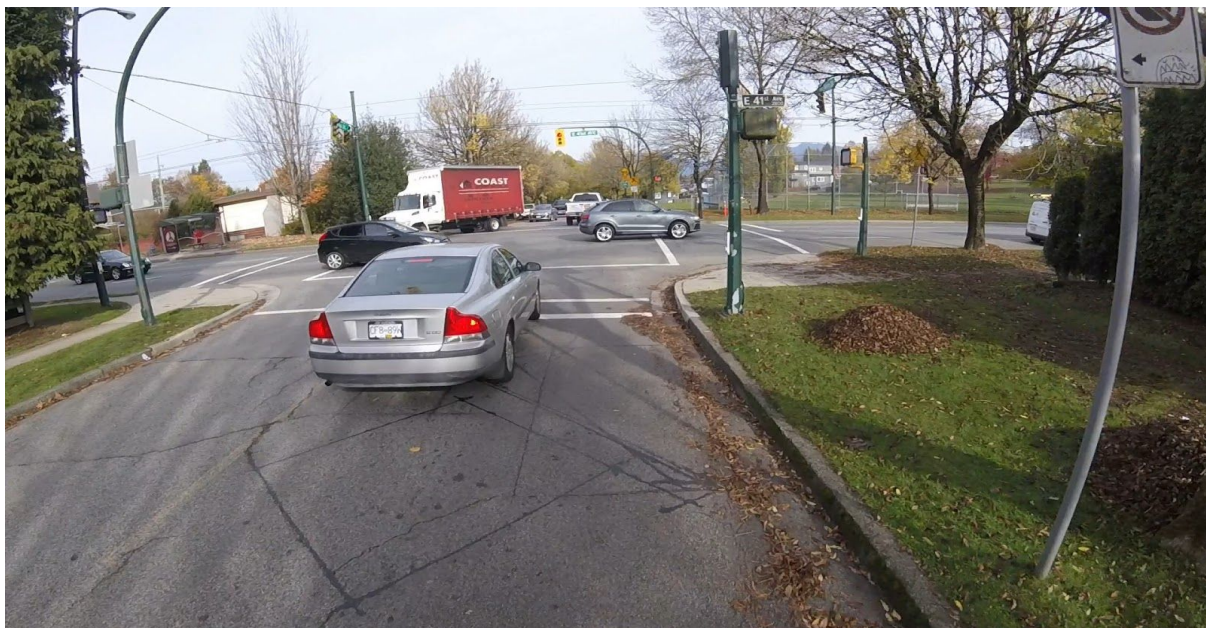
Earles St provides an alternate connection from 38th to 45th. It is part of the Sunrise bikeway. Earles St. had higher vehicle volumes, particularly near 41st (figure 21).

Figure 21 - Earles St at 41st Ave, showing a high volume of vehicles on the local street bikeway.

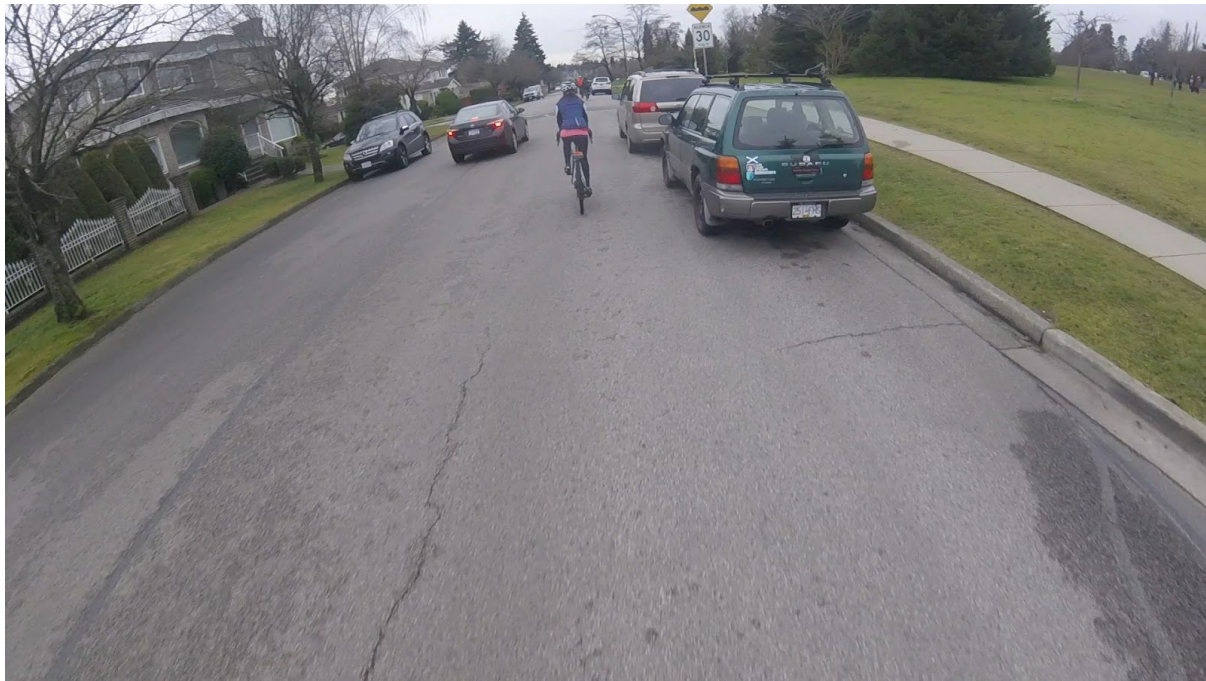
This section runs along the north side of Queen Elizabeth Park. Vehicles were observed travelling at relatively high speeds, despite the speed bumps (figure 23). This section appears to be used as a cut through to access Cambie St. Parking is permitted on both sides of the street. This section is in the Eric Hamber Secondary catchment up until Granville St. Consideration should be given to removing parking from alongside the park on the north side of 37th (figures 23 and 24). If parking is removed, it is recommended that the street be narrowed by putting in a protected bikeway - otherwise even higher speeds would result

Figure 23 - 37th looking west from Ontario showing an overtaking vehicle braking for the speed bump.

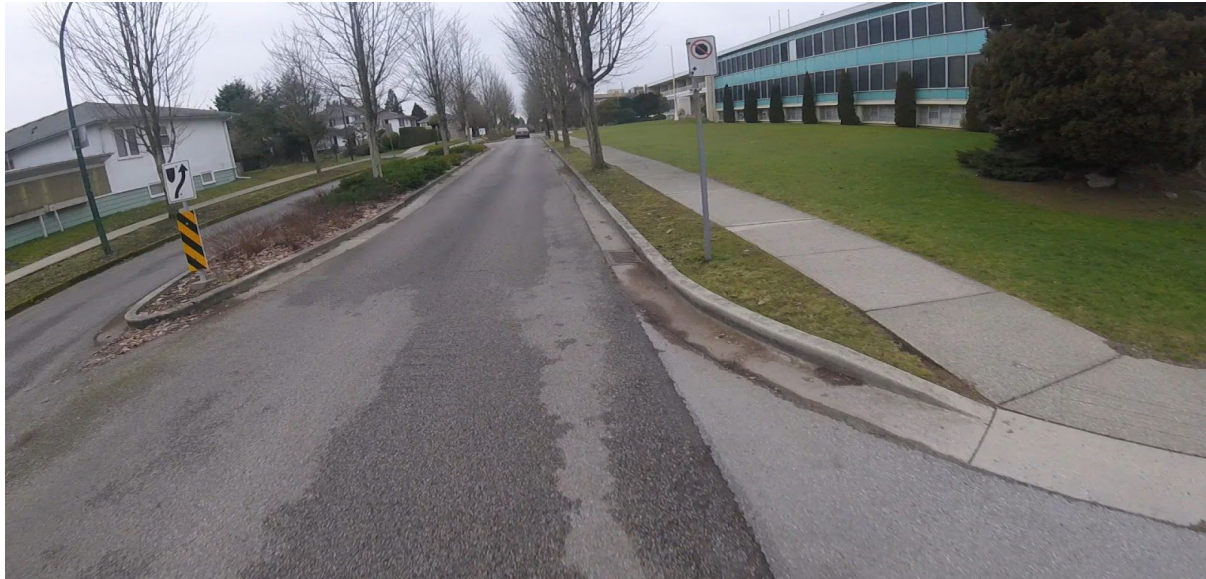
Along this section there is a centre boulevard island (figure 25). This creates narrow lanes that are not wide enough for overtaking. Signage (at least some of which should be on the street) is required indicating where people on bikes should be positioned in the lane, preferably in the centre. Redevelopment in this area has significant potential for impact on traffic patterns. Portions of this section are wide and straight, leading to higher vehicle speeds (figure 26).

Figure 25 - 37th Westbound from Cambie showing the centre boulevard island.

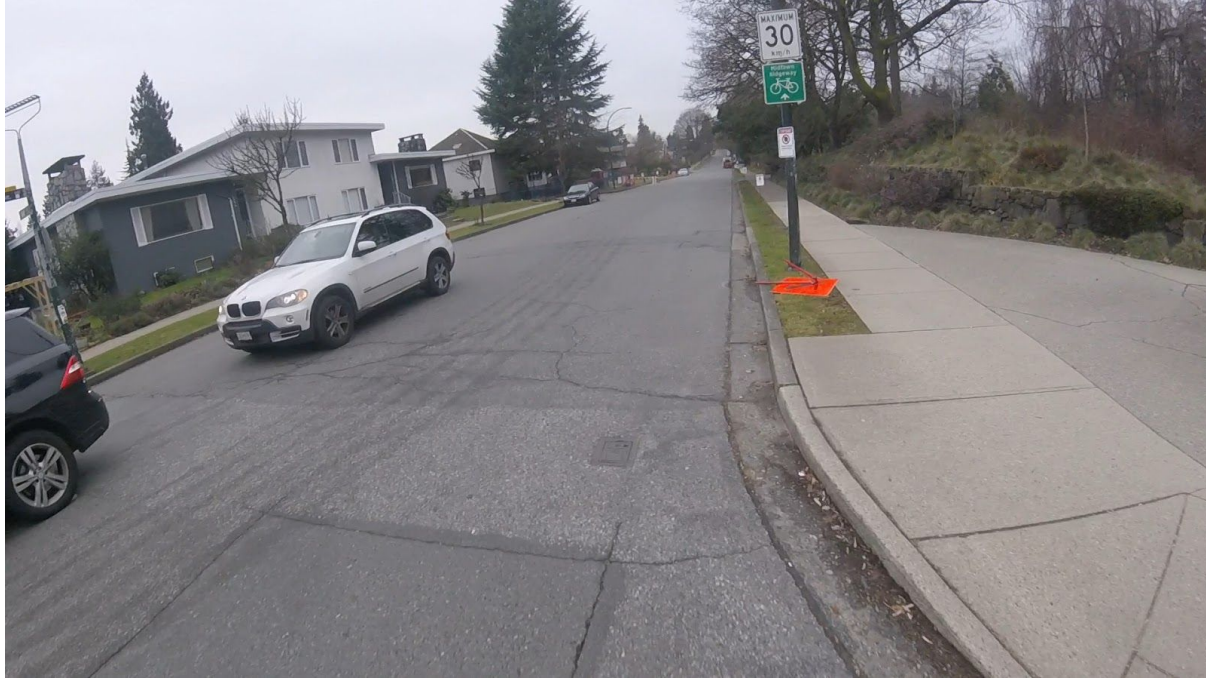
Figure 28 - 37th Westbound from Oak

From Oak St west, the roadway is straight and relatively wide (figure 28). Vehicles were observed travelling at higher speeds along this stretch, presumably cutting in between Oak and Granville. There are no traffic diversions at either Oak or Granville to reduce the incidences of vehicles cutting through this section (figures 27 and 29). The Van Dusen Gardens abutting this route holds events which cause significant traffic and parking issues when they are being held. During our ride, a film crew was observed taking down their equipment here.

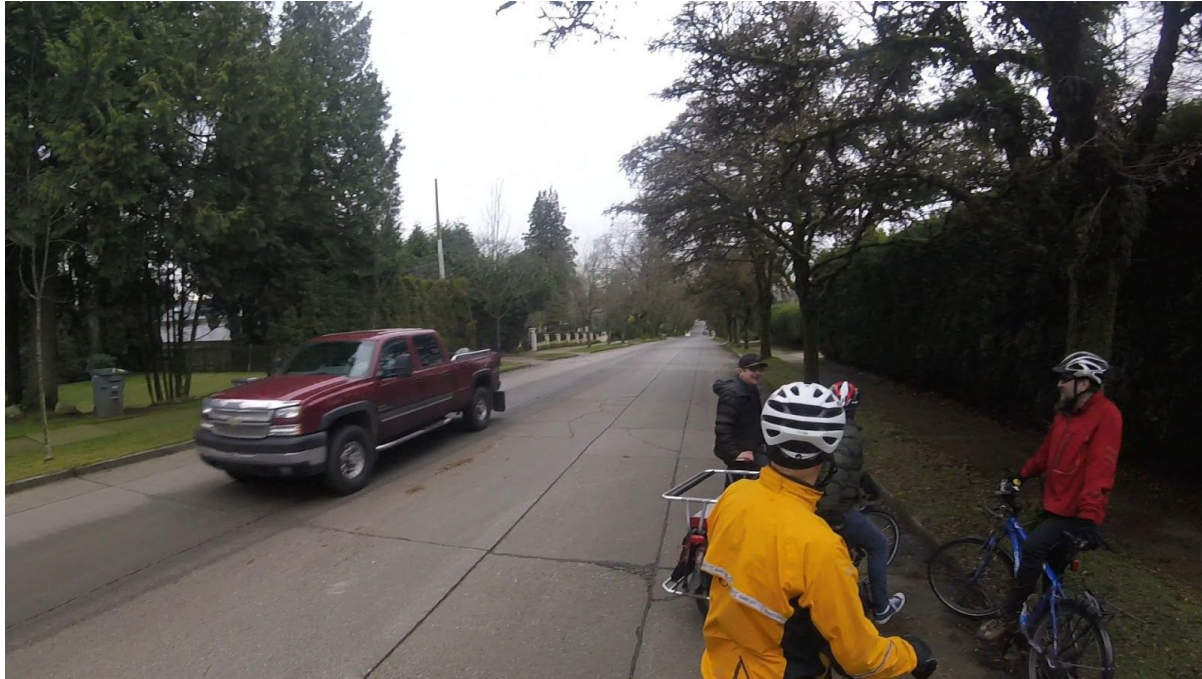
Figure 30 - 37th Westbound from Granville

From Granville St west, the roadway is straight and relatively wide (figure 30). Vehicles were observed travelling at higher speeds along this stretch, presumably cutting in between Arbutus and Granville. There is a single traffic diversion into this stretch (no left turn from Granville northbound). From Granville west is the Point Grey Secondary catchment zone.

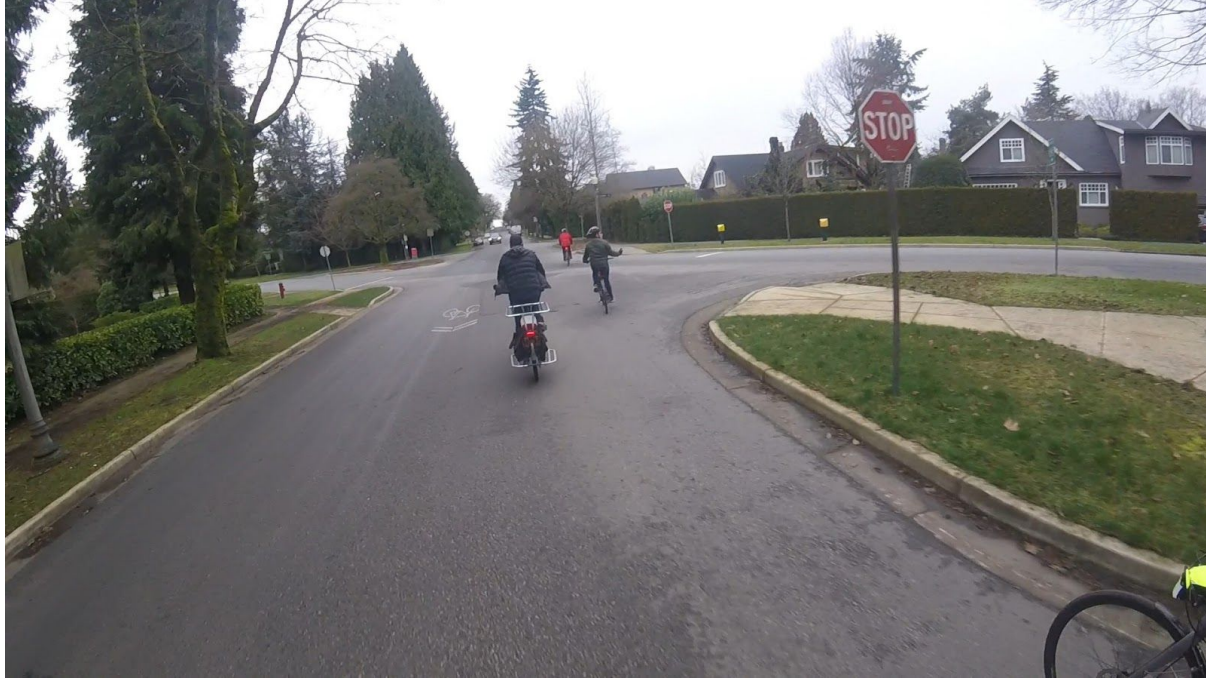
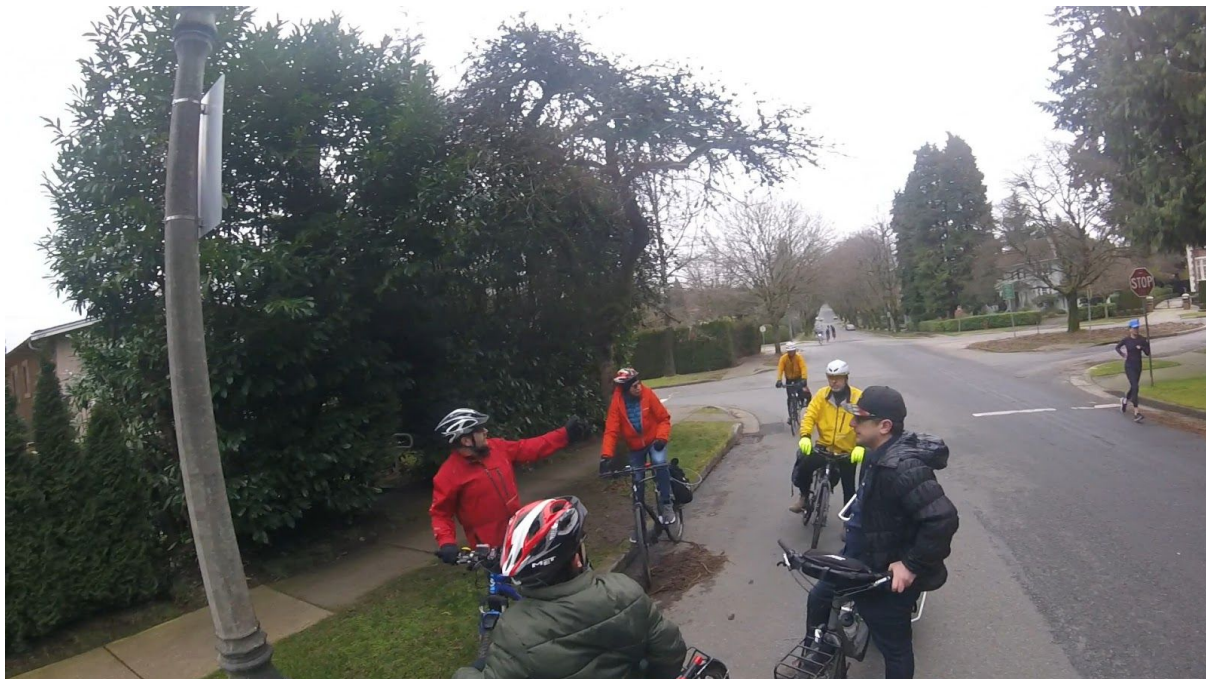
The 37th Midtown/Ridgeway bikeway intersects the Cyprus bike route on Angus Drive. The six way intersection at 37th, Angus Drive, and Pine is too large, especially considering the presence of two bike routes (figures 31 and 32). Normalizing the intersection by closing the southernmost section of Pine, with a bike-permeable parklet, would assist here. Relatively heavy vehicle traffic was observed travelling eastbound on 37th. Investigation of vehicle counts is recommended and may support adding traffic diversions to 37th to reduce these volumes.

The intersection at Clarendon would benefit from the implementation of a four way stop similar to other nearby cross streets along Clarendon. Angus Drive, Pine, and 37th is a 6 way intersection with a significant span in the east-west direction. Consideration should be given to closing Pine to vehicles from 37th to Angus, and moving the eastbound stop sign from Pine to Angus, normalizing this as a 4 way intersection. 37th and MacKenzie requires some form of crossing improvement, potentially with a 4 way stop similar to Clarendon. 37th and Blenheim has a small traffic circle, but with high vehicle speeds observed along Blenheim is uncomfortable and unsafe to cross. A recent crash with an overturned vehicle along this local street indicates how quickly some vehicles are travelling.

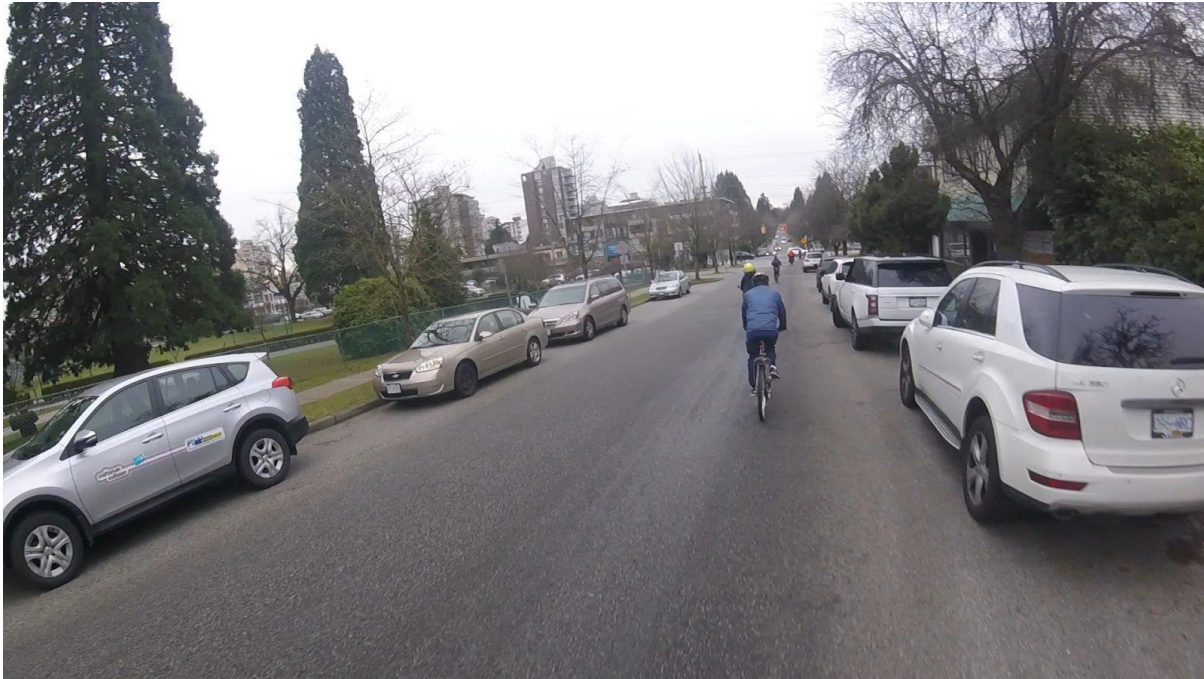
Figure 33 - 37th Westbound near Laburnum and Quilchena School

The stretch of 37th from Laburnum to Arbutus (West Boulevard) was observed to have heavy vehicle traffic, inappropriate for a local street bikeway (figure 33). This stretch
