## Proposal for Improvements to the Midtown and Ridgeway Bikeways

**March 5, 2019**

**Vancouver-UBC Local Committee**

**HUB Cycling**

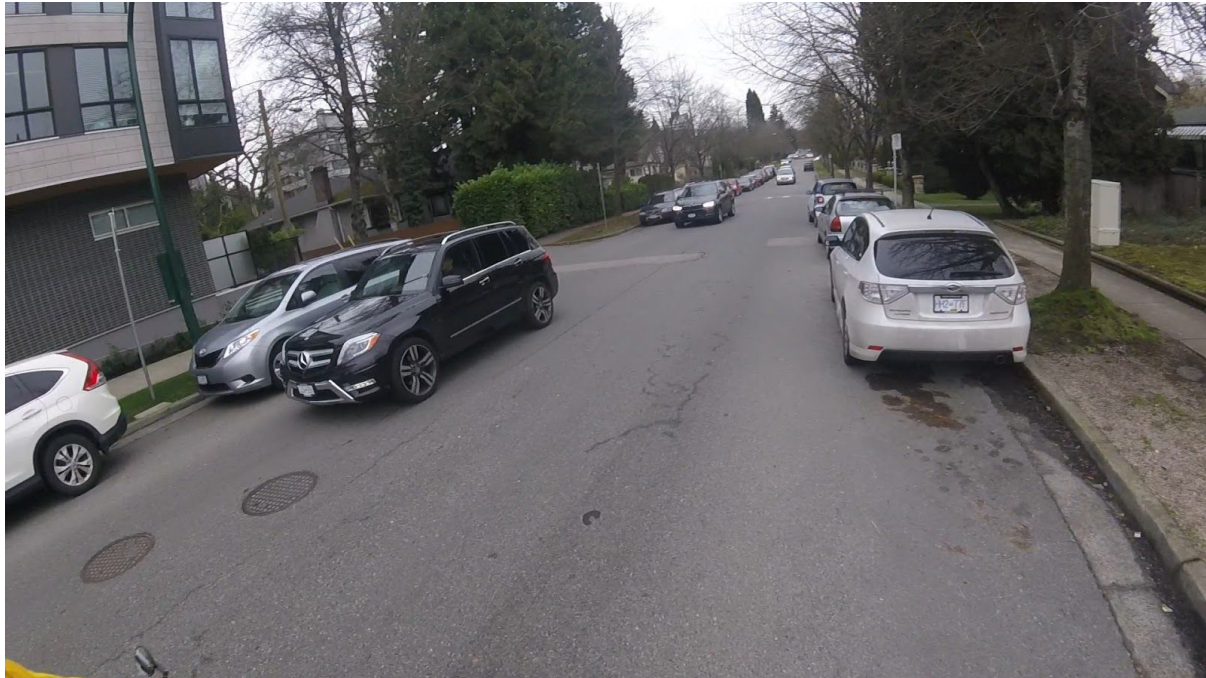
Figure 37 - 37th Westbound from Arbutus

Very heavy vehicle traffic was observed on the stretch of 37th from Arbutus to Yew (figure 37), and heavy vehicle traffic on the stretch from Yew to Larch (figure 39). The roadway is narrow, with vehicles parked on both sides of the street. Consideration should be given to implementing traffic diversions, allowing parking on only one side, or implementing a one way street.

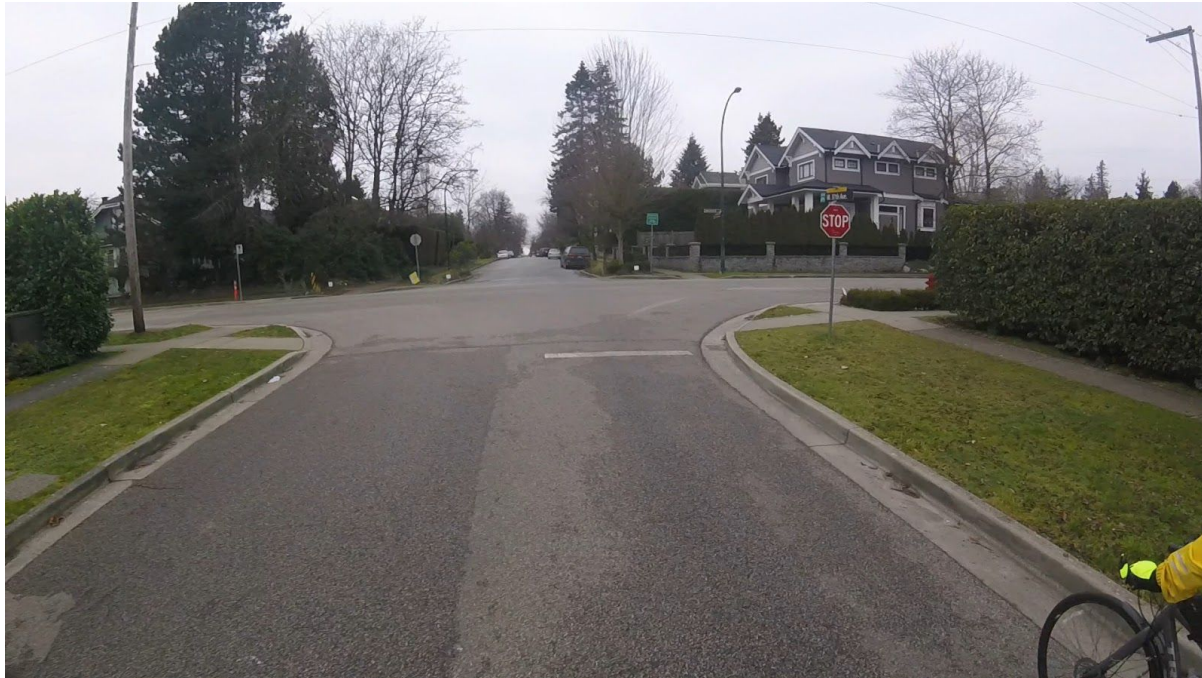
Figure 40 - 37th Westbound at MacKenzie

At most intersections, there are traffic circles or four way stops. Mackenzie is a transit route and collector route to Macdonald and hence has a greater volume of all types of vehicle traffic, with some vehicles observed to be travelling at higher speeds. The intersection has no crossing infrastructure lacking even a marked pedestrian crossing. It is recommended that some form of traffic control be considered for the crossing of MacKenzie on 37th.

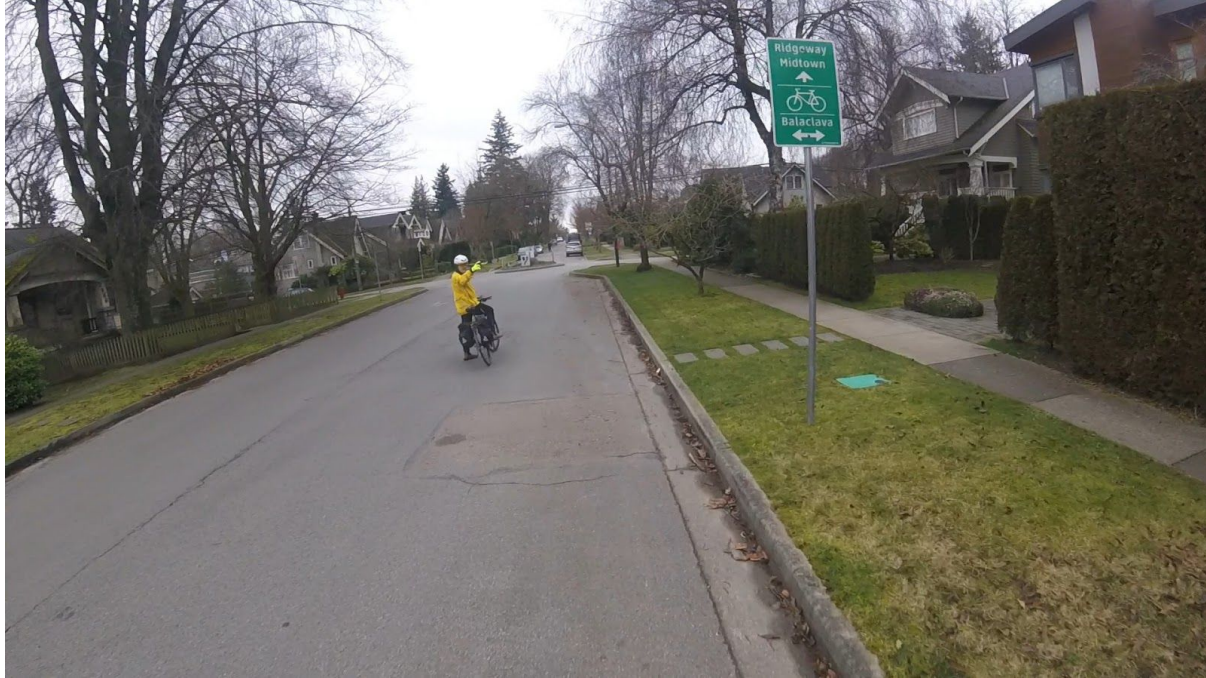
Figure 41 - 37th Westbound at Carnarvon

At Carnarvon, there is a sign for the Balaclava bikeway, which crosses 37th (figure 41). There is confusion because it is not on Balaclava St. At the next intersection, Balaclava, there is a sign for the Ridgeway bikeway heading north (figure 42). This section is discussed subsequently. It is not clear why there are two bikeways located on adjacent streets, with one of them being discontinuous at 31st. It is recommended that bikeways be assigned unique names, and that there not be multiple options for routes with the same name.

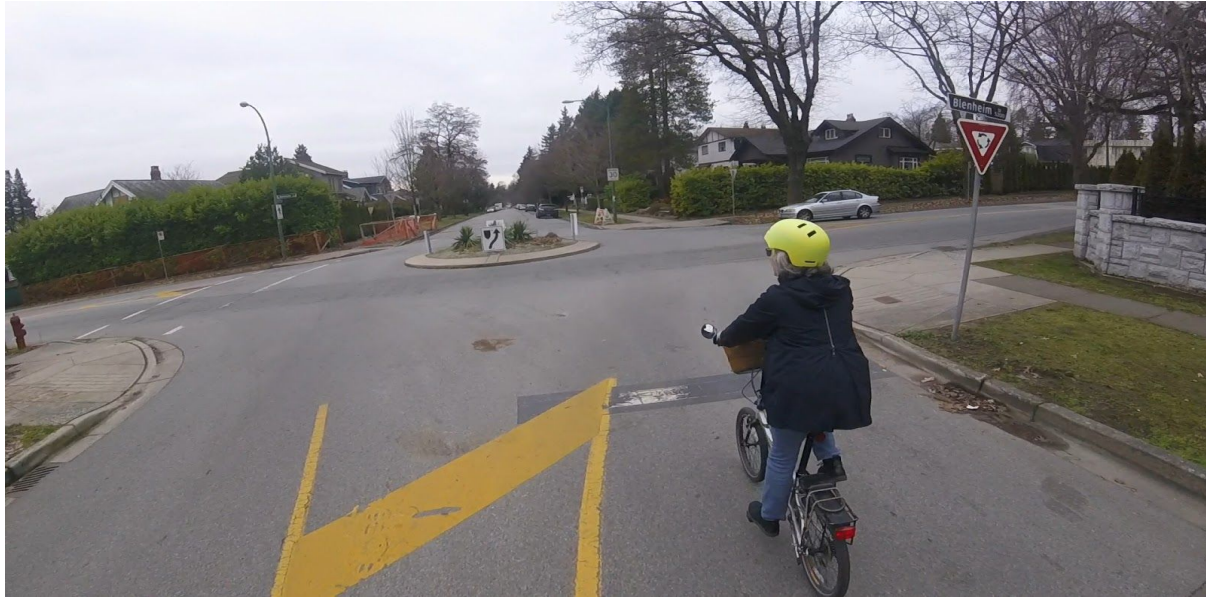
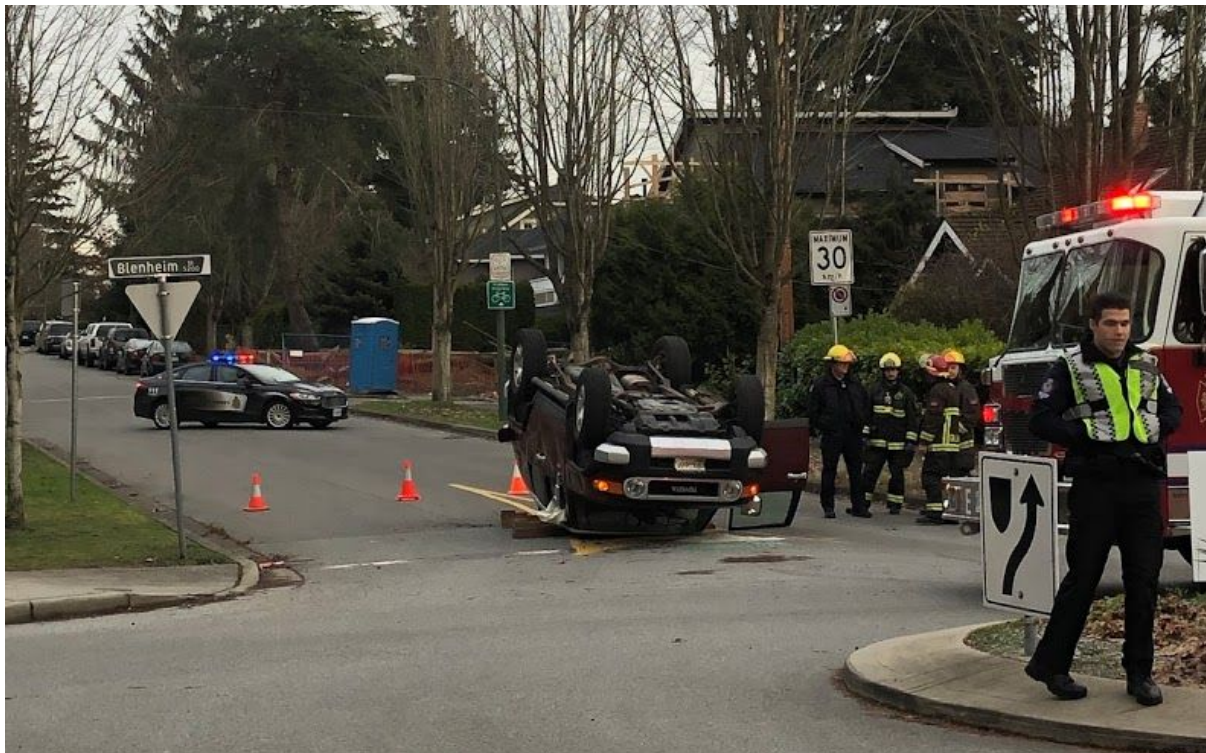
The intersection of 37th and Blenheim was observed to be dangerous, with vehicles travelling on Blenheim appearing to assume that they had the right of way over vehicles in the traffic circle. Sightlines are not good. Yield signs have been erected in each direction, presumably to help address this issue. Given the size of the intersection, the

need for additional signs, the additional yellow paint that has been added, and the history of crashes, it is recommended that this intersection be reviewed and alternate designs be considered. The need for this can be seen in Fig 44, showing a crash at the intersection.

Figure 44 - December 2018 crash at 37th and Blenheim

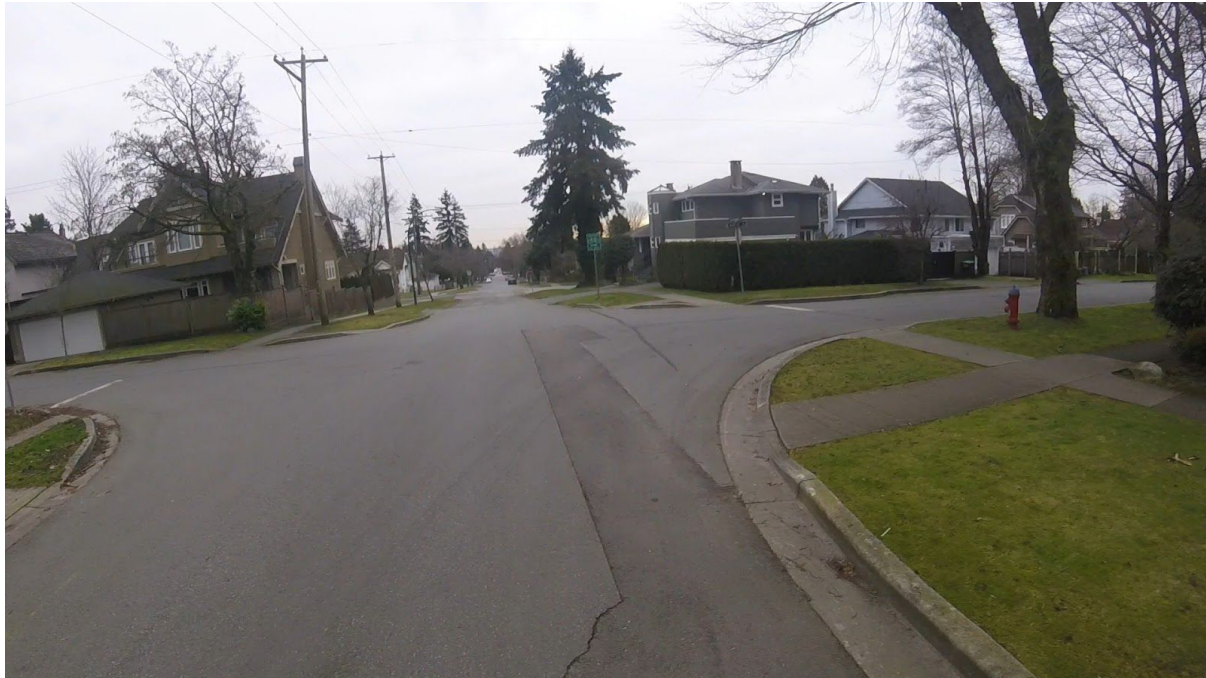
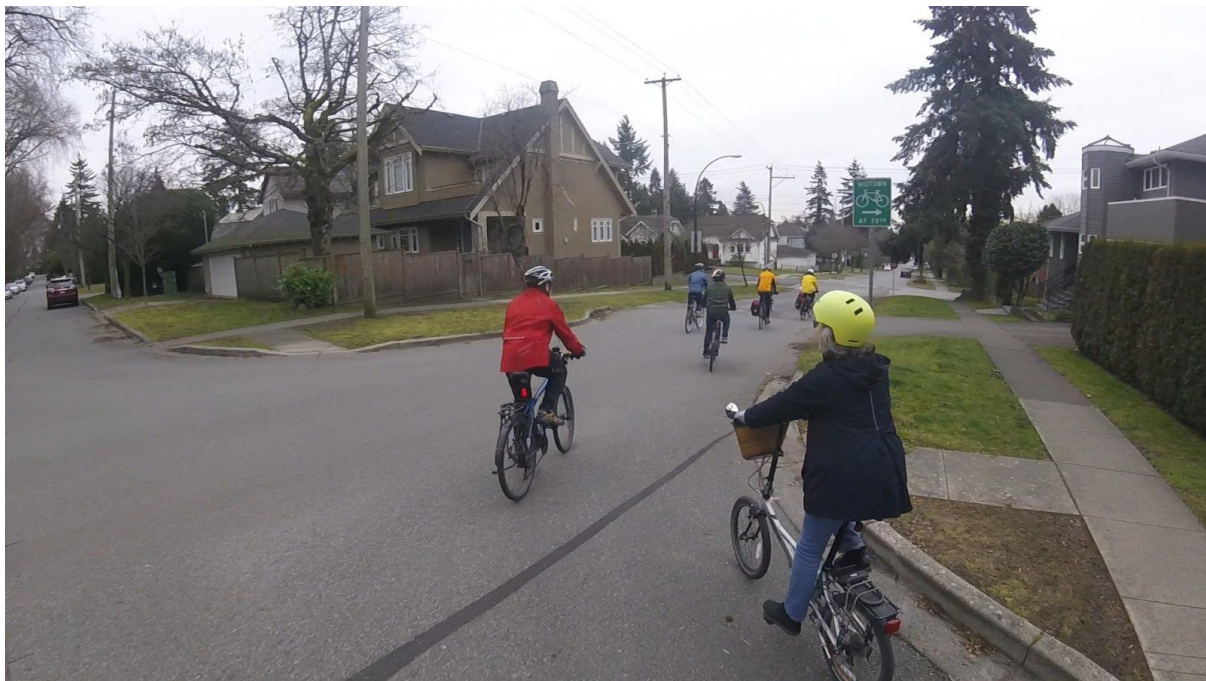
Heading south on Collingwood there is a sign posted at 38th. It is located next to 38th, and is confusing (figures 46 and 47). Text has been added to the sign to indicate that this is not the turn, but it would be preferable to move the sign to 39th and avoid this confusion. The pavement is in poor condition on Collingwood.

Figure 47 - Collingwood Southbound at 38th showing mispositioned sign

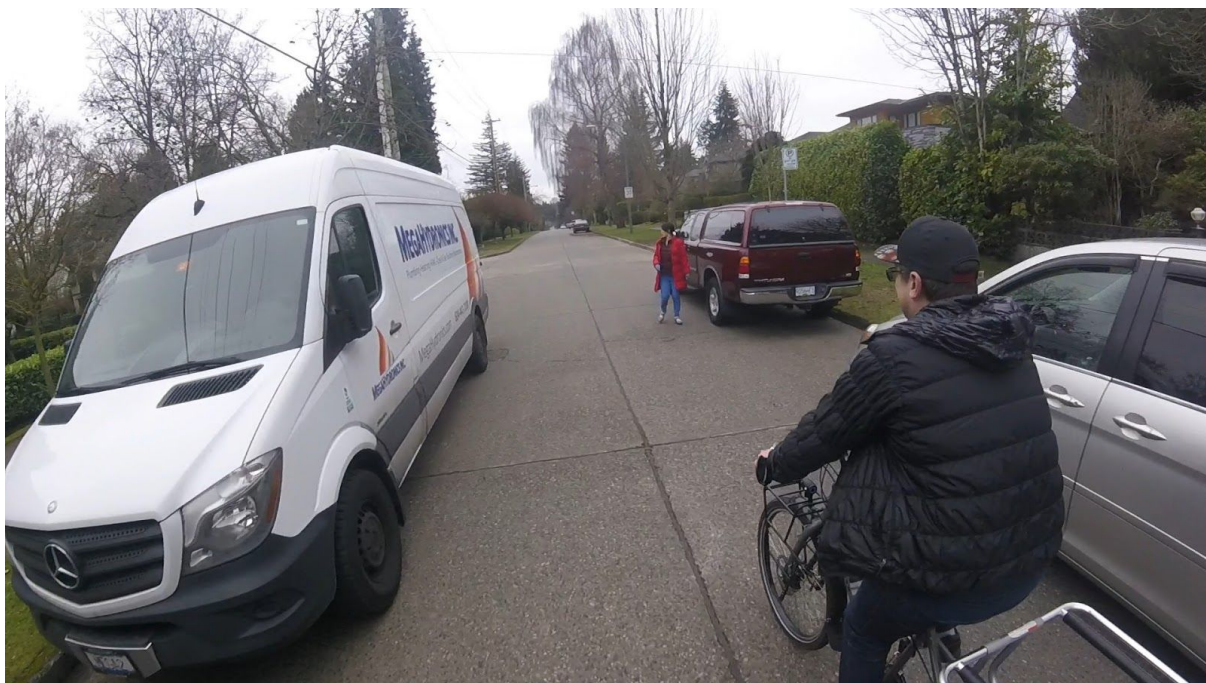
Figure 49 - 39th Westbound from Dunbar

Along 39th the roadway is narrow, and this is made worse by vehicles being parked on both sides of the street (figure 49). Ride participants noted that this section of 39th is used as a shortcut from SW Marine and 41st, due to the delays in turning left onto Dunbar at SW Marine and at 41st, for vehicles northbound on Dunbar.

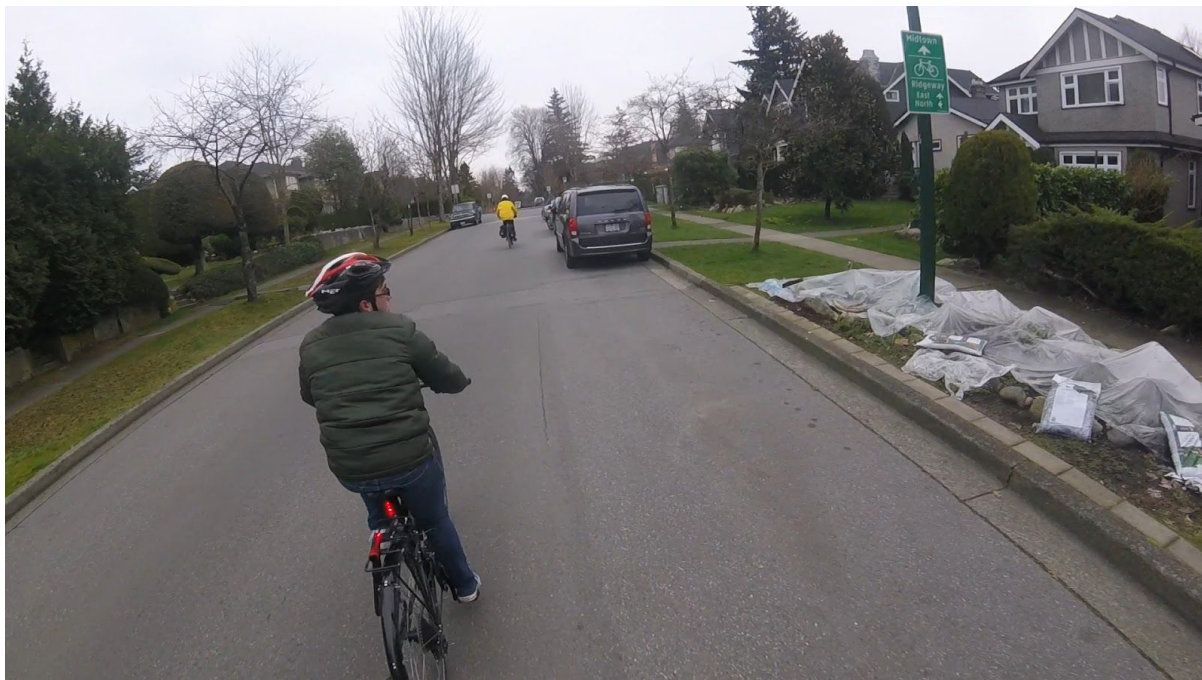
We returned to 37th and Balaclava, and headed north on the west arm of the Ridgeway Bikeway (figure 50). As noted previously, the Ridgeway Bikeway is located on Balaclava (from 37th to 31st), while the Balaclava bikeway is located on Carnarvon. At 31st the Ridgeway Bikeway intersects Balaclava Park (figure 52). There is a clear desire line across the park, as the Ridgeway Bikeway carries on along Balaclava north of the park. However, there is a detour posted around the park, taking people back to Carnarvon (eastbound), up to 29th (northbound), and then back to Balaclava (westbound).

Figure 50 - 37th Eastbound at Balaclava showing multiple branches of the Ridgeway Bikeway

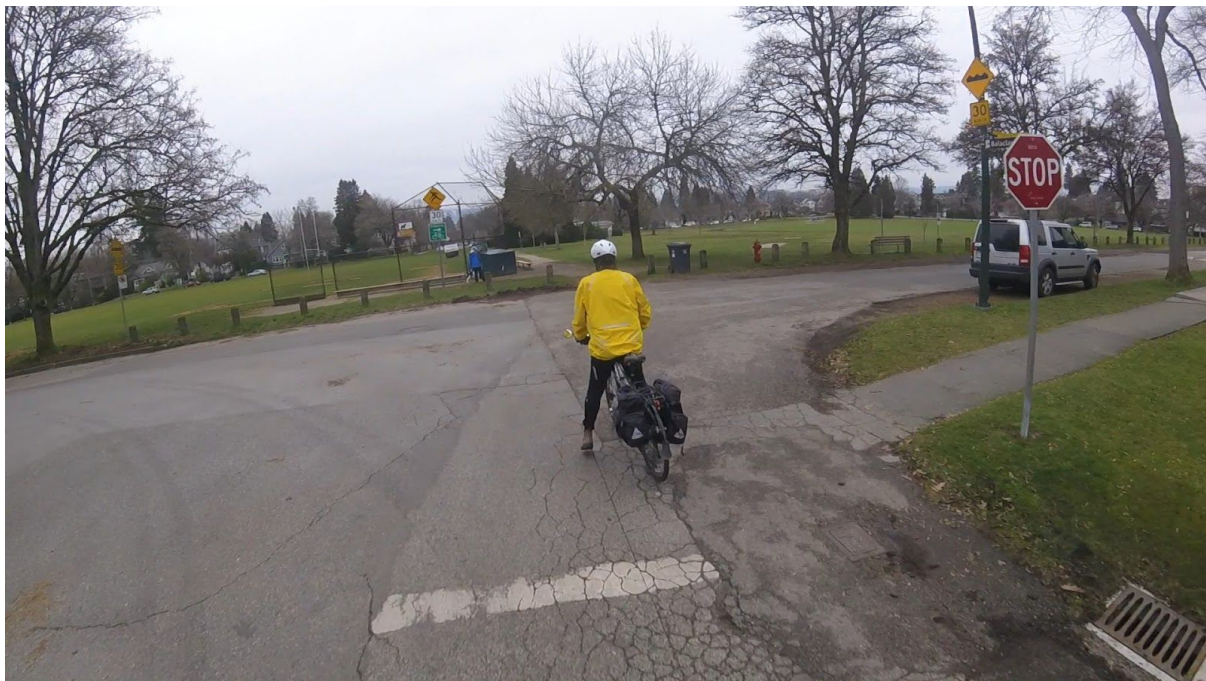
Figure 52 - Balaclava Northbound at Balaclava Park showing detour around the park and the desire line path through the park.
