HUB Cycling Accessibility Assessment Ride

May 10, 2023

təmtəxw̓tən/Belcarra Regional Park and Village of Belcarra

The purpose of the ride was to assess cycling accessibility for varied types of people cycling in the park and through the village.

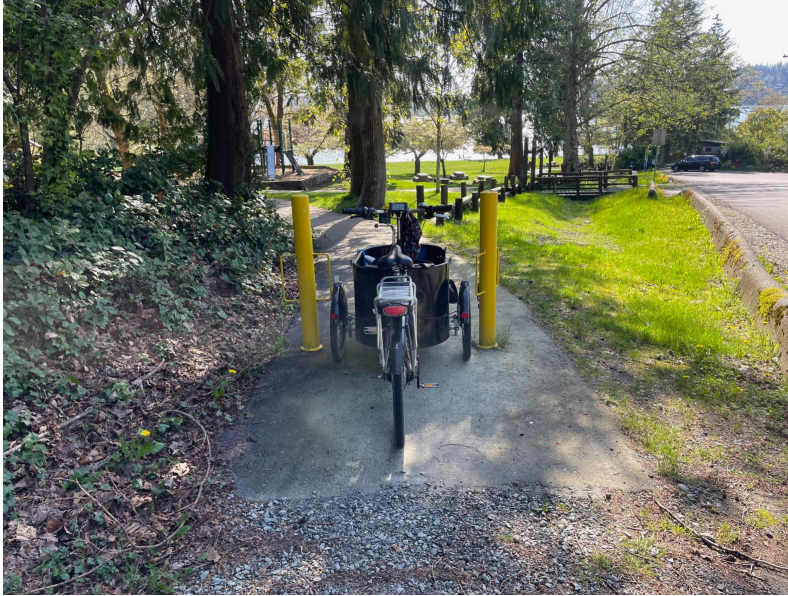
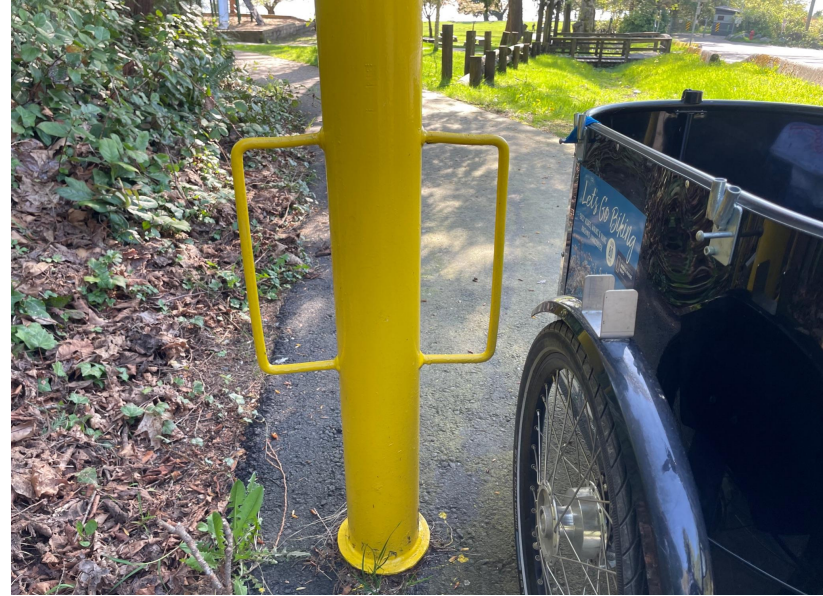
Gate 1 - Park east gate at playground

- Measurements: Two bollards with a gap of 44.5" between posts
- Adaptive rider was able to get through but pointed out the handles posed a hand injury risk
- Problem: 4.5" handles on bollards reduce travel space between to approx 35-36"
- Problem: too narrow for cargo bike unless handle is angled such as the one on the right
- Recommendation: remove handles to maximize width of gap or consider removing left side bollard

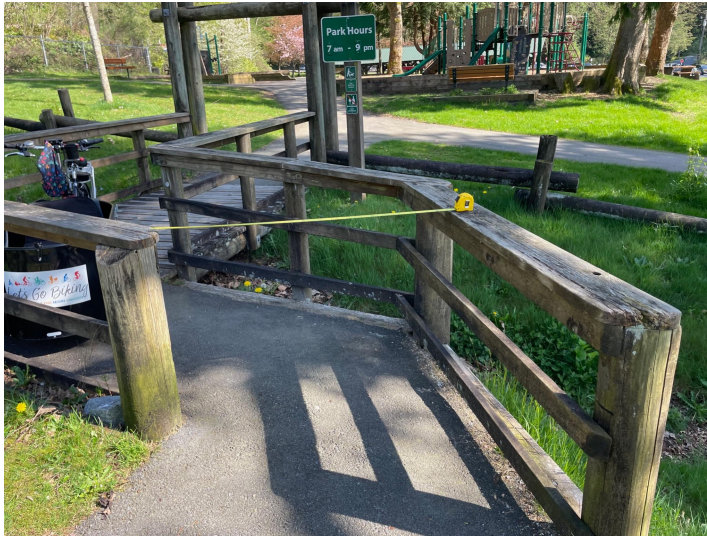
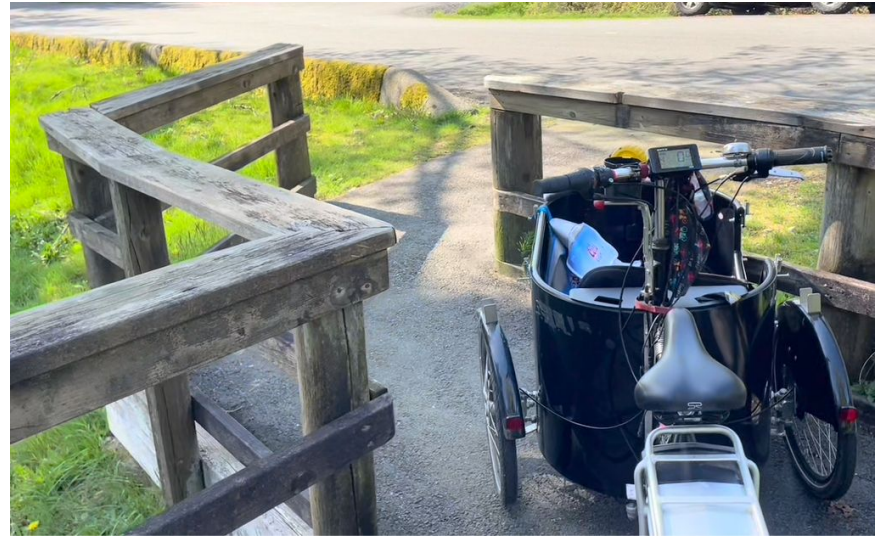
Gate 2 - Middle gate and bridge to playground

- Measures 49" wide
- Turning radius is fairly good, adaptive rider had no difficulty but cargo bike rider had to dismount and maneuver bike to get through
- Recommendation: If Gate 1 and Gate 3 are modified, this one could remain as is as there would then be alternate access available nearby

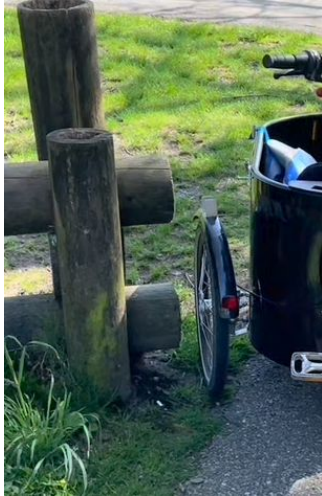
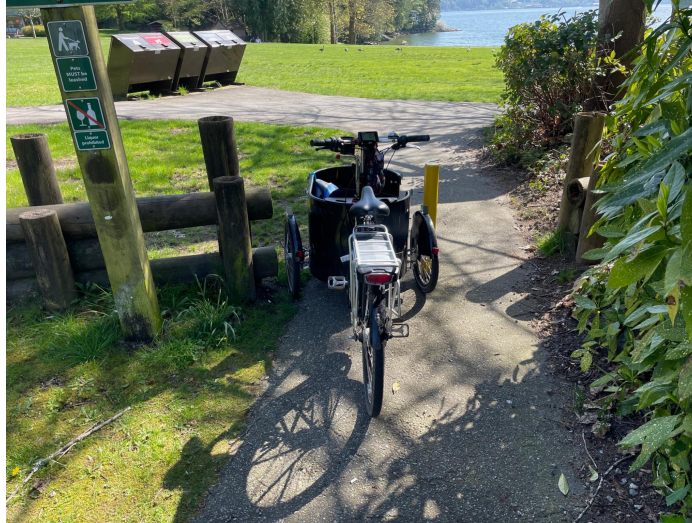
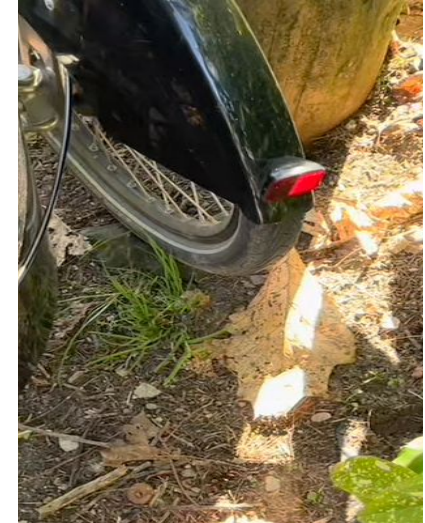
Gate 3 - Park entrance at Midden Rd + Belcarra Bay Rd

- Measurements: Left side gap is 39", right side gap is 40"
- Problem 1: cargo bike rider found the opening very tight and had to dismount to maneuver through
- Problem 2: adaptive cyclist felt openings were narrow and pointed out that the bollard and fence both posed a hand danger for him
- Recommendation: cut off fence on left side to widen gap, remove rock on right side, consider installing a flexible bollard

Rock impedes travel

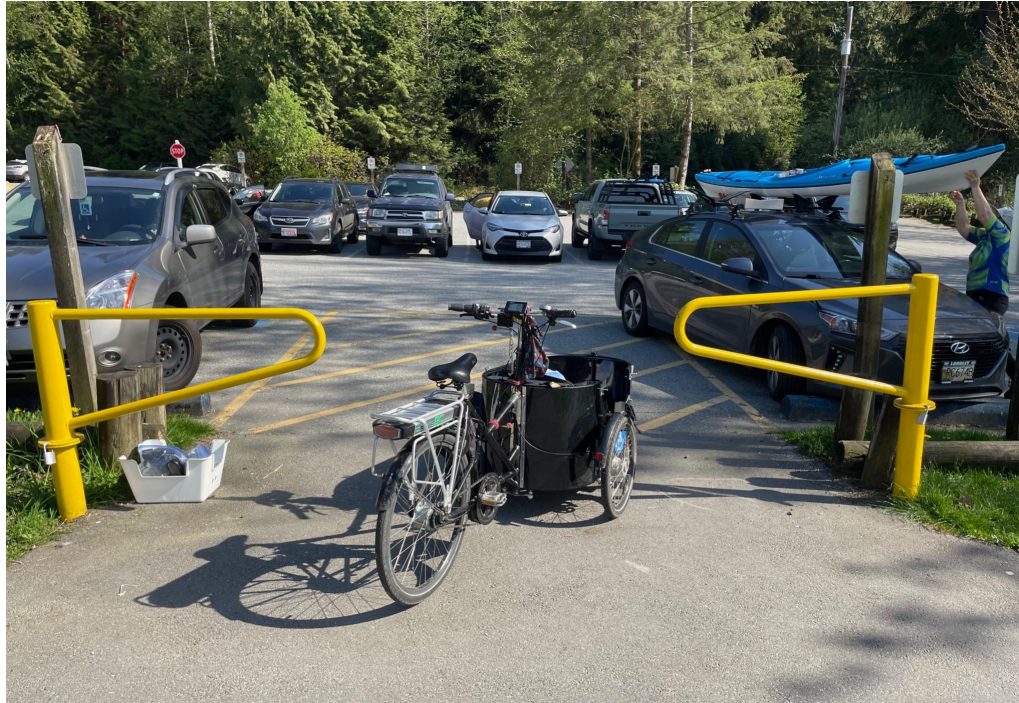
Gate 4 - Parking lot entrance

- Gate is very wide
- Access is good
- Recommendation: Make more gates in this style!

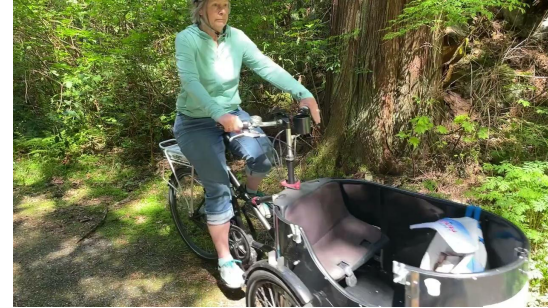
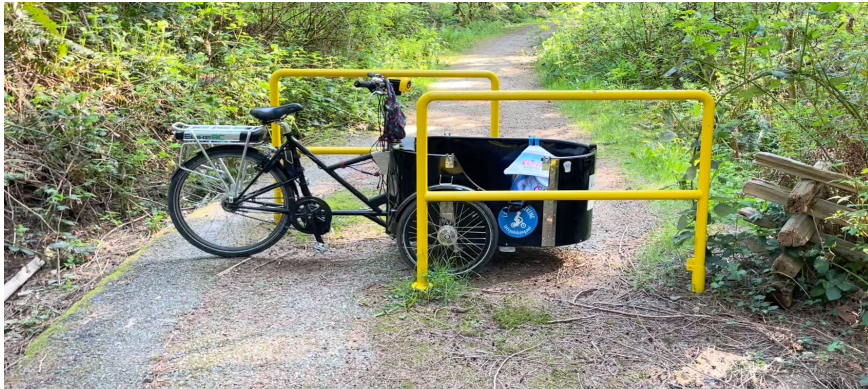
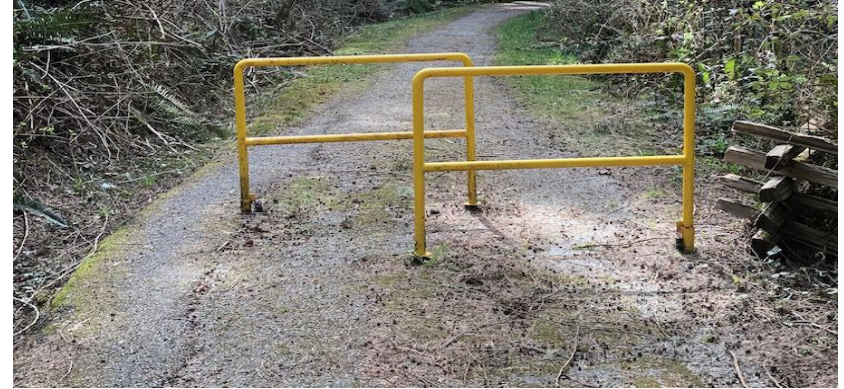
Gate 5 - Springboard Trail West Entrance

- Measurements: gap is 47", but narrows to 45" by problem 1.
- Problem 1: Raised post base plate eliminates 1" from each side of gap, reducing travel space to 45"
- Problem 2: Turning radius: adaptive rider was able to get slowly through gate, but was concerned about the poor turning radius on both sides as this could pose a tipping hazard for an adaptive rider
- Problem 3. Cargo bike rider found the turning radius was not wide enough for the cargo bike to maneuver through both sides of the gate, rider had to dismount to move through the gate - *see video*
- Recommendations:
 - a) Remove both sides of the maze gate -- there is no car traffic near this entrance
 - b) If needed consider installing a flexible delineator/bollard to reduce chance of injury
 - c) if only one side of gate is removed we prefer the left side as there is a hand injury hazard at the fence

Post base problem

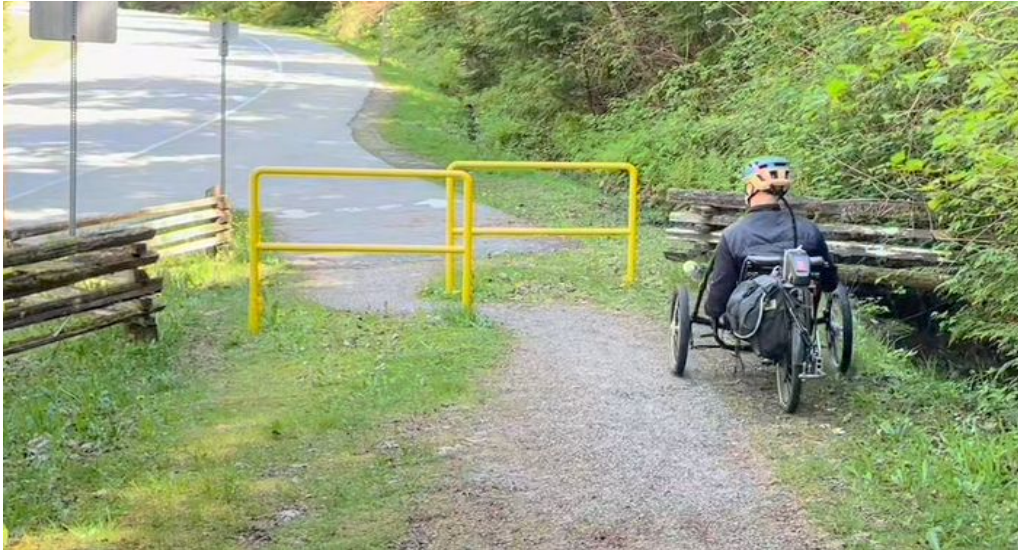
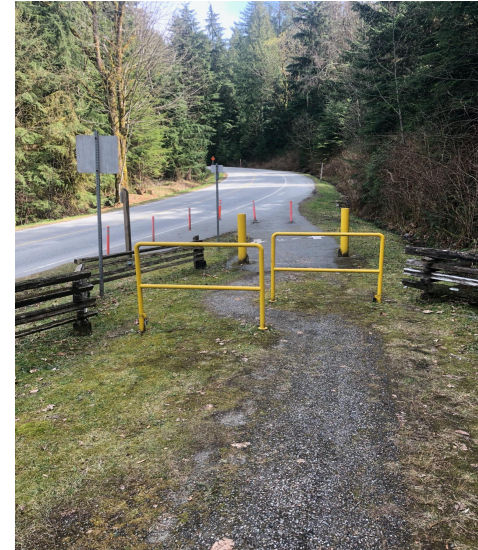
Gate 6 - Trail Section on road shoulder

- Measurements: gap is 47.5" but raised bollard bases reduce gap to 45.5"
- Turning radius is slightly better at this gate
- Problem 1 - adaptive rider felt the the turning radius needs to be wider as ditch on the right side poses a tipping hazard for an adaptive bike

- Problem 2 - cargo bike rider had to dismount due to the turning radius limitation, had to hand push through the gate
- Problem 3 - parking in Active Transportation (AT) Lane (- more on next slide)

- **Observation:** in 2019 there were bollards just east of the gate. Had these been left in place and both sides of the maze gate removed there would be better accessibility at this entrance, thus we suggest the gates be removed and bollards reinstated.

Note ditch on right side

Bollards in 2019 photo

- Recommendation: Remove both the maze gates, consider a flexible bollard/delineator if needed.
Or remove one side of the gate, left side preferred to avoid tipping hazard and possible hand injury due to fence on the right

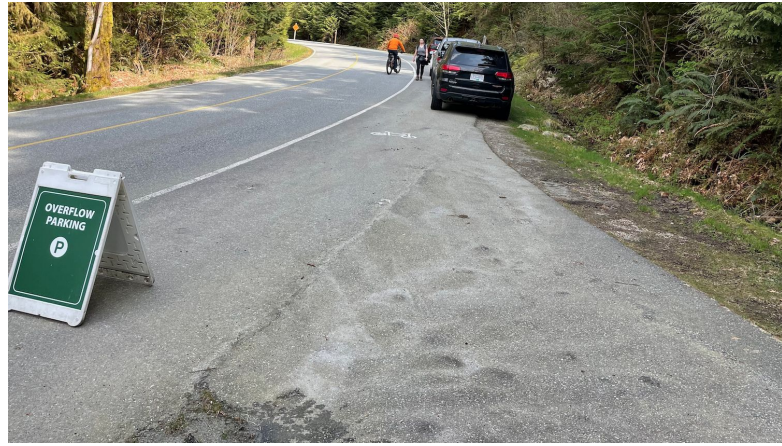
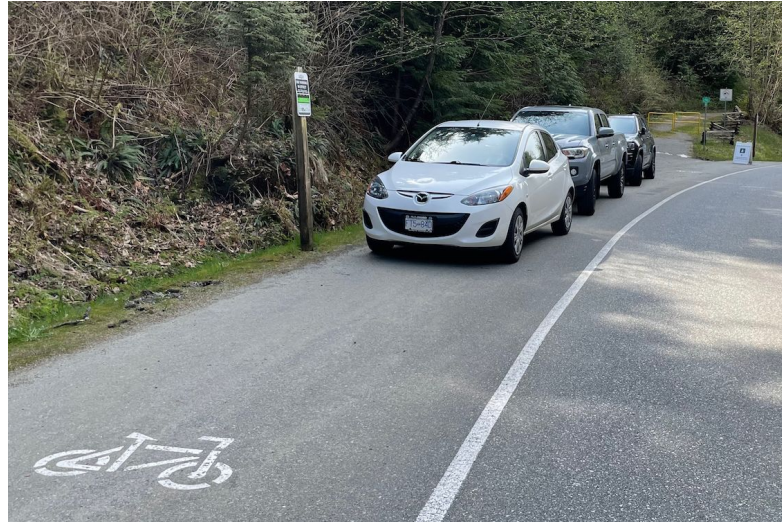
Problem: Cars parked on the Active Transportation Lane

- The Springboard Trail was built for people to enjoy cycling and walking in Belcarra Park. By allowing parking on the road segments of the trail, people no longer have a safe place to ride and walk.
- The trail was built to provide safe active transportation for people choosing to ride or walk to the park. Assessment riders felt that allowing parking discourages active transportation to the park.
- Problem 1: Overflow parking in the Active Transportation Lane forces the rider into the travel lane
- Problem 2: Parked cars sometimes block entrance/exit from the gate (*see photo next slide*)
- Recommendation: Do not allow parking on the Springboard Trail road sections. Consider installing barriers to protect people cycling and walking on road sections.

Urgent recommendation: Remove parking from the Springboard Trail on road sections to provide a safe place to walk and ride and to encourage people to choose getting to the park on foot or by bike.

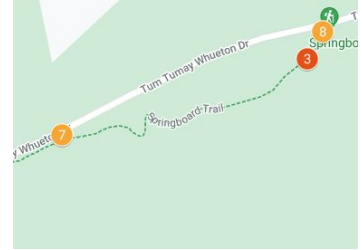
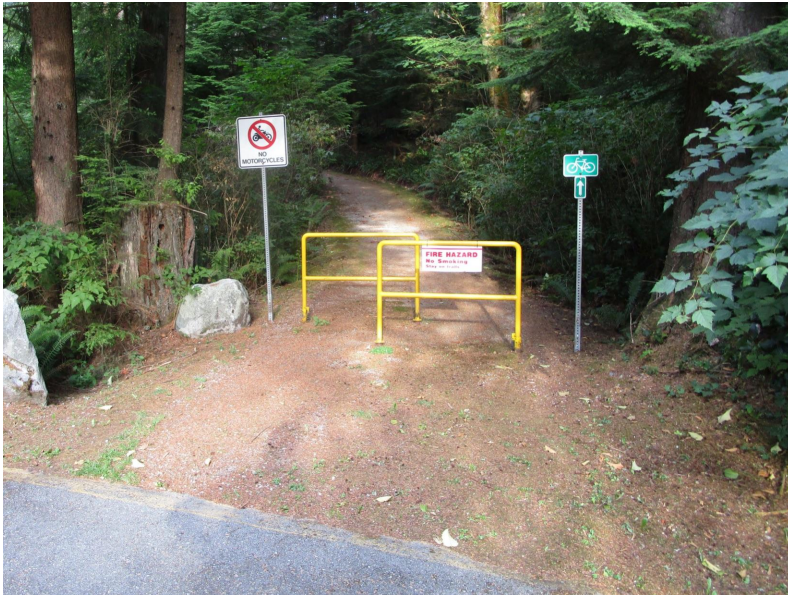
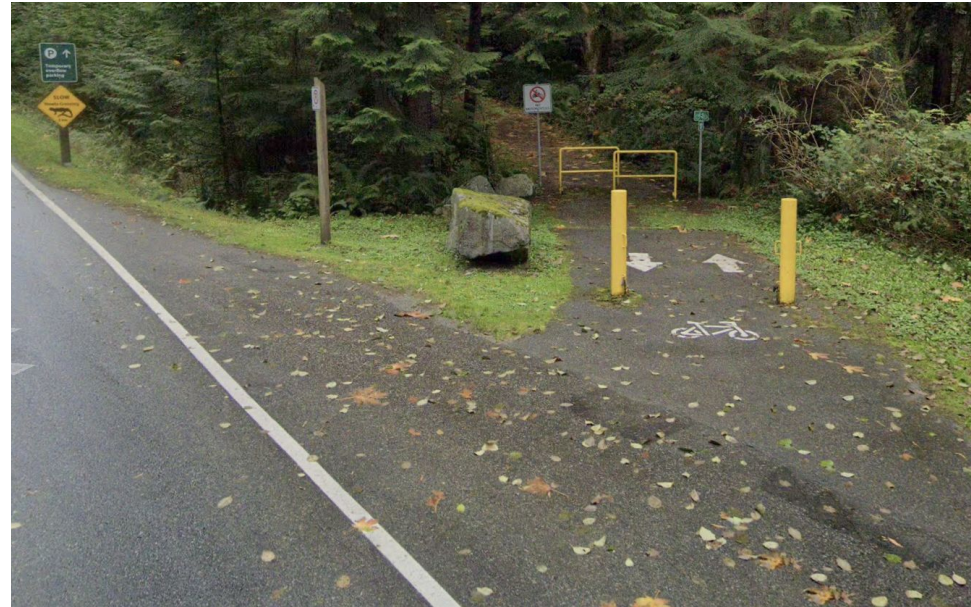
Gate 7 - gate near Newt Crossing sign

- Adaptive rider was able to enter this gate but due to the low speed he found it hard to get started up the hill
- Cargo bike rider had to dismount and wheel bike through and also found it hard to build enough speed to climb the hill
- Recommendation: a) remove both sides of the maze gate, b) consider a flexible delineator if needed or c) remove one side of the gate being aware of hand injury and tipping risks
- Observation: in 2019 there were bollards just east of the gate. Had these been left in place and both sides of the maze gate removed there would be better accessibility at this entrance, thus we recommend the gate be removed and bollards reinstated.

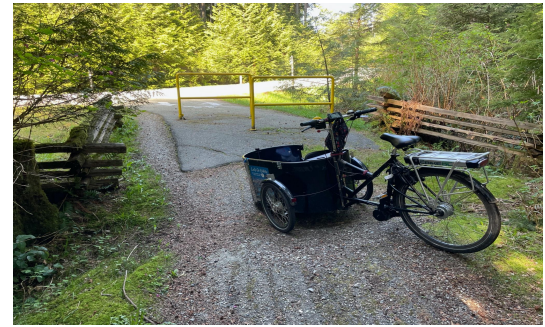
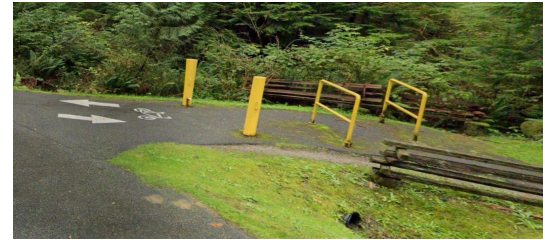
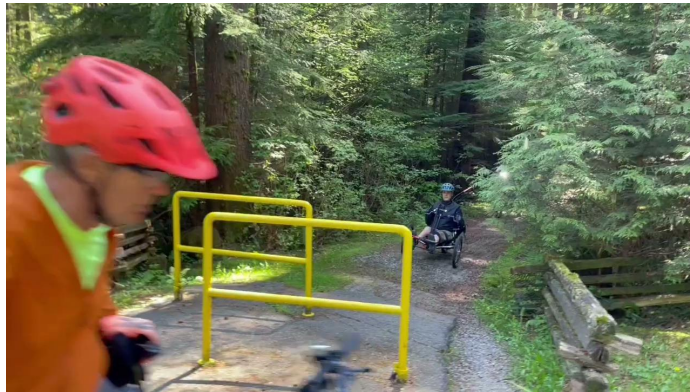
Gate 8 - Top of 'newt hill'

- Of all the gates in the park, this one is the most urgent in need of repair.
- The adaptive rider, cargo bike rider and 3 cyclists all feel it is dangerous.

- Problem 1 - the trail surface approaching uphill to the gate has eroded and a deep dip has formed
- Problem 2 - The adaptive rider was not able to make it up on his first attempt and had to be pulled through by a helper(*see video 1*)

- Problem 3 - The cargo bike got stuck in the dip and needed help to get through the gate (*see video 2*)
- Observation: in 2019 there were bollards just east of the gate. Had these been left in place and both sides of the maze gate removed there would be better accessibility at this entrance, thus we recommend the gate be removed and the bollards reinstated.

Stuck
in dip

Former
Bollards

- Recommendation: Fix the trail surface by leveling and paving the steep uphill grade, remove one or preferably both of the maze gates being mindful of the fences and tipping hazards.

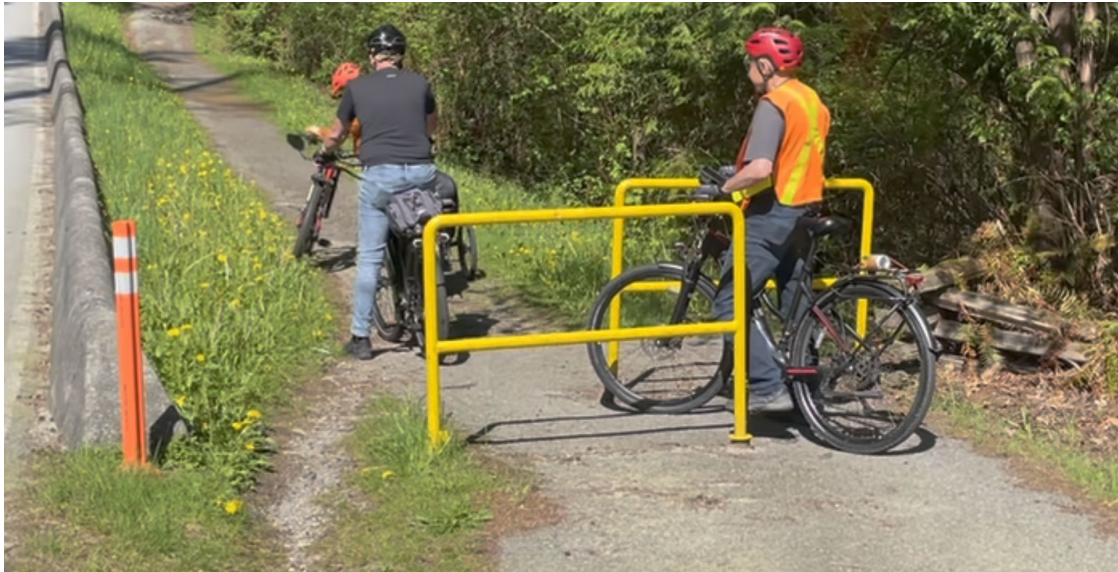
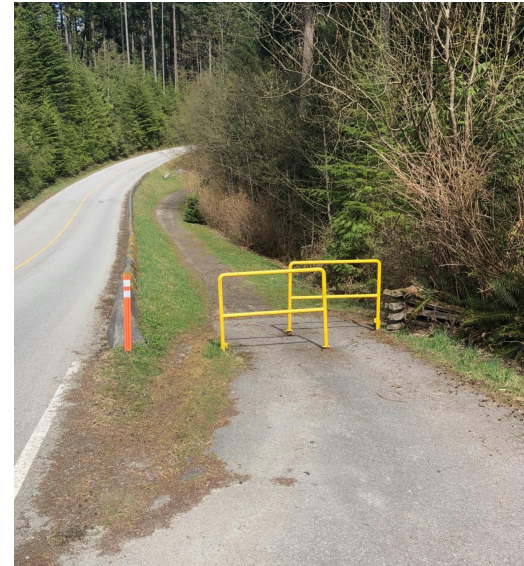
Gate 9 - Woodhaven Swamp West

- This gate has a poor turning radius. Every rider had to dismount and walk through the gate
- The adaptive rider had to take this one slow due to lack of turning radius and ditch on right side (tipping hazard)
- Recommendation: a) remove both sides of the maze gate, it would be unlikely for a car to enter this narrow path, consider signage if necessary

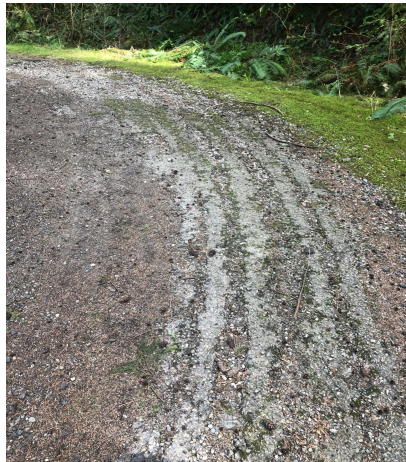
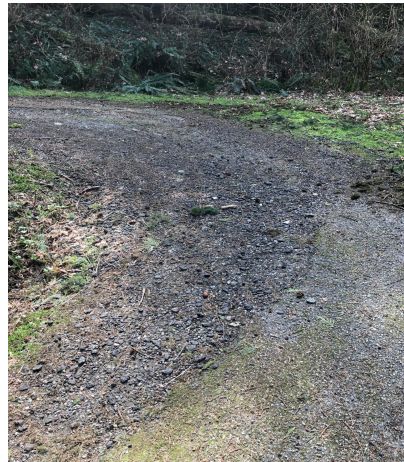
- Most of the Springboard Trail surface is good, but we noted many eroded sections that need re-paving and some trail segments in need of crushed gravel. Note: The quality of gravel is important. It must pack down hard to create a smooth surface. Loose or round gravel is a safety hazard for sliding, falling, and reducing equity for some wheeled users due to bumpiness.
- Three areas are identified as most urgent:

- Near the west end of the Springboard trail the first two corners were more difficult for all riders. (See orange location markers 1 and 2)
- Recommendation: remove encroaching vegetation to widen corner. Due to the steep grade at these corners, we recommend re-paving.

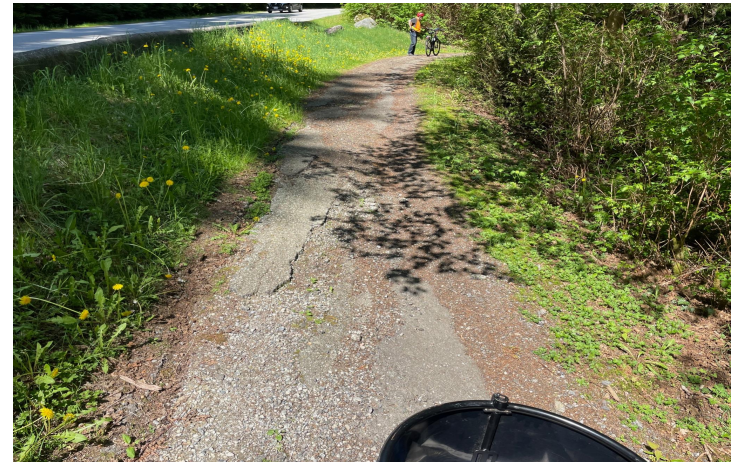
- (5) This section of the trail near Woodhaven Swamp needs surface repair (near Gate 9)

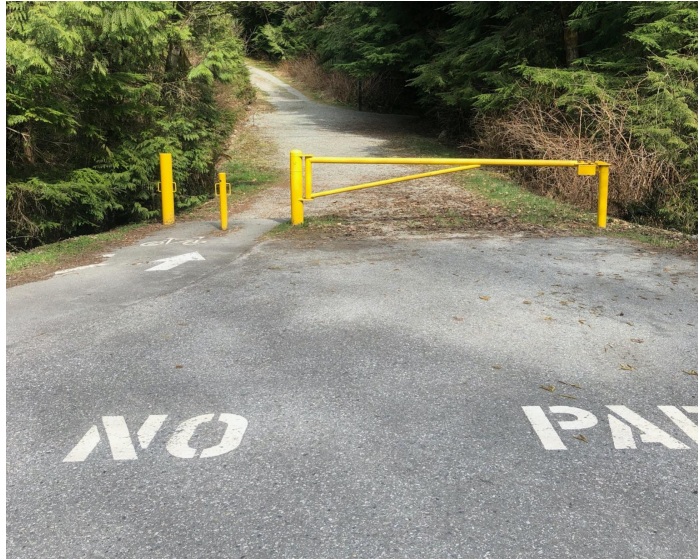
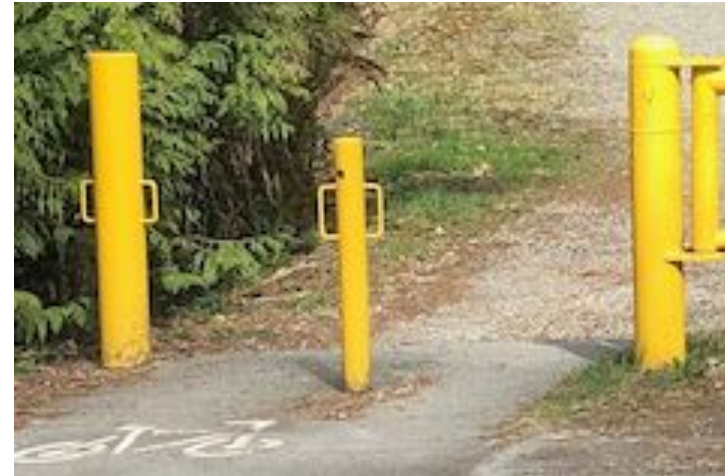
Gate 11 - A good example of a gate!

- Width is adequate for both an adaptive rider, cargo bike rider and other people cycling.
- Access is flat and straight
- Problem: Handles on bollards reduce travel space and pose a risk for injury, specifically a hand injury for an adaptive rider.
- Recommendation: Remove bollard. Next best option: rotate handles on bollards to widen gap, consider replacing rigid center bollard with a flexible bollard

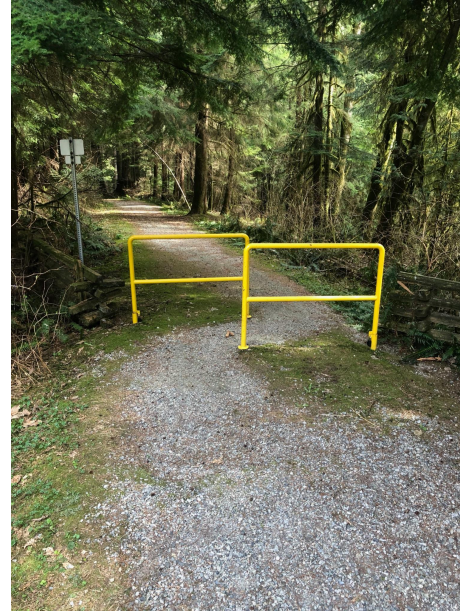
Gate 12 - Across Tumtumaywheuton heading east

- Gate is same size as others in the park, so the same issues
- Adaptive rider was very concerned about edge risk and tipping his bike, note the helper standing in dip and ready to keep him level (see *video*)

- Recommendation: Remove one or both of the maze gates, keeping in mind the fences on either side may need to be cut back to avoid a hand injury for an adaptive rider

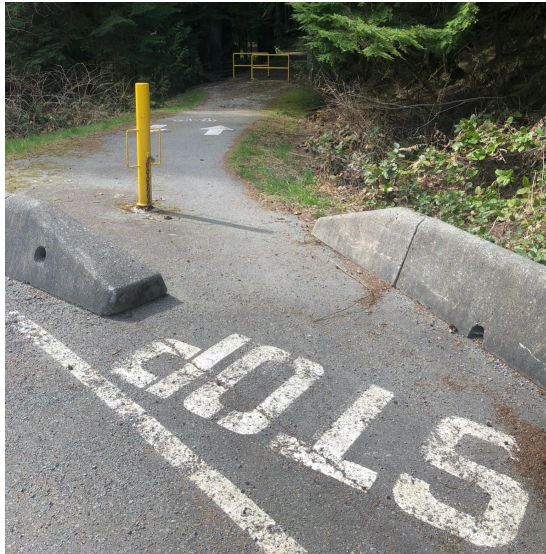
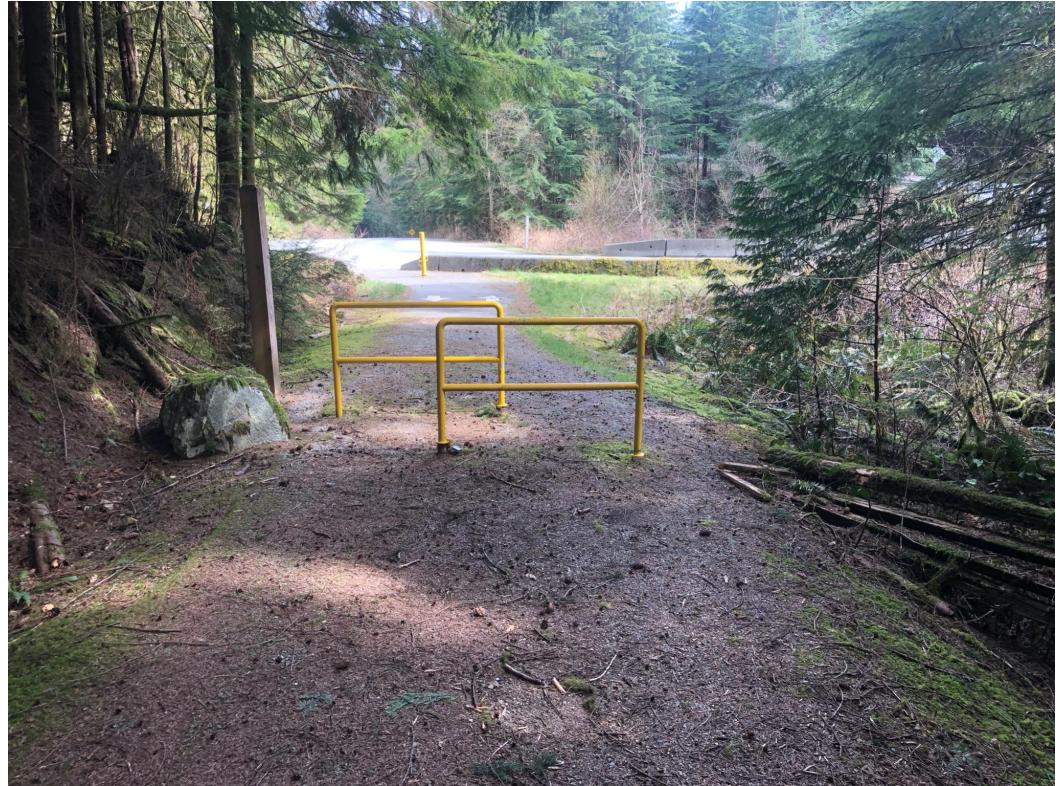
Gate 13 - Springboard Gate east park exit

- Measurements are the same as other maze gates thus same issues
- Adaptive rider found the turning radius limited due to the rock on the left
- Adaptive rider was concerned about tipping hazard on right side
- Recommendation: Remove both maze gates as they are unnecessary as there is a bollard that does the job

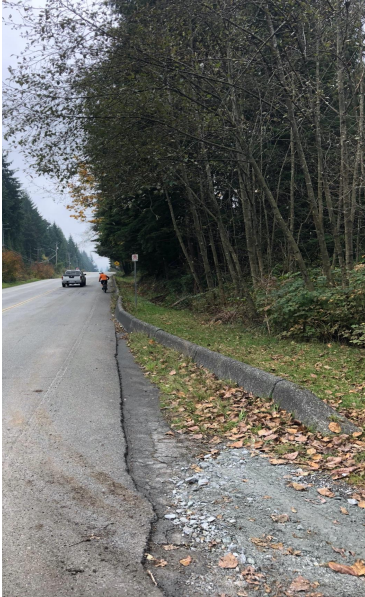
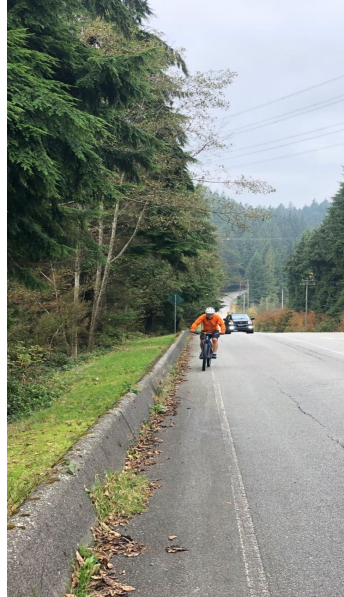
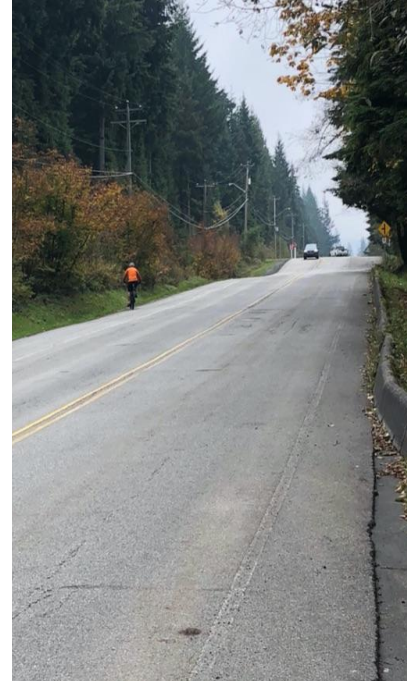
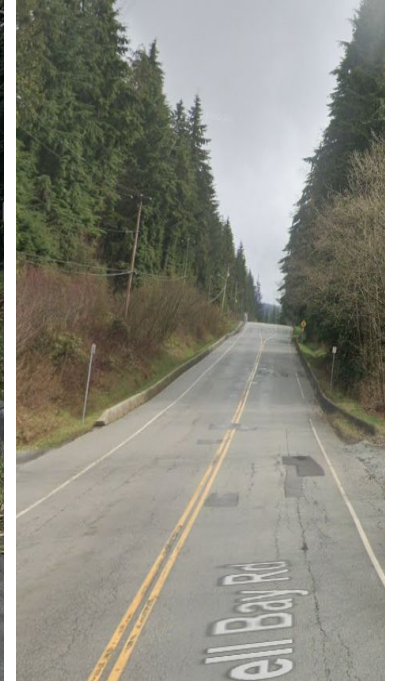
Connecting White Pine Beach and Belcarra Park

- To get from the main park to White Pine beach, a rider has to take the steep hill on Bedwell Bay Road.
- The south side shoulder is extremely narrow for cycling and walking and dangerous with the fast moving traffic as cars and trucks accelerate up the hill.

- People walking and cycling often use the wider north side shoulder.
- Concrete barriers were installed recently to block cars from parking on the shoulder, narrowing the shoulder width.
- It is suggested that these barriers be moved to the white line in order to create a protected space for people walking and cycling

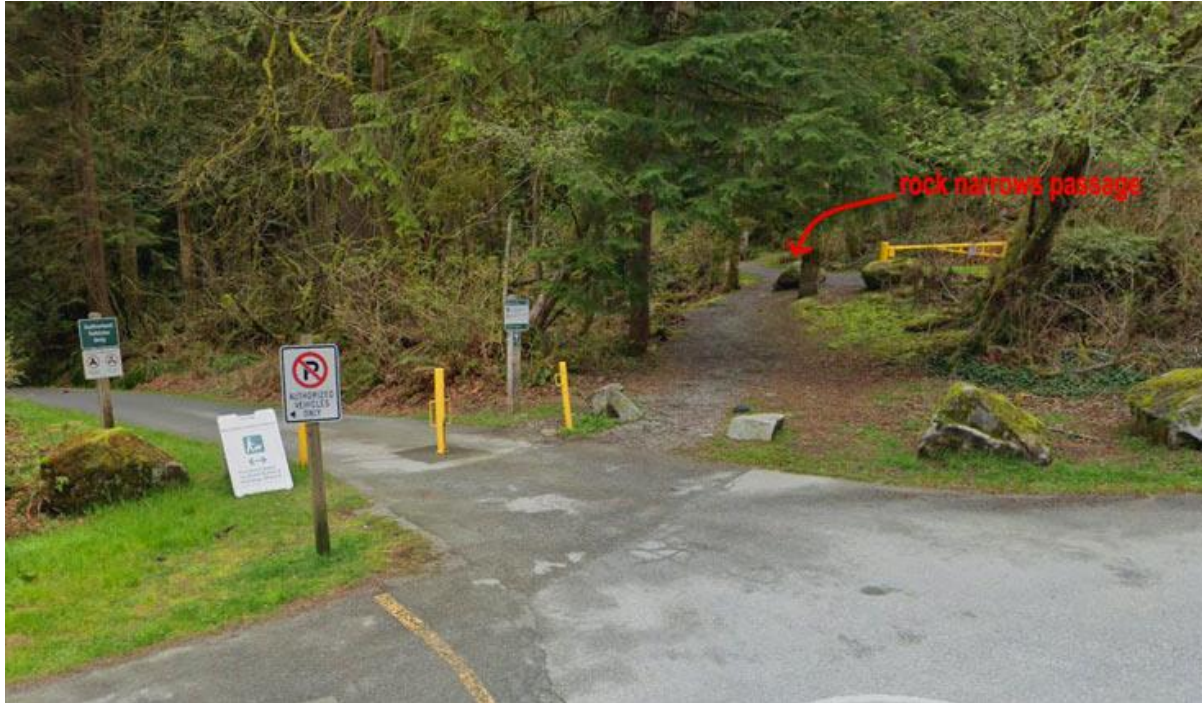
Gate 14 ~ White Pine Beach - Bowser Trail east gate

- Beach access road provides good access to beach for an adaptive bike, bollards are placed wide and there is lots of room for both the adaptive rider and cargo bike rider
- Bowser Trail access: Rock impedes passage for adaptive rider and cargo bike barely squeezes through. Rock is a hand injury issue for the adaptive rider
- Recommendation: Remove rock or tree to enlarge opening

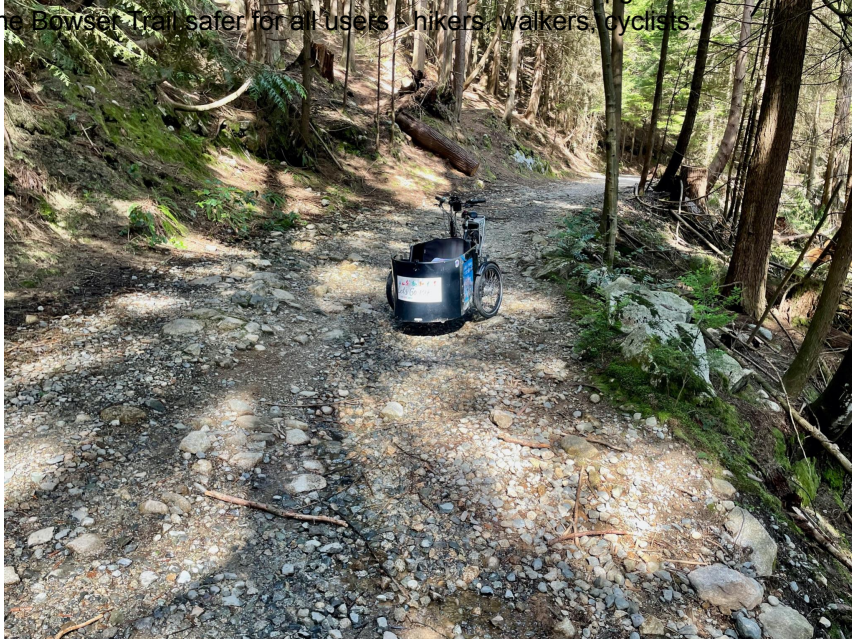
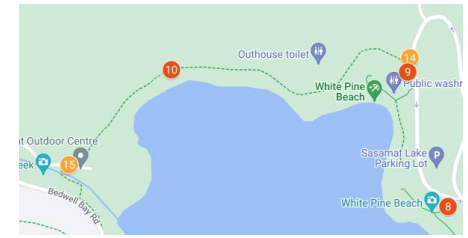
The Bowser Trail (10) offers a flat and safe option to travel from the Belcarra picnic area to White Pine Beach via Marine Avenue.

- Surface repair is needed to upgrade sections of the trail for walkers and people riding bikes. There are some difficult sections of the trail due to erosion and large rocks. The adaptive rider was concerned about the risk of tipping. The cargo bike rider had to dismount and walk through some sections. The mountain bike assessment riders had to dismount through two sections due to the large rocks. It is noted that a neighbour who walks this trail have mentioned they are concerned about the rough surface as it poses an ankle injury risk.

Recommendation: Repair rough sections on the trail to make it safe for walkers and people riding bikes. Note: the full width of the road wouldn't have to be upgraded, just the width of a trail. This will make the Bowser Trail safer for all users - hikers, walkers, cyclists.

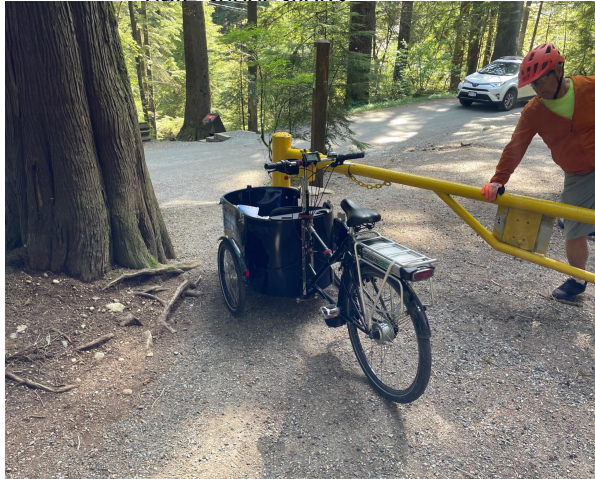
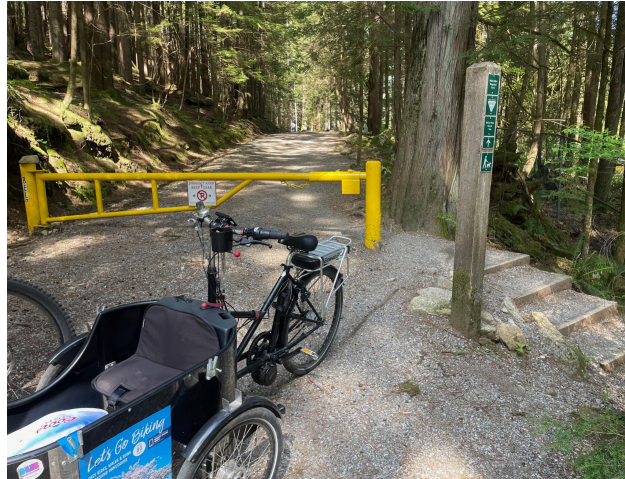
Gate 14 - Bowser Gate west exit

- Problem 1: Opening is narrow, hindered by tree root
- Problem 2: Stairs are too close to allow a proper turning radius
- Adaptive rider was concerned about tipping on the stairs
- Cargo bike rider couldn't ride, had to have help getting through opening and turning onto road
- Recommendation: Make gate smaller and to allow wider access, see *other gate suggestions*
