7 September 2024

Assessment of Burnaby's Central Valley Greenway

The Burnaby Local Committee of HUB Cycling conducted an assessment ride of Burnaby's section of the Central Valley Greenway (CVG) on Saturday, 10 August 2024.

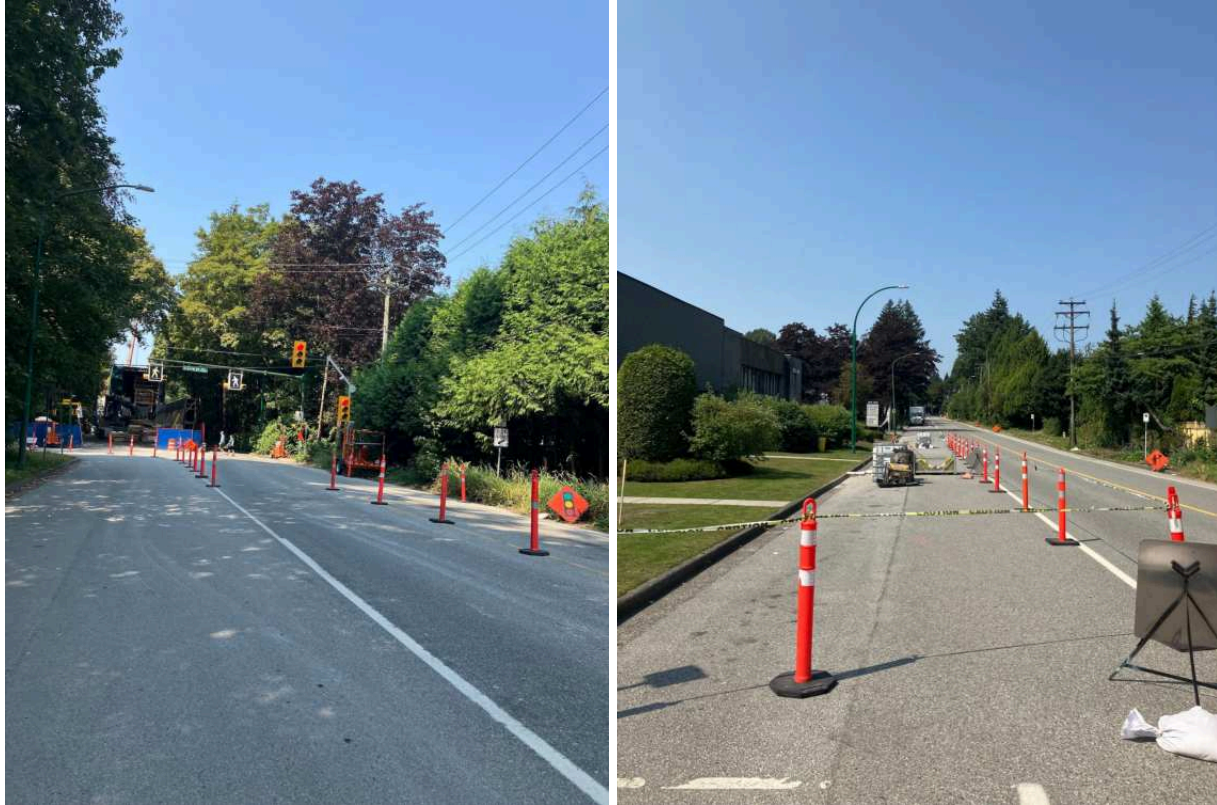
Figure 1: Sharing the lane on Winston St. Left: Single-lane alternating traffic along Winston St. This works for people driving, but is extremely uncomfortable for people cycling and potentially dangerous if followed by a person driving aggressively. Right: The construction site on Winston St. unnecessarily takes away all road space for people riding bikes and forces them to share a narrow lane with vehicles.

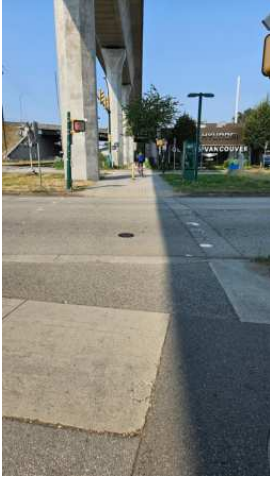
Boundary Rd	<p>Medium ▾</p>
2	<p>No markings for shared pedestrian/bicycle use. Also, we recommend the use of stencils on the pavement to indicate bollards and reduce crash incidents. For example:</p>

No.	Issue Description	Photo	Location	Priority
1	<p>Faded elephant's feet markings.</p> <p>Recommendation: Add a dedicated bicycle signal so people on bikes do not need to unnecessarily stop at the STOP sign when the WALK symbol is on. Green paint would be helpful at this busy intersection.</p>

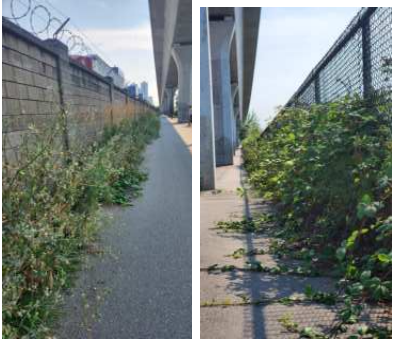
Under the SkyTrain between Gilmore Ave and Boundary Rd	Medium ▾
4	Broken pavement from plant roots

3	Overgrown vegetation on both sides of the path resulting in narrower path and increased potential for conflicts

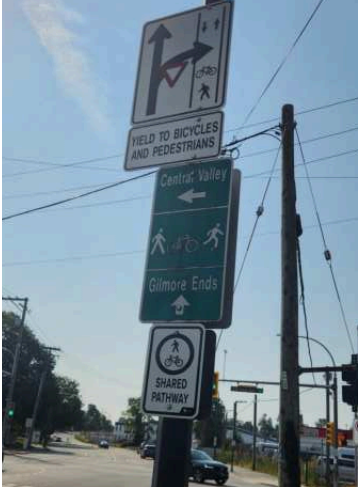
North-west corner of Still Creek Dr and Gilmore Ave	Low ▾
6	Curb cuts/dropdowns should be widened to allow more comfortable access to path

South of Home Depot	High ▾
5	Cycling wayfinding sign erroneously claims that Gilmore Bikeway ends (Gilmore MUP used to end at Still Creek but has since been extended northwards to Canada Way and beyond)

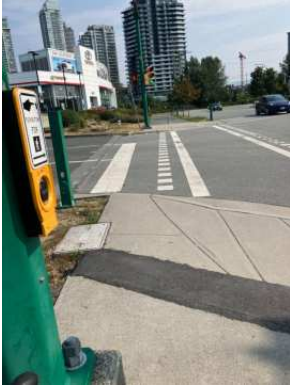
<p>7</p>	<p>Pedestrian signal should show WALK signal automatically (instead of requiring the call button)</p>

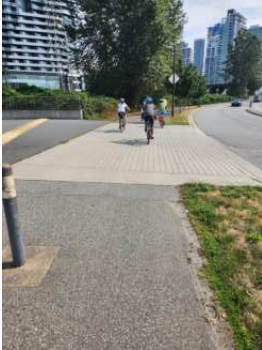
<p>Still Creek Ave and Still Creek Dr</p>	<p>High ▾</p>
<p>8</p>	<p>Green paint should be added to indicate the conflict zone at the driveway</p>

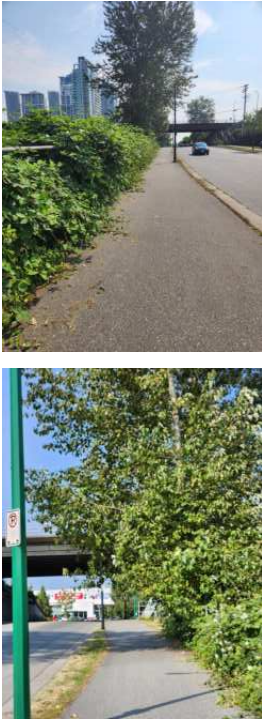
<p>4451 Still Creek Dr Driveway into Destination Toyota dealership</p>	<p>Medium ▾</p>
<p>9</p>	<p>Narrow path further narrowed by overgrowth</p>

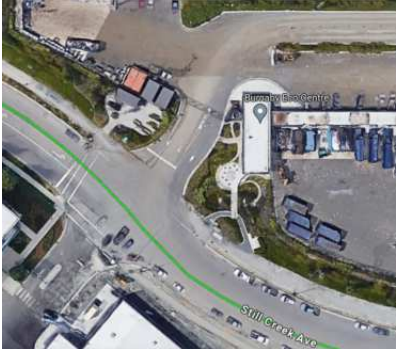
10	<p>Pedestrian signal should show WALK signal automatically (instead of requiring the call button)</p>

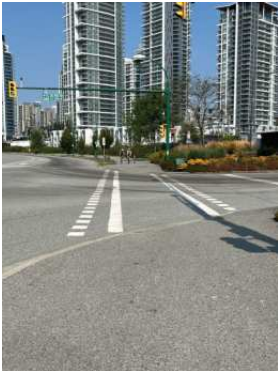
<p>Still Creek Dr at the Eco Centre</p>	<p>Medium ▾</p>
11	<p>Curb cuts/dropdowns should be widened to allow more comfortable access to path.</p>

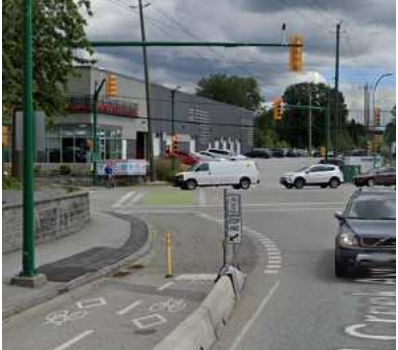
<p>Still Creek Ave eastbound at Douglas Rd</p>	<p>High ▾</p>

<p>Still Creek Ave quick build protected bike lanes</p>	<p>High ▾</p>
13	<p>Hold line is far back: people on bikes cannot be seen by vehicles coming down Douglas Rd. southbound.</p> <p>Good implementation on Douglas Rd of the white painted X before the intersection and “Stop line here” that helps reinforce the “No Right Turn on Red” restriction from Douglas Rd onto Still Creek Dr.</p>

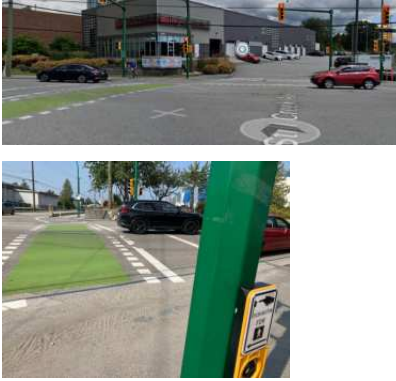
<p>14</p>	<p>Call button is hard to reach.</p> <p>In practice many people will not wait at a second light (east side southbound) just to cross a driveway. Infrastructure should accommodate it.</p>

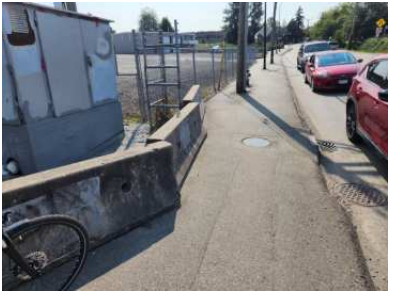
<p>Still Creek on east side of Douglas Rd</p>	<p>Medium ▾</p>
<p>15</p>	<p>Path narrows significantly due to barriers around electric box</p>

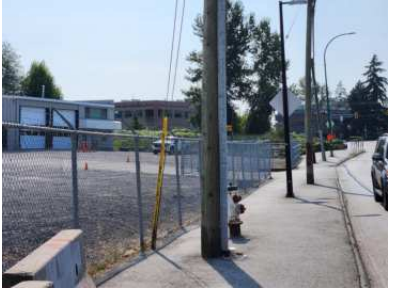
<p>Still Creek on East side of Douglas Rd</p>	<p>High ▾</p>
<p>16</p>	<p>Many obstacles - telephone poles, fire hydrants, street lights</p>

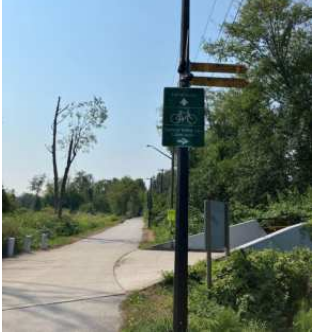
<p>West side of Winston St. overpass</p>	<p>Medium ▾</p>

<p>Still Creek on East side of Douglas Rd</p>	<p>High ▾</p>
<p>17</p>	<p>Add mode separation through pavement markings and signage after paving</p>		<p>Greenway between Douglas Rd and Sperling</p>	<p>Very High ▾</p>
<p>18</p>	<p>Missing shared path signage / markings.</p> <p>Missing wayfinding signs for CVG. Existing signs are faded and dirty.</p>

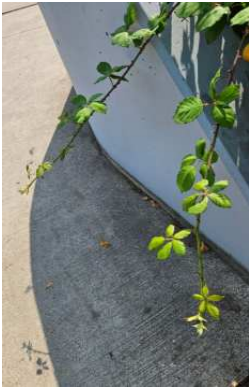
West side of Winston St. overpass	Medium ▾
20	Overgrowth with thorny vegetation. Also blocking sightlines

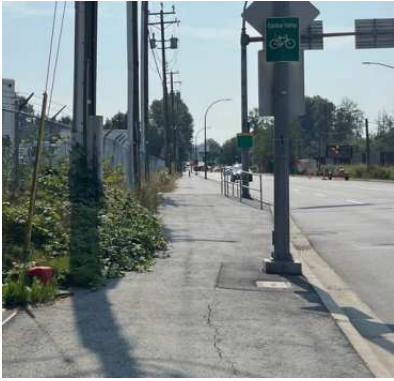
Winston St. south of the overpass	Medium ▾

CVG / Lakes intersection at the overpass	High ▾
22	Narrow but bi-directional shared path

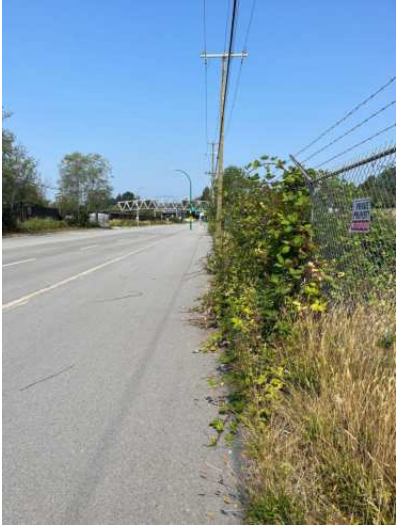
<p>23</p>	<p>A fence could be added for protection from vehicles.</p> <p>Overgrowth with thorny vegetation.</p>

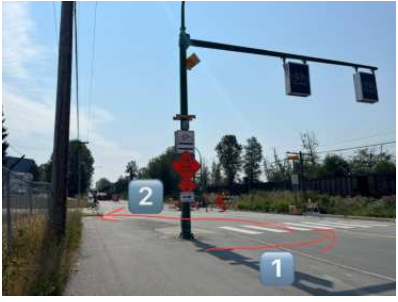
<p>Winston St south of the overpass</p>	<p>Low ▾</p>
<p>24</p>	<p>Confusing and unrealistic detour: People on bikes are directed to cross at the crossing and then to immediately turn left onto Greenwood St.</p>

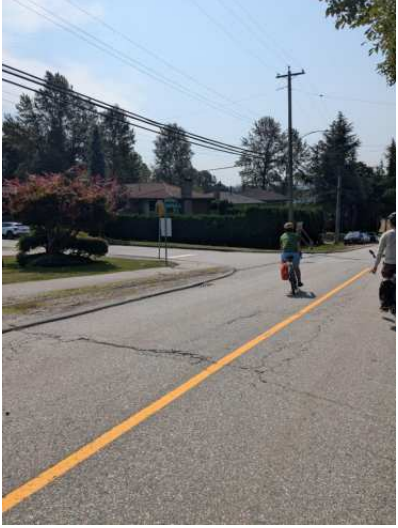
<p>Winston St and Greenwood St</p>	<p>Medium ▾</p>
<p>25</p>	<p>No signage for construction detour, only further down after turning left</p>

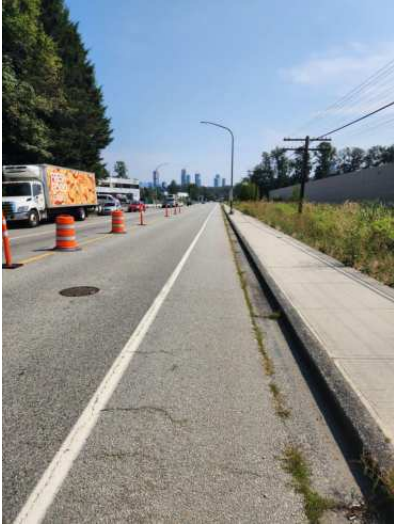
All along Winston St.	Low ▾
27	No physical protection. This is a truck route and popular alternative route to Lougheed Hwy for people driving.

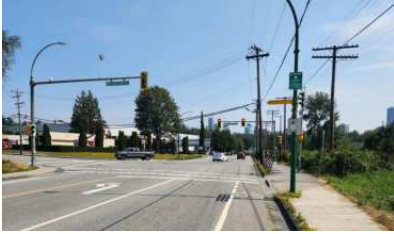
Winston St.	Very High ▾
28	Unclear signage/road markings to instruct people riding bikes to move up from painted bike lane to the MUP.

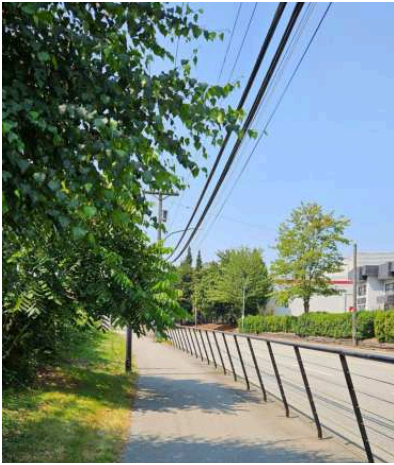
Along Winston St across from Costco	Low ▾

Winston St and Brighton Ave	Medium ▾
29	Low head clearance from overgrown foliage.

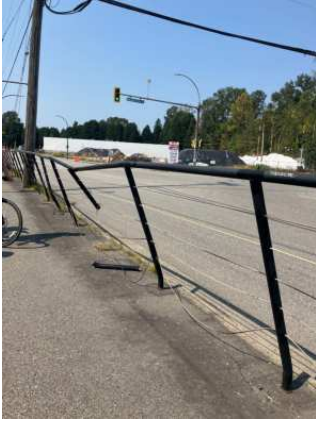
<p>30</p>	<p>Multiple sections of damaged fencing.</p>

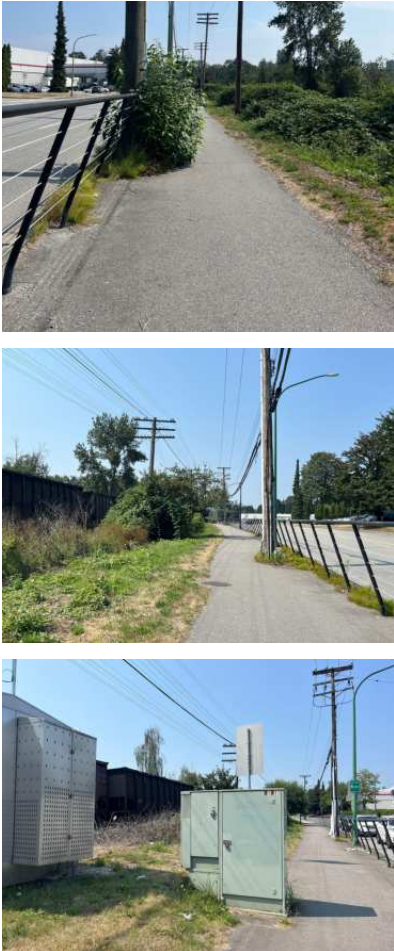
<p>Along Winston St MUP across from Costco</p>	<p>Very High ▾</p>
<p>31</p>	<p>Narrow MUP further narrowed by obstacles (overgrown bush, pole, and electrical box). Missing shared path signage / markings.</p>

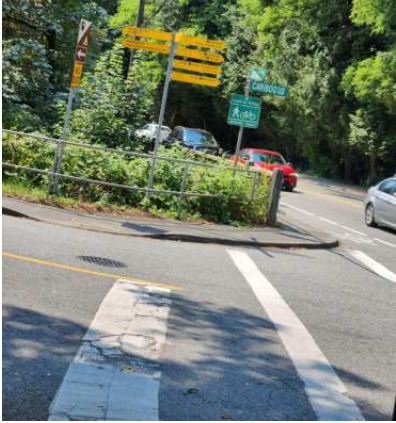
Cariboo Rd and Cariboo PI	Medium ▾
33	Unclear signage on where to continue (CVG continues to the left). Small left arrow on existing signage, no pavement markings

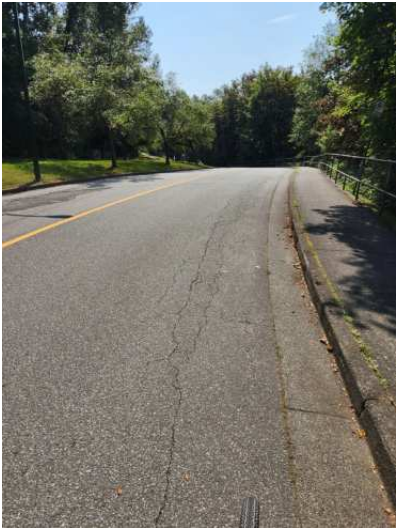
Cariboo Rd and Cariboo PI	Low ▾
34	No protection or pavement markings
