# Seaside Greenway South Assessment Ride 1

HUB Vancouver UBC Local Committee - *Seaside South Working Group*  
24 June 2015

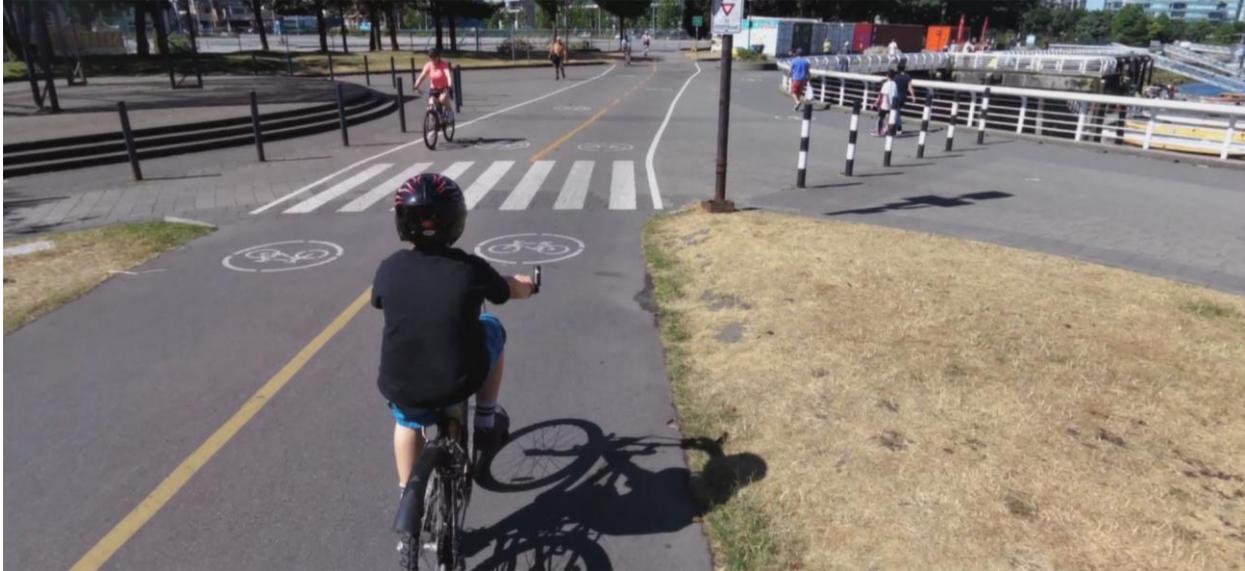
Figure 2

This section of the Greenway is well-provisioned. People on bikes are mostly separated from pedestrians, and the separated bike lane is clearly marked both for usage and for direction. Pedestrian crossings are clearly indicated with zebra crossings. The path is not always wide enough for faster cyclists to safely pass slower cyclists without crossing into the oncoming lane.

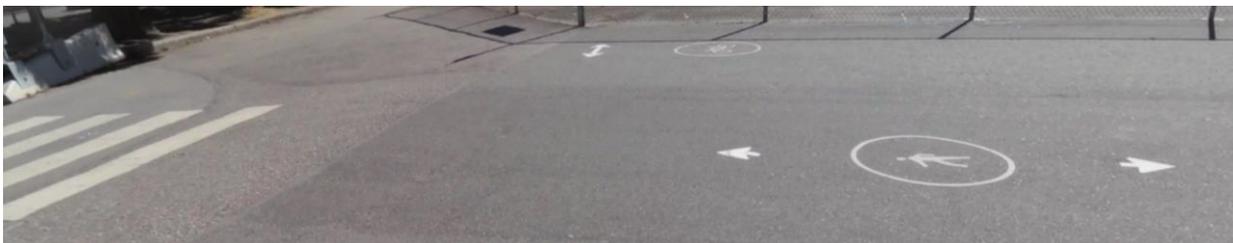
Figure 3

Beyond the Science World Plaza, the path runs past a yet-to-be-developed lot and becomes less desirable. In particular, where the Ontario Bike Route joins the Seaside Greenway, the usage and directionality indications are confusing, non-standard, or even absent. In Figure 3, even among the group of experienced users performing the assessment, there was considerable disagreement over the intended meanings of the arrows.

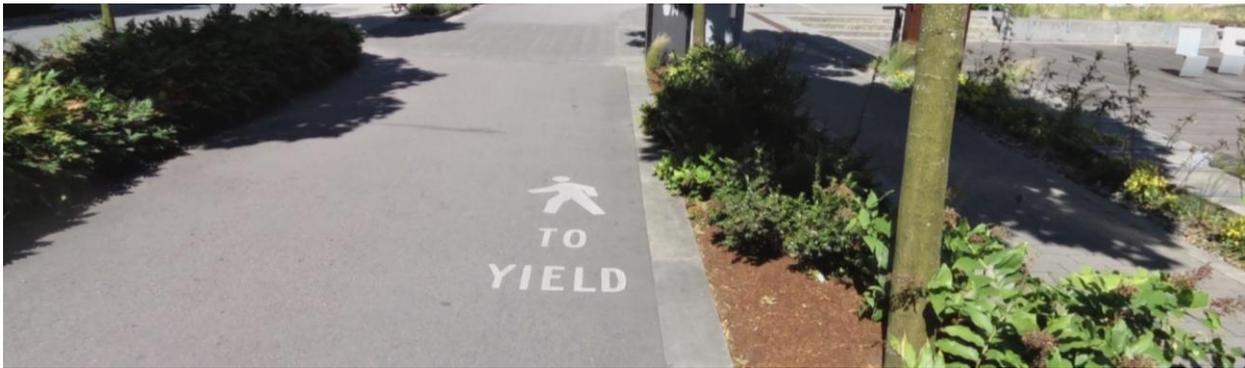
Wayfinding and signage continue to be problems along this section. In particular the painted symbol in Figure 4 is confusing: some people read it as “pedestrians to yield” when in fact the intended meaning is completely the opposite.

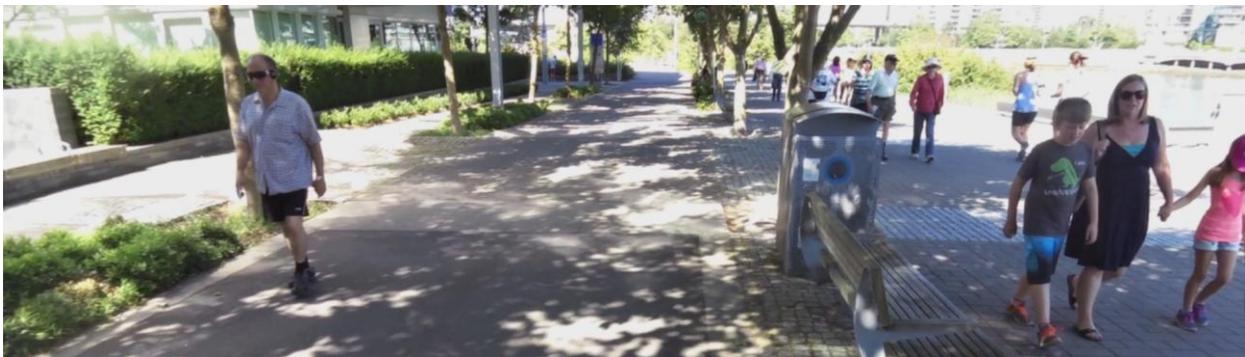
Figure 5 illustrates how the different surface treatment and small signs high out of people’s sight are not sufficient to prevent pedestrians from using the cycle path (although we did not observe any cyclist using the pedestrian path).

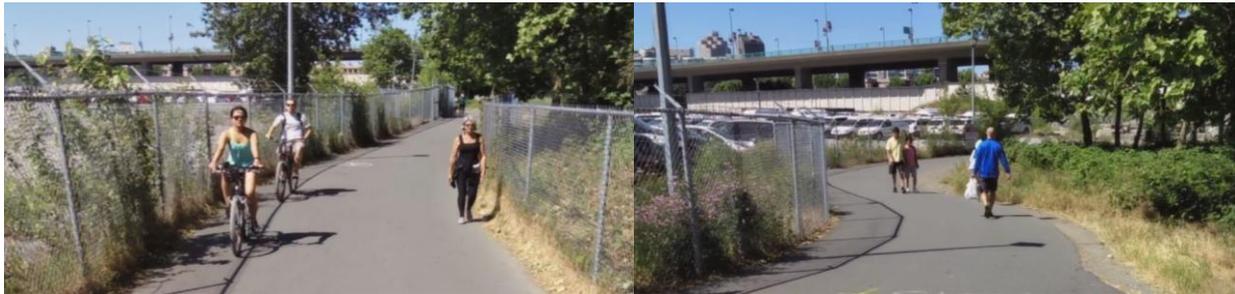
Figure 6

This segment of the Greenway consists of two distinct sections. The first section continues the separated path that runs through the Olympic Village but it soon turns into a multi-use path of variable width. There is no indication of which users are supposed to be in which part of the path, or what direction they should be travelling. The transition is abrupt and the lack of consistency is confusing. As a consequence of the lack of markings, people use the path in unpredictable ways; this also lends to meandering where neither people on bikes or pedestrians maintain consistent travel lines. The MUP is bordered in parts by tall chain-link fences which reduce the usable width of the path considerably.

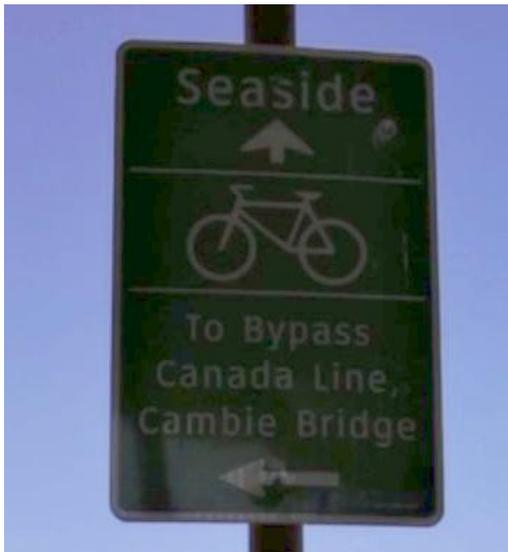
As with all sections, wayfinding signs are essentially missing. Figure 8 shows one sign in particular that is utterly confusing and is, in fact, completely misleading.

Note that the sign indicates to turn left to bypass the Canada Line and Cambie Bridge. What it intends to convey is to turn left to get to the Seaside Bypass, the Canada Line, and the Cambie Bridge. It is unlikely that people unfamiliar with the area will understand this intention. Further this sign is located well above most people's line-of-sight and may be entirely overlooked in the first place.

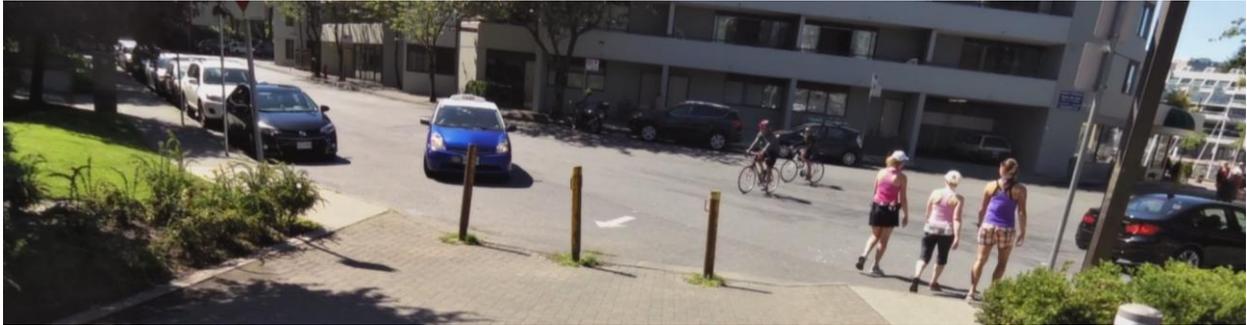
Figure 13 shows the approach to Stamp's Landing from the east. All modes are expected to use the same space without any separation or guidance. The taxi is navigating the cul-de-sac, while people on bikes and on foot cross the cul-de-sac.

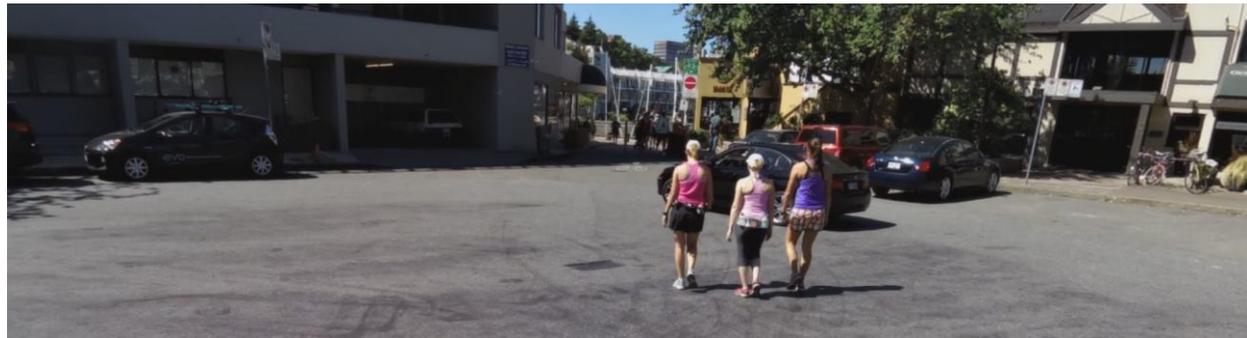
Figure 14 shows three pedestrians taking the shortest route to the continuation of the Seawall, through the middle of the cul-de-sac. Again, there is a vehicle navigating the cul-de-sac.

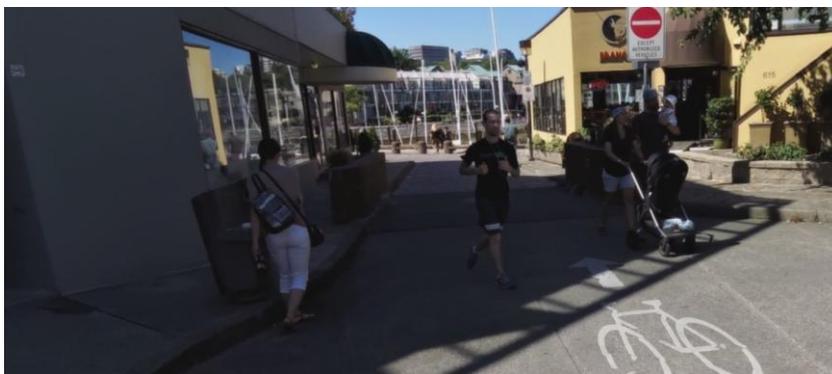
Figure 15 illustrates the chaos at the western side of Stamp's Landing. The No Entry sign does not mention bicycles.

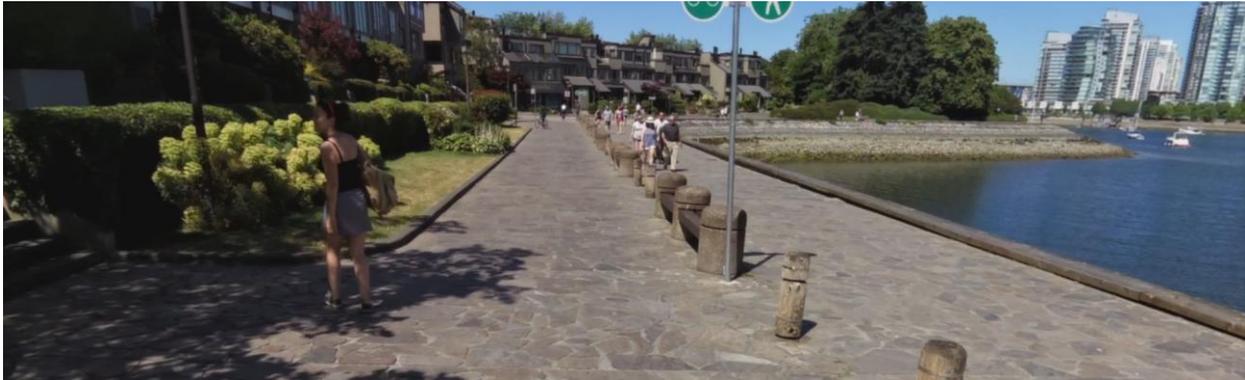
Figure 16

This segment of the Seaside Greenway is older than the previous segments. There is some mode separation using short concrete and wood bollards and seating (Figure 16). The bollards are not always obvious in low lighting situations due to a lack of contrast. The path width is excellent. While the cycling path is shared with vehicles, the vehicles are few in number.

The most serious issue in this section is the flagstones. The flagstones are uneven, bumpy, slippery (particularly in wet and winter conditions), and in a poor state of repair. The flagstones cause problems for bikes with small wheels, both road bikes with narrow tires, and children's bikes with small diameter wheels and training wheels.

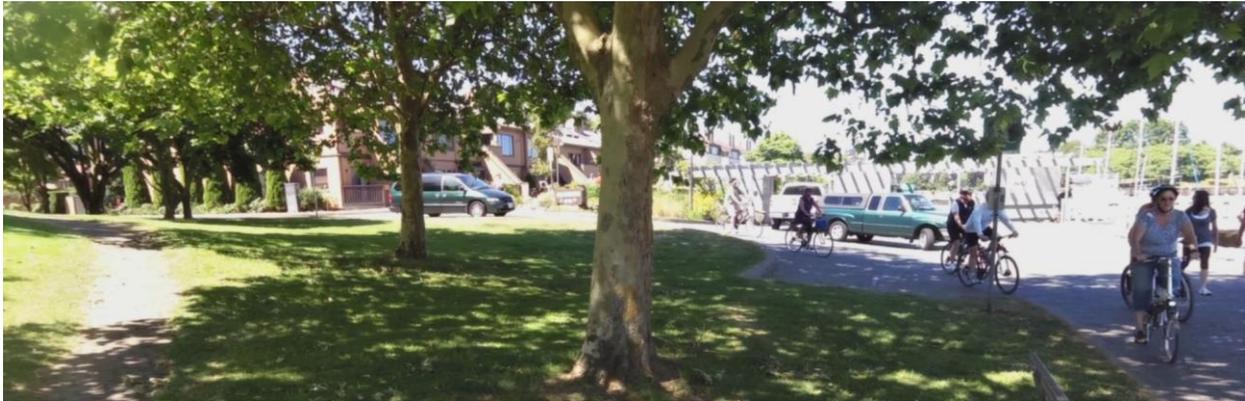
The seawall makes a “S” turn up a slight hill. This S-turn includes a portion of road for access to the marine. Figure 20 shows two motor vehicles trying to navigate the area with a constant flow of bicycles and pedestrians competing for the same space.

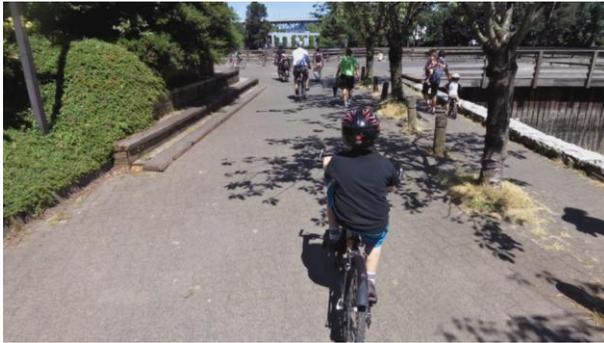
Figure 22

This segment of the Seaside Greenway is characterized by a relatively narrow and curved mixed-use path. The portion along Alder Bay (Figure 22) is naturally separated by cherry trees, but heaving of the path by the tree roots and the narrowness space between the trees and the edge of the seawall mean that few pedestrians use that portion of the path.

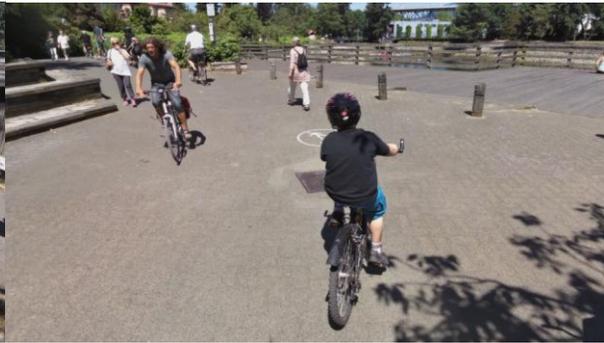
Figure 23

The curvature of the path reduces sightlines to dangerous levels in places, and the presence of some features creates collision hazards. (Figure 23).

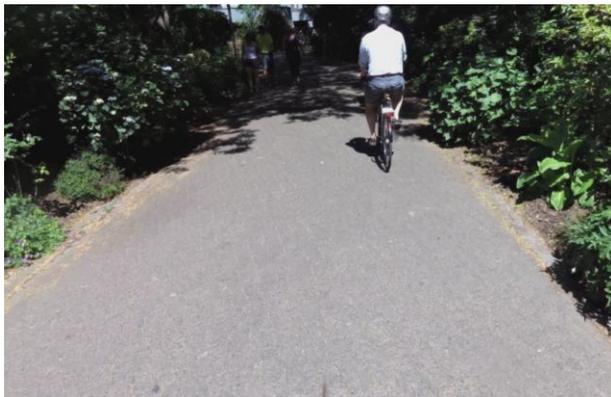
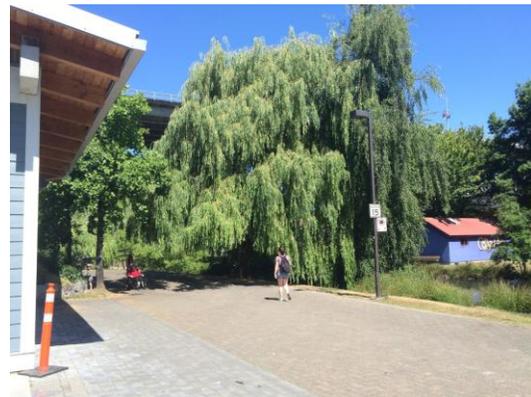
Vegetation encroaching on the path narrows the path considerably in places (Figures 24 and 25) and causes most people to avoid at least half of the available space.

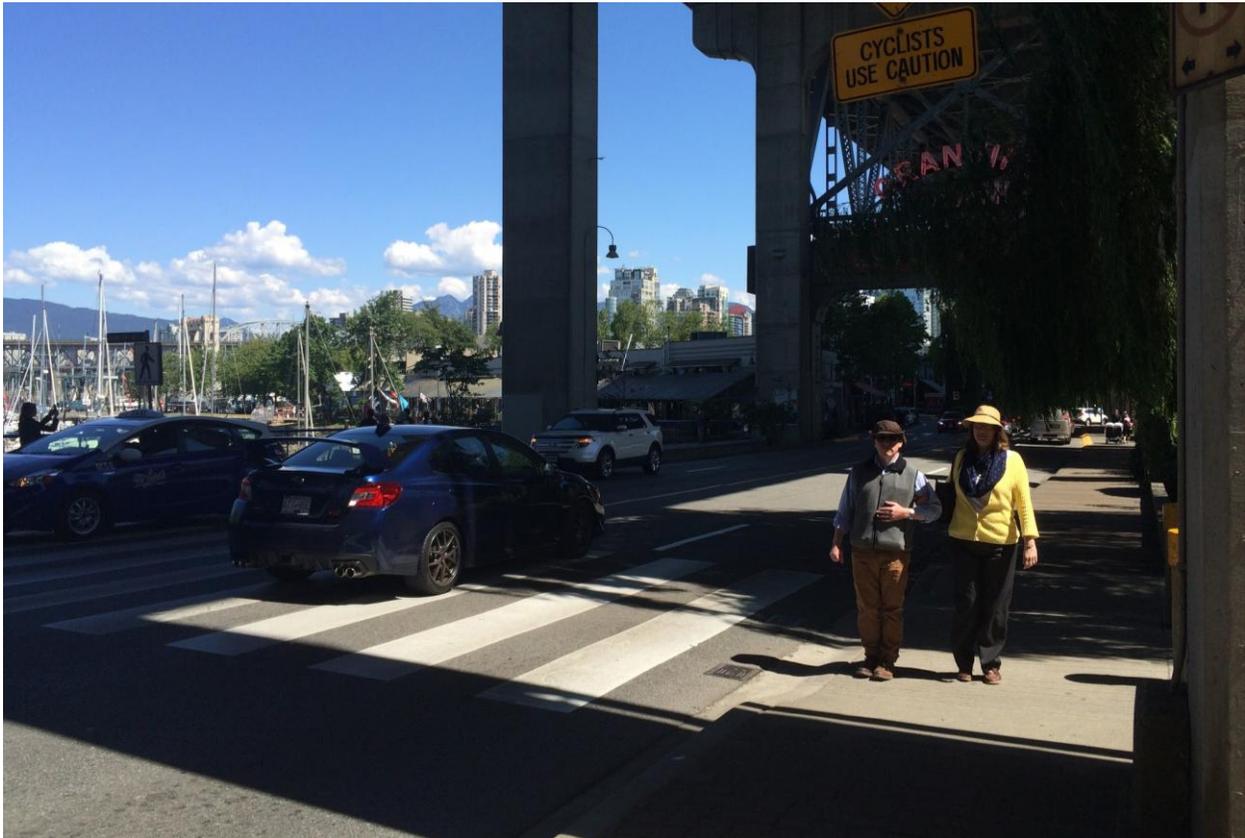
Figure 26

At the western edge of this segment, the path crosses Anderson Street, the only motor vehicle access to Granville Island. (Figure 26) The MUP passes on the north side of two bridge support

columns, causing significant sight line issues for all modes looking for motor vehicle traffic coming from the south. Bikes are permitted to cross through the crosswalk here (permission granted by sign) but the crosswalk isn't painted as a cross-bike with elephant feet as in other areas of the city. Conflicts occur in this area frequently as pedestrian traffic tries to walk along the sidewalk north and south while pedestrians and people on bikes try to cross both sidewalks and four lanes of traffic. Neither motor vehicles or pedestrian traffic is controlled by a signal.

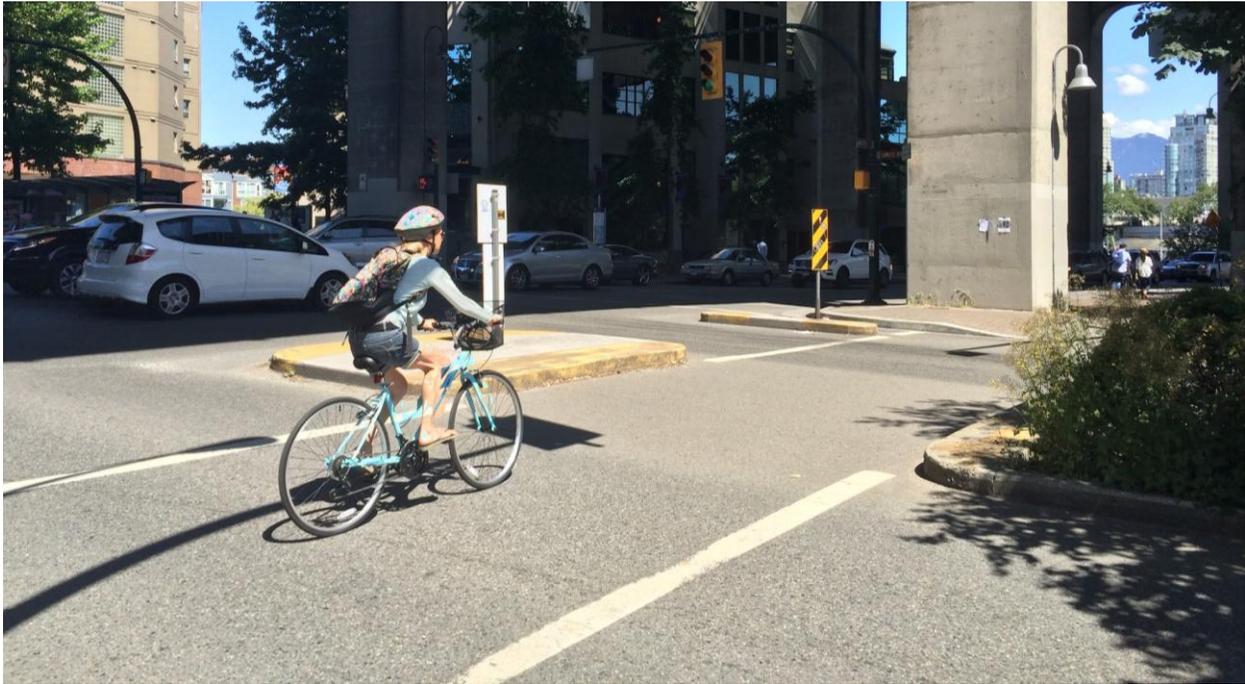
Figure 27

The intersection of West 2nd Avenue / Lamey's Mill Road and Anderson Street underneath the Granville Street Bridge (Figure 27) is a difficult intersection for all users. There is no clearly marked route for people on bikes in this area, heading in any direction. For cyclists heading on to Granville Island or just trying to get on to the Seaside Greenway, the options are to either ride in the heavy traffic as a vehicle, get off and walk on the sidewalk, or to divert to Old Bridge Road in an attempt to avoid heavy motor vehicle and pedestrian traffic. However, there is no easy, safe, or comfortable way to do this.

For cyclists heading along the Seaside Bypass, westbound motor vehicle traffic is not permitted to turn north on to Anderson Street, but it happens often enough that cyclists have to be very cautious about right-hook collisions in that location. For eastbound people on bikes, they have to navigate a roadway that has traffic turning both north and south on Anderson Street, as well as through-traffic. Two lanes on the west side collapse to a single lane on the east side. Lamey's Mill Road on the east side of the intersection is narrow and takes an immediate tight turn.

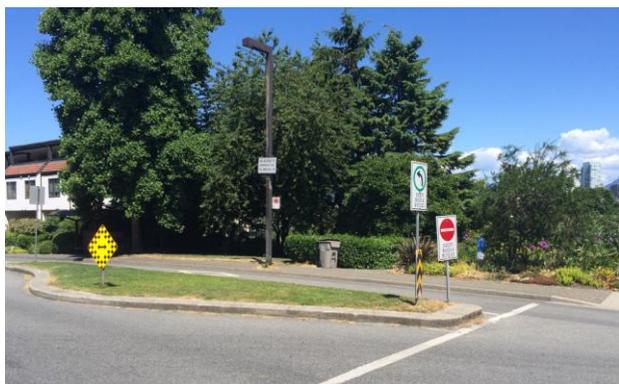
Figure 28

At Alder Crossing (Figure 28) motor vehicles (except for buses) are diverted to prevent westbound through traffic. Unfortunately, this diversion is poorly observed and traffic behaves quite aggressively here. While the assessment ride was happening, a fast westbound bus honked at a westbound cyclist for no apparent reason other than to force him to the curb in a lane that the person on the bike was entitled to be in (and otherwise cycling safely in).

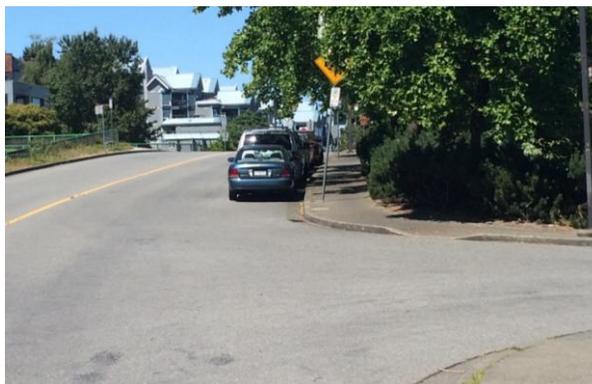
Figure 29

The advance signs indicating the diversion (Figure 29) are hardly visible due to overgrown vegetation.

There is easy access to the Seaside Greenway at two points along Lamey's Mill Road; at Old Bridge Road for access near Granville Island, and at The Castings. Neither of these access points are indicated by wayfinding signs. Furthermore, as can be seen in Figure 29, the access at The Castings of people on bikes heading on to the Seaside Bypass eastbound is impeded by poor visibility caused by parked cars on the north side of Lamey's Mill Road.

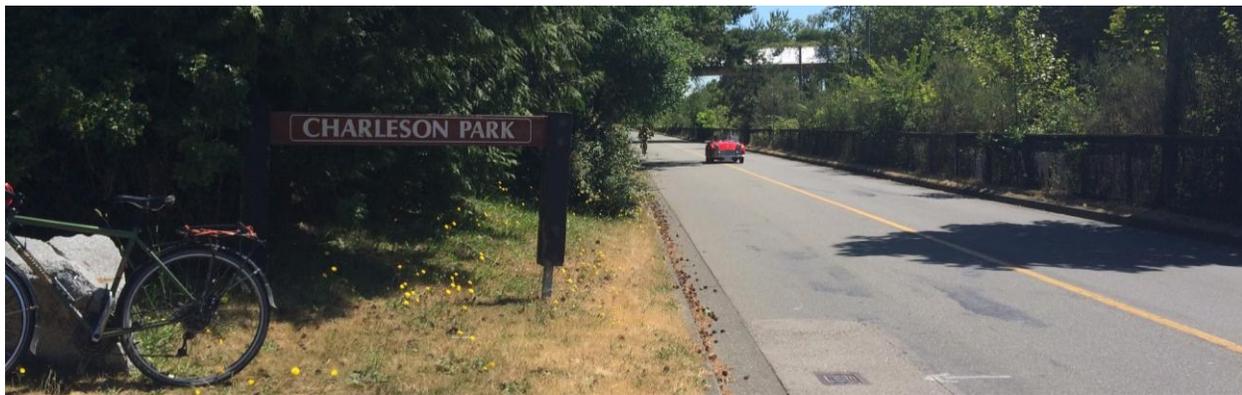
Figure 30

Charleson Road passes under the Laurel Street Land Bridge (Figure 30). There are two pedestrian paths leading up to the land bridge at this point, but neither path is suitable for bikes. One path is surfaced with wood chips and is unlit; the other is more suitable but gates at the bottom of the path prevent bikes from using the path. This would be a popular place for faster cyclists to get on and off of the Seaside Bypass if it were improved. Keeping faster cyclists on the Seaside Bypass serves to improve the safety and reduce the conflicts on the seawall. The Seaside Bypass needs to be identified, and promoted as a safe and fast alternative both with sufficient infrastructure and wayfinding signs in order for that to occur.

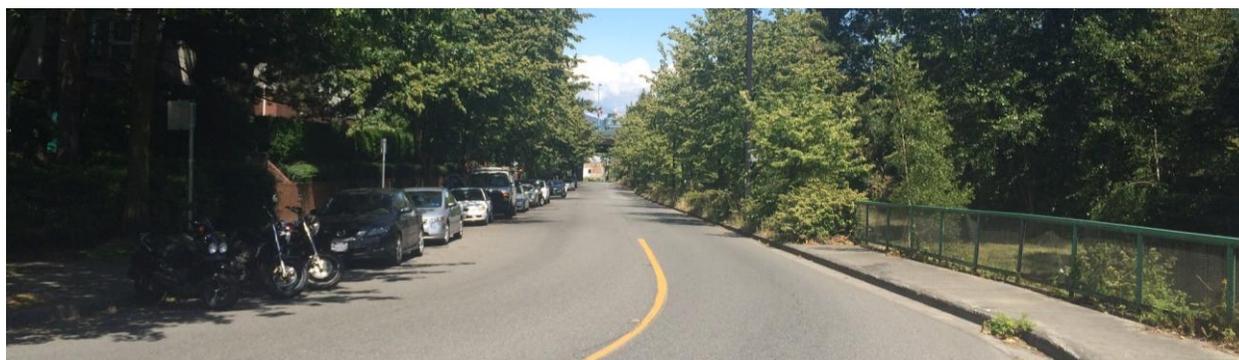
Figure 32

The segment of the Seaside Bypass between the end of Charleson Park and the Cambie Street Bridge is a relatively quiet residential road (Figure 32). Parking is only permitted on one side of the road. As Commodore Road passes under the Cambie Street Bridge, a painted bike lane begins.

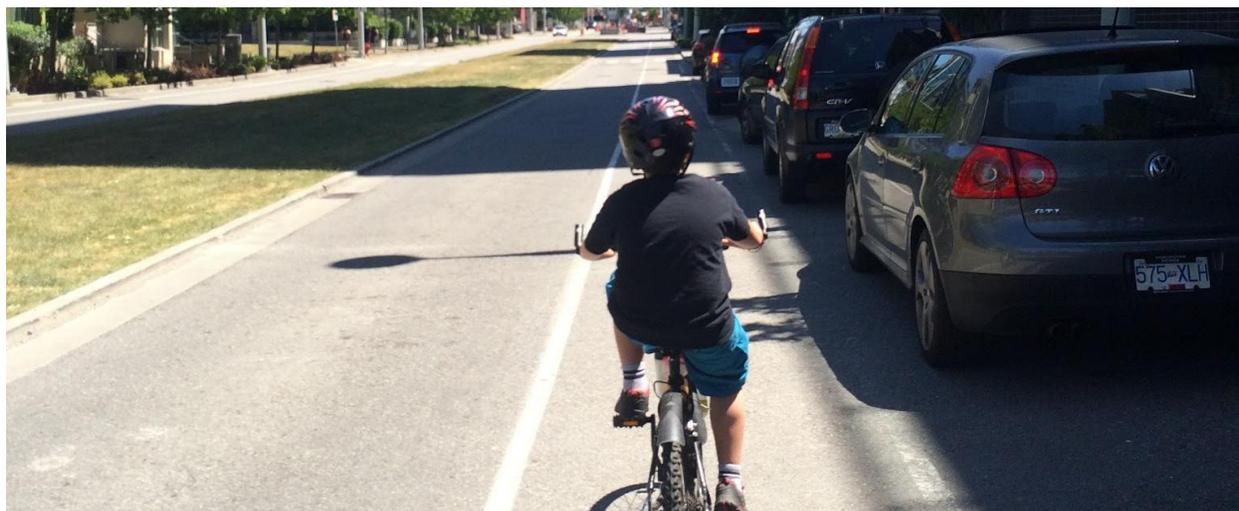
Figure 33

The segment of the Seaside Bypass from Spyglass Place to Ontario Street runs through the heart of the new Olympic Village development. There is a painted bike lane with parking on the curb side (Figure 33). Unfortunately both the parking and travel lanes are narrow so people on bikes end up in the door zone of the parked cars. There is a large median along this route, suggesting there is sufficient room to provide more separation and better protection for people on bikes.
