RE: Cycling Infrastructure Deficiencies at Murray Creek Ravine on 40 Avenue

Observed infrastructure deficiencies

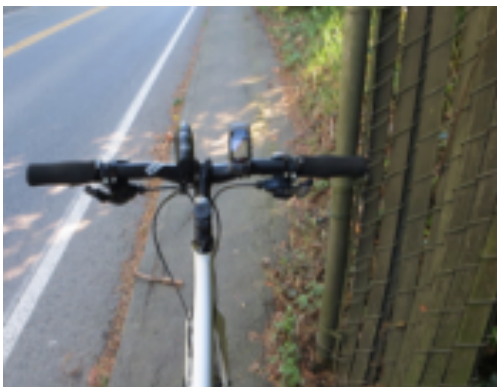
Figure 1.2 Narrowest section of sidewalk.

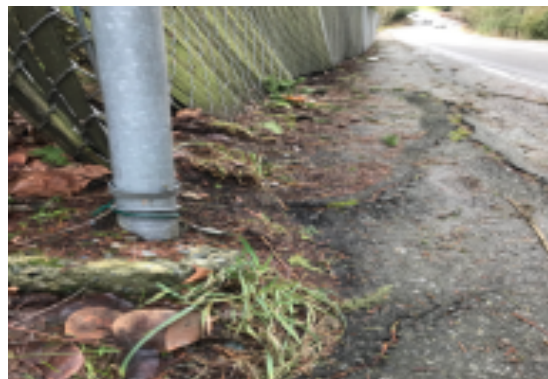
Figure 1.3 Exposed concrete base is a tripping hazard.

Closer inspection of the sidewalk reveals numerous locations where tree roots have heaved and broken the asphalt surface, thereby creating tripping hazards for pedestrians and crash zones for cyclists. This type of hazard can easily cause pedestrians and cyclists to fall into the path of passing vehicles. Few if any bike commuters will attempt to negotiate the hazards on the unsafe sidewalk. Instead, cyclists choose to ride on the smooth surface of the roadway. Unfortunately, there is no space for a cyclist to commute safely on the east/westbound lanes and motorists must move into the oncoming lane when passing cyclists.

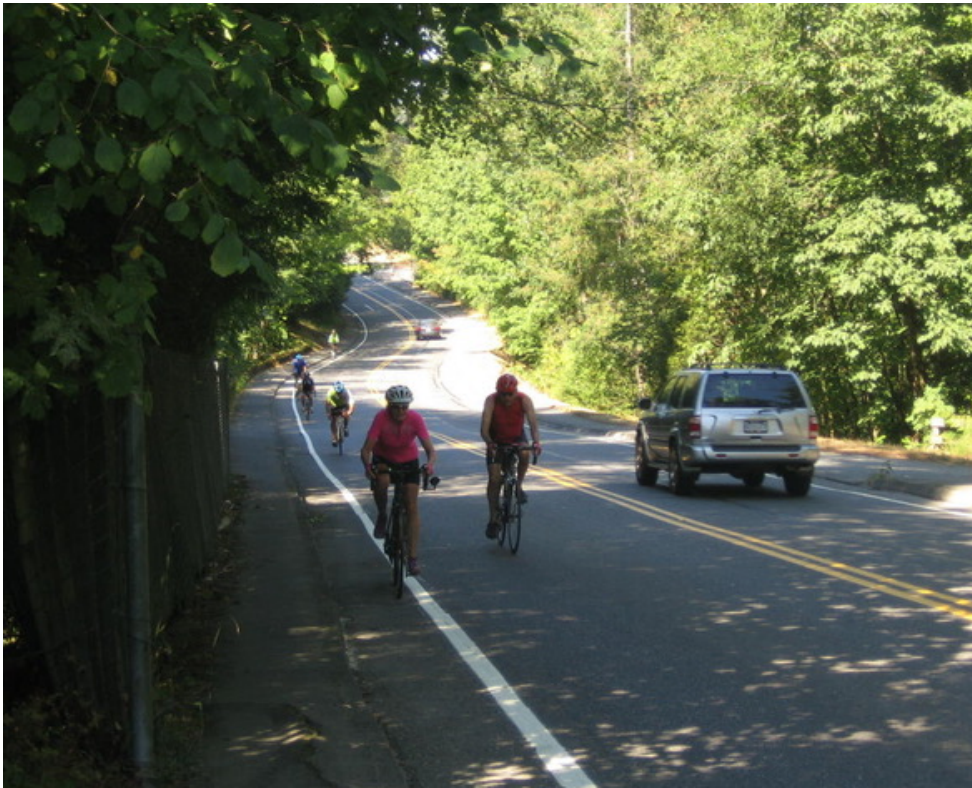
Figure 1.4 Eastbound cyclists avoiding use of the narrow sidewalk.

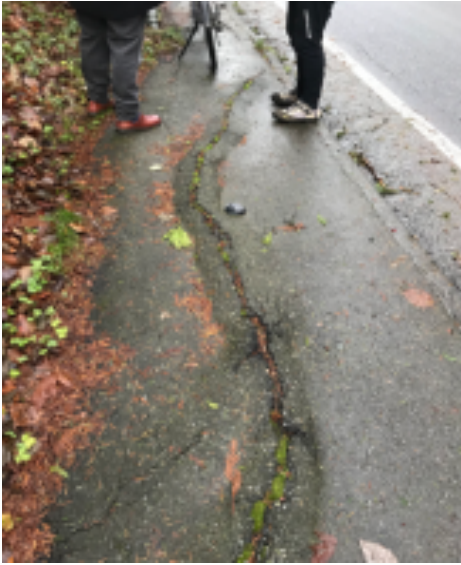
Figure 1.5 Sidewalk on southside of 40 Avenue.

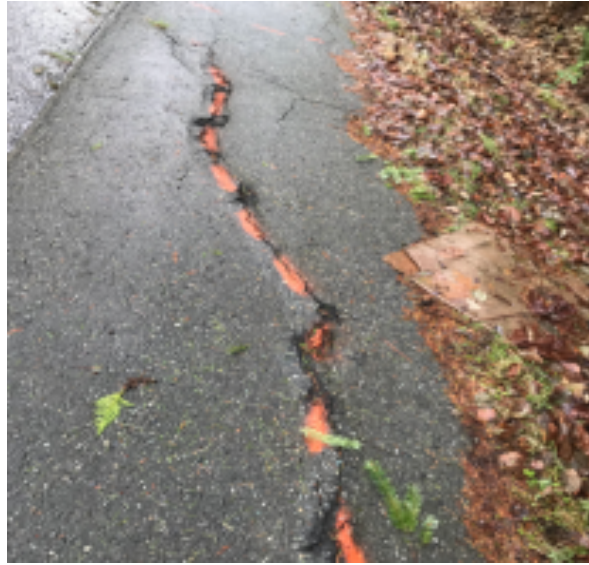
Figure 1.6 Sidewalk on north side of 40 Avenue.

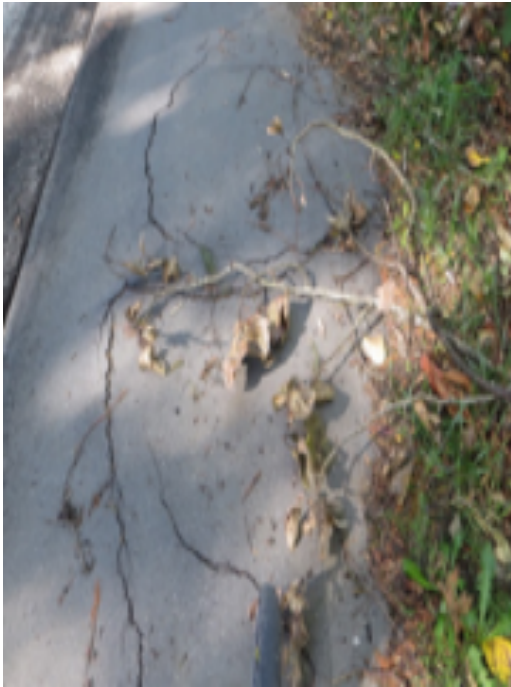
The most serious safety issue is where the eastbound sidewalk is on an incline from Murray Creek. There is an approximately 60 foot chain link fence that borders the immediate edge of the asphalt. At its narrowest point the usable portion of the sidewalk is 82 cm wide. Bicycle handlebars range in width from 46 - 71 cm. As a person slowly pedals along the incline of this sidewalk, they become less stable and can catch the right handle in the chain link fence causing them to crash and or the bicycle veers off the raised sidewalk into eastbound traffic. At the eastern end of the chain link fence, a concrete fence post base reveals itself as a tripping hazard and a large tree root has heaved and cracked the asphalt surface. This root crack runs along the length of the sidewalk for about 10 meters.

Figure 1.7 Minimum distance to edge of traffic lane for speed of 60 km/h speed is .5 meters (TAC).

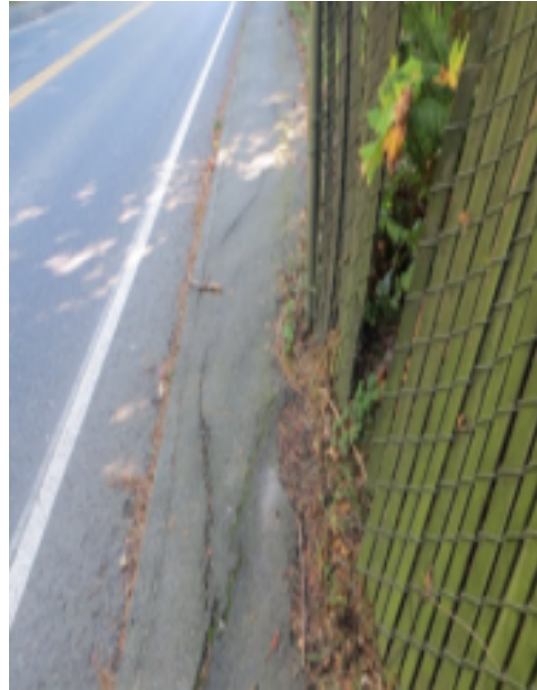
Figure 1.8 Dangerous conditions for cyclists and pedestrians.

Improvements can be made long before major road upgrades at Murray Creek ravine are undertaken. HUB Cycling Langley strongly recommends the removal of the graded sidewalk and the creation of an at road level multi-user path on the north and south side of the highway. Elimination of the 1.35 meter raised sidewalk creates a 1.75 meter wide path from the edge of the fog line. An asphalt curb should be added to the outside of the fog line so that motor vehicles cannot stray onto the MUP. The south sidewalk comes to an end a short distance east of the chain link fence by a driveway entrance. Beyond this point the eastbound sidewalk is at road level with a 163 cm wide shoulder until the intersection at 216 Street. This portion of the shoulder has sufficient room for pedestrians/cyclists and would only require the addition of a protective asphalt curb.

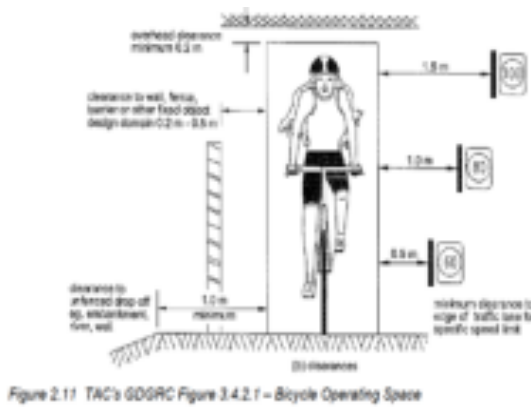
Figure 1.10 The chainlink fence in Fig 1.11 is in contravention of TAC standards.

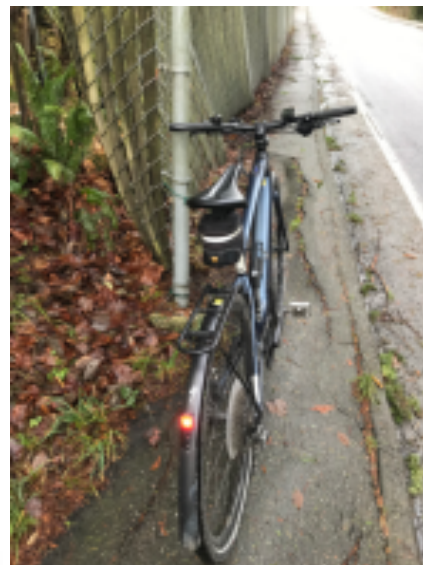
Figure 1.11 This sidewalk does not meet TAC standards.

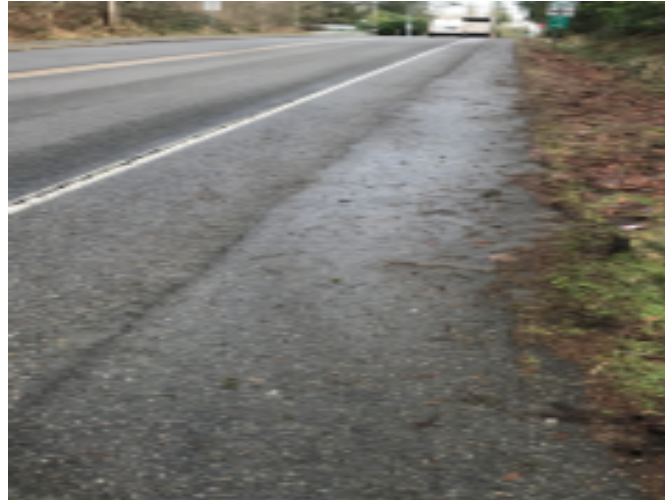
Figure 1.12 From the east end of the south side fence to 216 Street the bike/pedestrian pathway is at travel lane level and 163 cm wide.
