## **Ongoing issues with the Pitt River Bridge Cycling infrastructure (DRAFT, 6 feb 2013)**

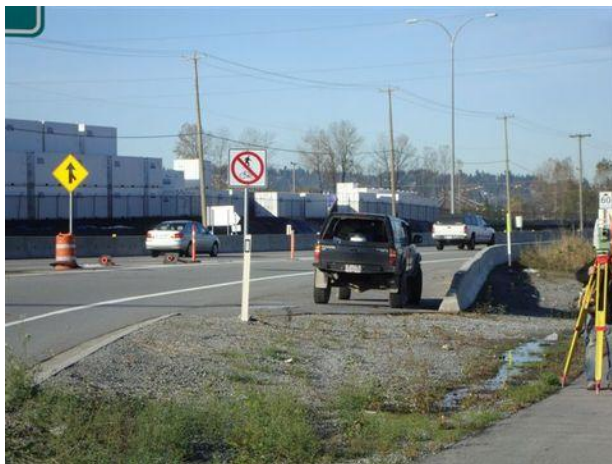
### 1. Cycling prohibition: Freemont connector to Lougheed, westbound

At the entrance ramp from Freemont to Lougheed (westbound) there is a sign prohibiting cyclists from using the wide shoulder on Lougheed. This is the only place on Lougheed where there is such a restriction. Cyclists are free to ride on the shoulder at all other locations. The shoulder is ~ 2m wide. The speed limit is 60km/hr. There are no challenges here for average road cyclists. A good example of a comparable structure where cycling is permitted is the shoulder on the xxx bridge. Recreational weekend cyclists have an alternative off-road MUP which is adjacent to this area.

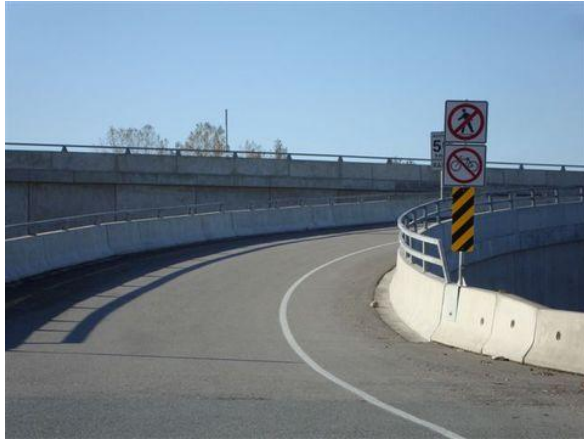
## 2. Cycling prohibition: Freemont overpass to Maryhill bypass.

The Freemont overpass provided key access for commuters travelling from PoCo or points east to the Maryhill Bypass. There is a 2m wide shoulder. Cars are travelling at low speeds (50 km/hr posted limit). There is no credible reason for prohibiting cyclists from using this ramp.

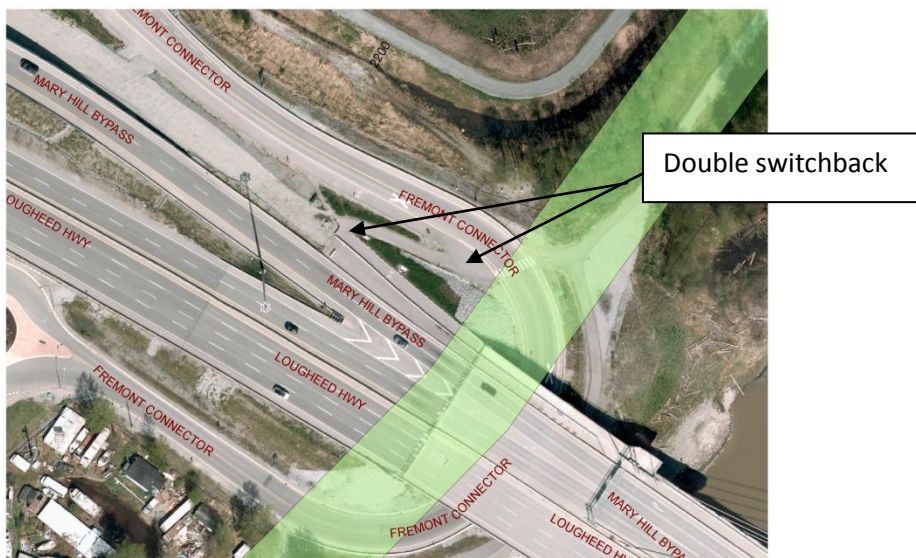
## 3. Switchbacks on western end of Pitt River Bridge mixed use path

The current design of the multi use path (MUP) on the Pitt River bridge has a serious problem on its western end. Riders are forced to make two very sharp 180 degree switchbacks to bring them down to the MUP onto the Freemont Connector. The switchbacks are a hazard for cyclists particularly in the winter during icy conditions. Tandem riders and cyclists with trailers may not be able to negotiate the switchbacks at the best of times. The design of the switchbacks isn't supported by any design guidelines that we are aware of. We can see no reason for the switchbacks, and request that they be removed and replaced with a single straight connection. We have been requesting help on this for over three years. A video of the situation is available here: [http://www.youtube.com/watch?v=IYL3no0eo\\_A](http://www.youtube.com/watch?v=IYL3no0eo_A)

Another problem is that after descending down the switchbacks the cross walk is placed in the apex of the curve for the Freemont Connectors. Cars approaching from the east are going downhill and then veer right onto the cross walk. Cars coming from the south veer left across it. Pedestrians (and people on or walking bikes) on the South side of the Freemont connector have to look across about 270 degrees to ensure there is no traffic. First to their left, and can only see about 100m to the crest of the hill. Then to their right where they can only see about 75m under the bridge. The cross walk should be 100-200m farther west where the connector is straight and driver's attention is directly ahead to see people crossing. The users of the cross walk would then only need to look across 180 degrees and have a longer distance to view incoming traffic. By coincidence, possibly the best location is where the extension of the walkway from the bridge hits the existing sidewalk (currently an unofficial dirt track through a ditch.)

The other problem is that after descending down the switchbacks to the cross walk, it (the cross walk) is placed in the apex of the curve for Belfast St. Cars approaching from the East are going downhill and then veer right onto the cross walk. Cars coming from the south veer left across it.

Pedestrians (and people on or walking bikes) on the South side of Belfast have to look across about 270 degrees to ensure there is no traffic. First to their left and can only see about 100m to the crest of the hill. And then to their right where they can only see about 75m under the bridge.

The cross walk should be 100-200m farther West. Where Belfast is straight and drivers attention is directly ahead to see people crossing. And the users of the cross walk only need to look across 180 degrees and have a longer distance they can view traffic coming from.

By co-incidence, possibly the best location is where the extension of the walkway from the bridge hits the existing sidewalk (currently through the ditch.)

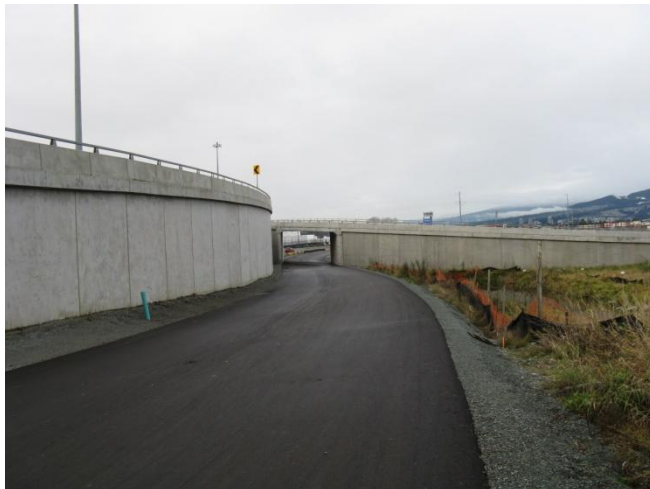
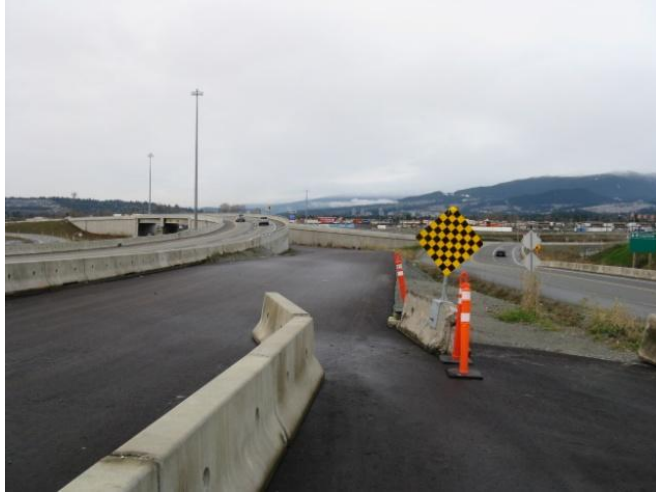
#### **4. Bus lane:**

There is a new bus lane being constructed to channel buses under the Freemont connector directly onto Lougheed (westbound). This lane has a width of 24 feet and could easily support a 2 m shoulder on the north side. Access to this lane was temporarily granted in the fall of 2012 as shown below, however, the concrete dividers have now been closed back up.

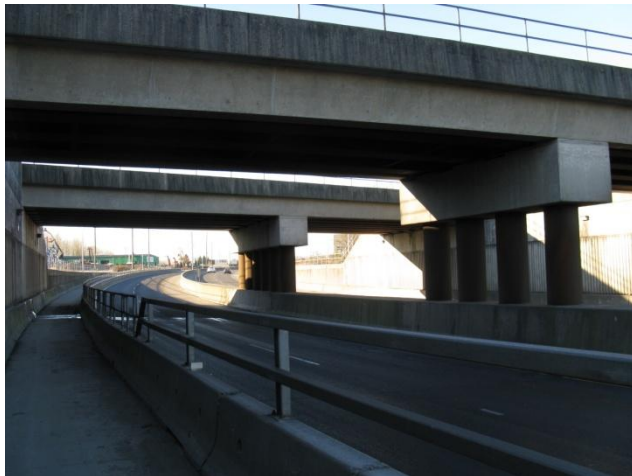
##### **5. CP rail underpass**

This is a longer term issue, however we can see no good reason why there cannot be a shoulder on the south side of the eastbound lane on the Maryhill bypass where it passes under the CP rail tracks just west of the bridge. This would require relocation of the road markings by 2m to the north, but there is plenty of room to do this.

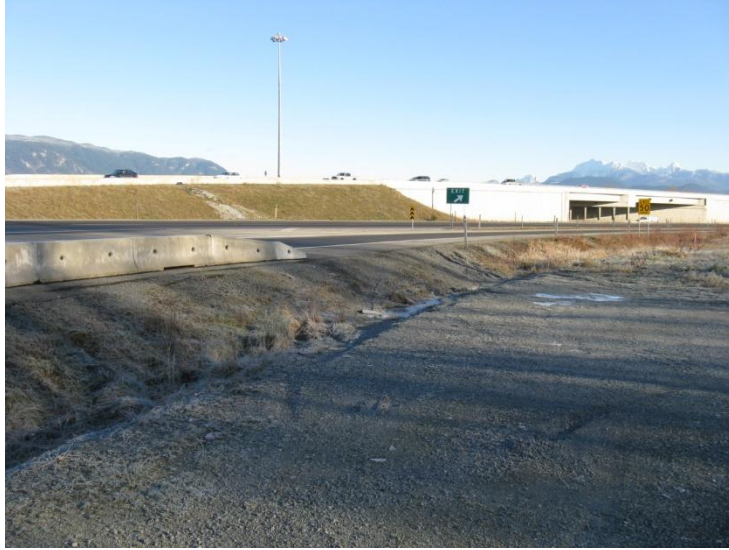
##### **6. Lack of eastbound access to the bridge from south side of Maryhill bypass**

Another issue is access to the eastbound shoulder of the main bridge roadway, which is legal for cyclists to use but which cannot be accessed unless one takes the roadway through the CPR underpass described previously (# 5). There should be bicycle access provided from the adjacent MUP north of the underpass to the shoulder of the eastbound Mary Hill ramp to the bridge, at least until the requested shoulder space through the underpass is provided.

Also, if one uses the eastbound shoulder on the bridge one finds oneself on a very narrow shoulder (perhaps 60 cm wide?) between the Esso station and the Dewdney Trunk intersection. This shoulder, which appears to have been narrowed by the inappropriate placement of concrete barriers, should be widened to a minimum of 1.5 m.
