## Assessment of Adanac Cycle Route - East of Gore

November 1, 2013

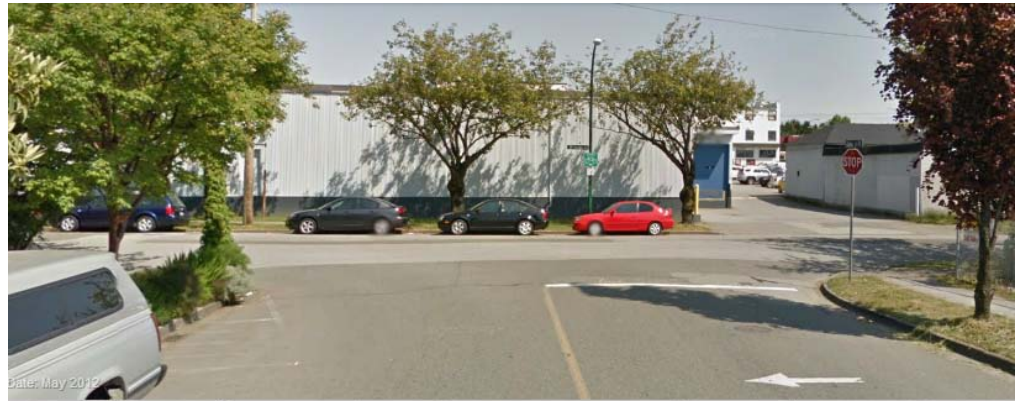
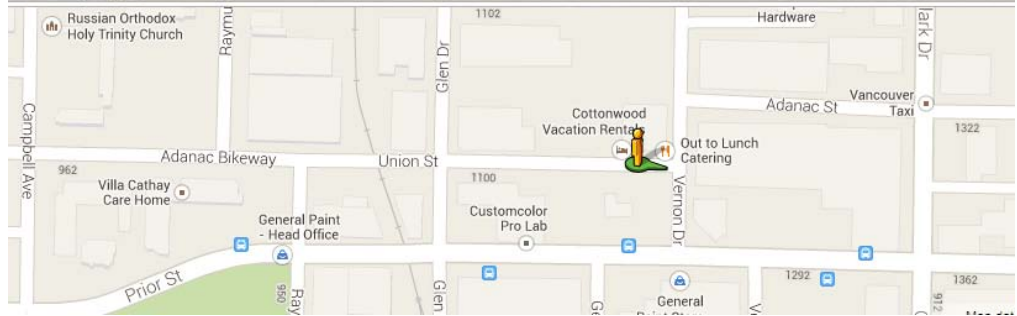
### Union Street and Vernon Drive

To encourage use of the Adanac bikeway we recommend reducing bicycle travel time by eliminating unnecessary stops. To this end, we recommend replacing the east-west stop signs on Union Street at Vernon Drive with yield signs. The eastbound stop sign is depicted below.

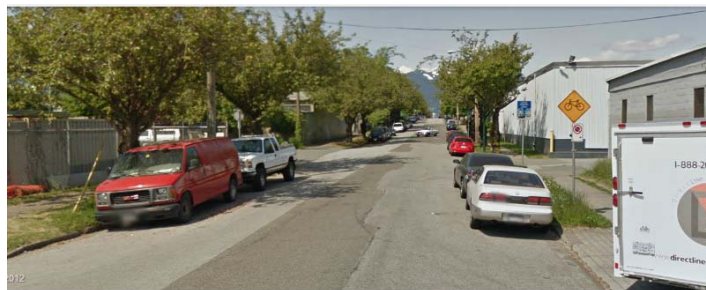
To improve cycling safety at this intersection, we recommend improved traffic calming. Cyclists have reported motorists travelling at high speeds north on Vernon Street. Motorists travelling north are not faced with a 30 km/h speed limit sign. We recommend a speed bump for north-bound motorists. We have depicted below the northbound view on Vernon Street:

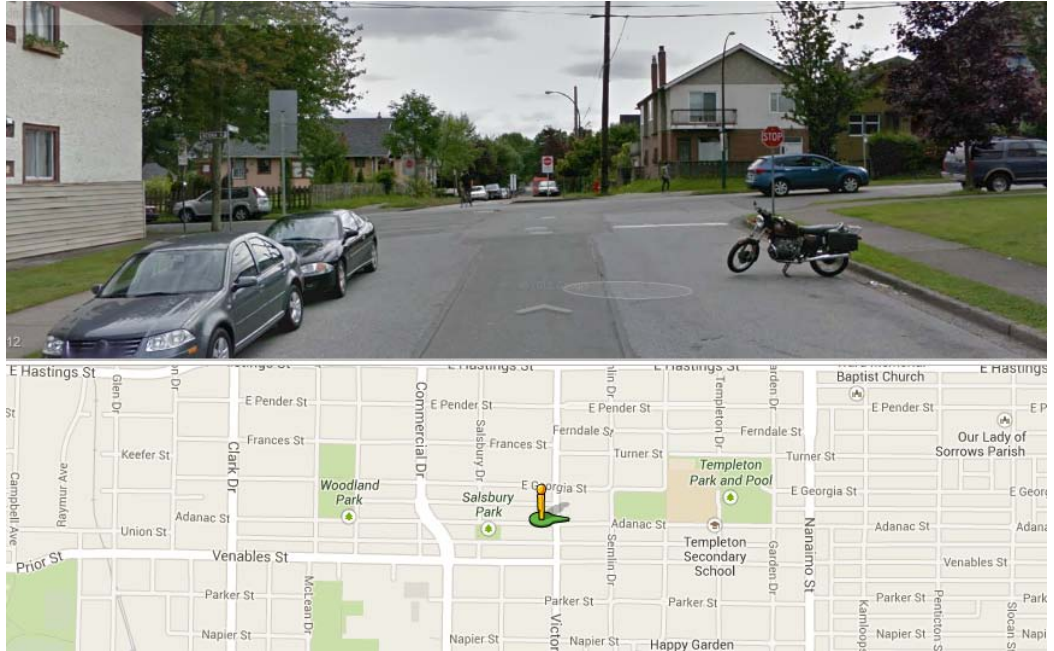
### *Adanac Street and Victoria Drive*

The visibility at the intersection of Adanac Street and Victoria Drive is poor. For a cyclist stopped on Adanac Street facing eastbound (as depicted below), it is difficult to gage the traffic travelling south on Victoria Drive due to the parked cars. One solution is to remove the parking spaces that obstruct that perspective.

An additional improvement to this intersection would be the creation of a stoplight and a bicycle activated loop detector. This configuration would both improve the safety of crossing that intersection and eliminate unnecessary stops at the stop sign.

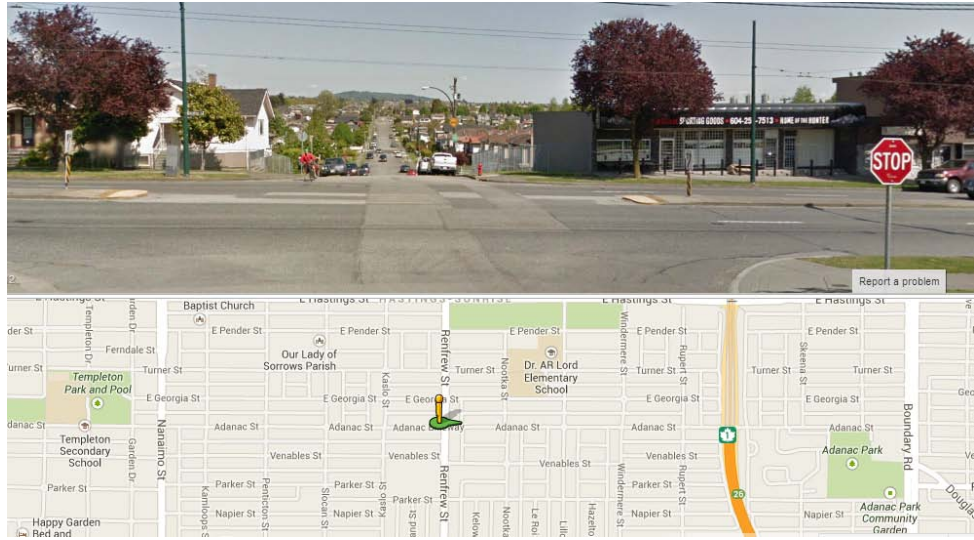
### *Adanac Street and Renfrew Street*

The intersection at Adanac Street and Renfrew Street is particularly dangerous for cyclists. It is not an AAA intersection. Cyclists must cross four lanes of high-speed traffic without the benefit of a stop sign for north-south traffic. In addition, the constant, high volume of traffic on Renfrew Street requires significant delay in the cyclist's trip.

The intersection at Adanac Street and Renfrew Street is depicted below.

HUB recommends the installation of a stoplight and a bicycle activated loop detector. In the alternative, the refuge island should be more secure and wide enough to accommodate cyclists. A more effective refuge can be found at 8<sup>th</sup> Avenue and MacDonald Street.

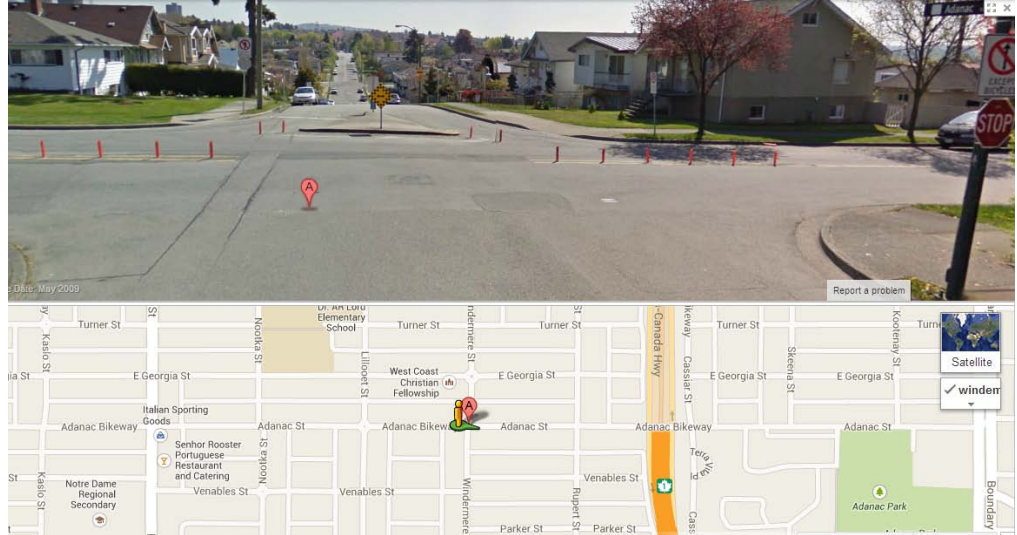
### *Windermere & Adanac:*

The flexible bollards at this intersection are confusing and do not conform to traffic markings used elsewhere in the City. We recommend the use of green paint and bike stencils to clearly identify cyclist zones.

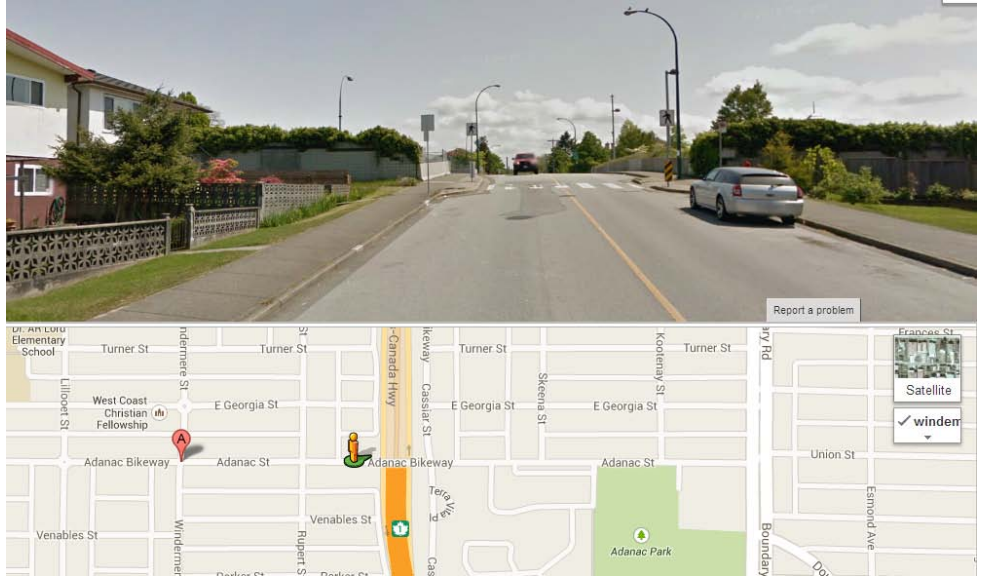
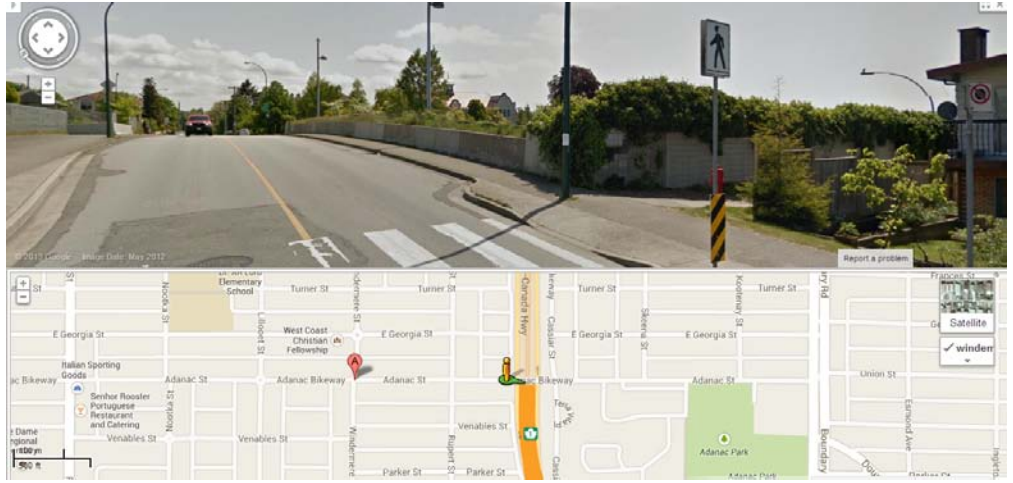
### *Adanac Street & Cassiar Overpass to Boundary Street*

The Cassiar overpass is a dangerous area for cyclists and motorists. There is no marked bicycle lane or signs indicating to cars to share the road. Cyclists are going slower uphill eastbound and cars pass into oncoming traffic that is travelling over the hill to get around them. The parking and pedestrian bulges narrow the street forcing those cycling to "take the lane". Cyclists report that traffic speeds through the area to connect between Rupert and Boundary exceed 50 km/h.

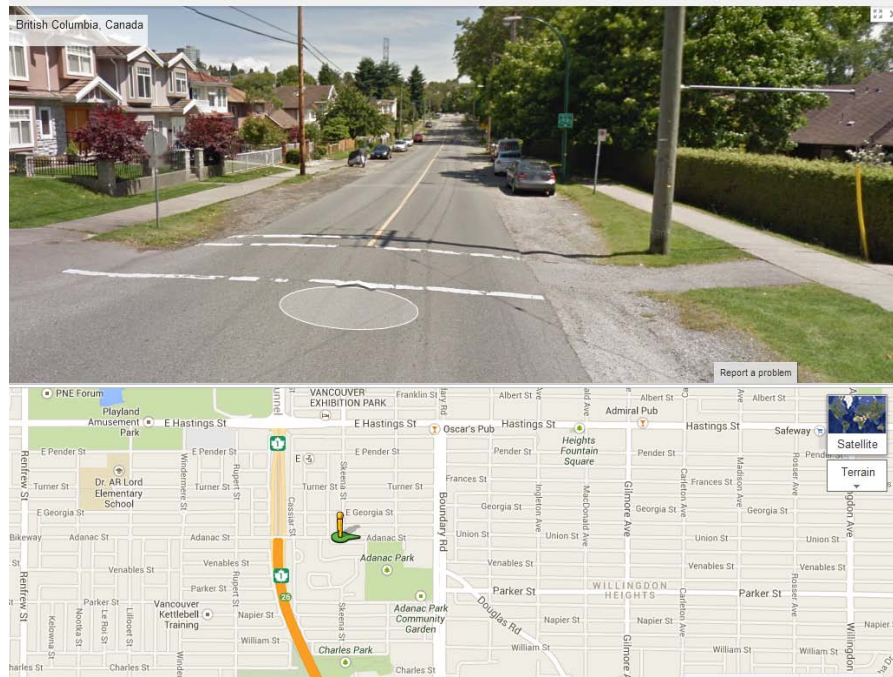
Between the overpass and Boundary Road, the sides of Adanac Street become gravel. We recommend that the City pave the sides of Adanac Street to eliminate sliding, ruts and potholes. This is a busy street unlike further west which is traffic calmed. Paving the sides would increase space for cyclists who must still distance themselves a metre from the opening doors of parked cars.
