NW Marine Drive (Seaside Bypass Bikeway) Recommendations

Prepared by the Vancouver UBC Local Committee of HUB Cycling

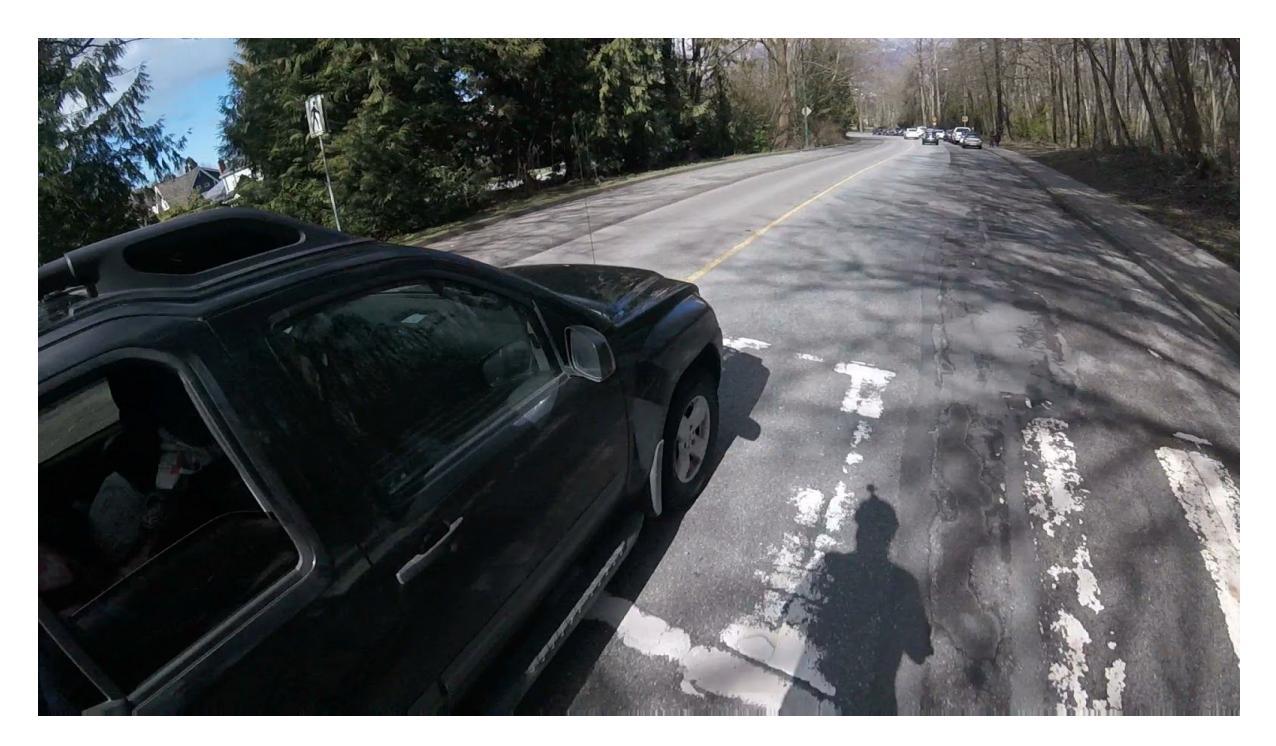
Fig 2 - Along NW Marine from 4th to Discovery, there is a wide roadway, without lane markings apart from a centre line. The inner (curb) lane has been partially re-paved, but still has rough pavement next to the curb. There are no signs indicating where a person cycling should position themselves. Vehicles were observed passing close to cyclists in the travel lane prior to new pavement being applied, as shown in this photo. This section is marked on the Vancouver bicycle map as a "Shared Use Lane," which is defined on the map as a relatively busy street with painted markings that indicate where people cycling should position themselves. These markings are absent. Vehicles were observed to be speeding up through this section. When people on bicycles rode on the smoother pavement (at the right hand side of the travel lane) prior to the re-paving work, some vehicles were observed to be crowding the bikes, and not crossing the centre line to overtake. One ride participant experienced a truck passing on the right side on this stretch on a different day; the truck driver was presumably frustrated with the speed of the cyclist.

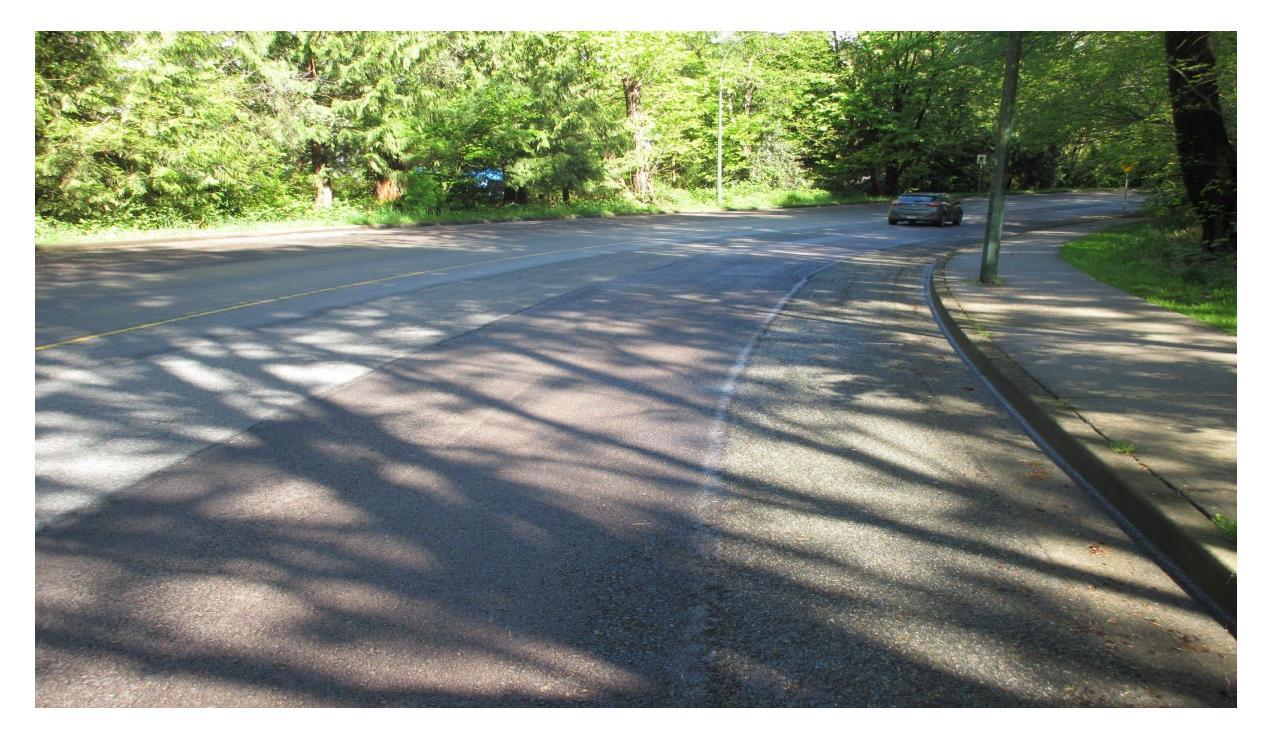
Fig 3- New pavement adds room for people on bikes, but doesn't make it clear where a person should position their bicycle. Parking is permitted along this section. If the new pavement was applied to the curb it would be clearer that a person on a bike should ride as close as practicable to the curb, apart from the parked vehicles.

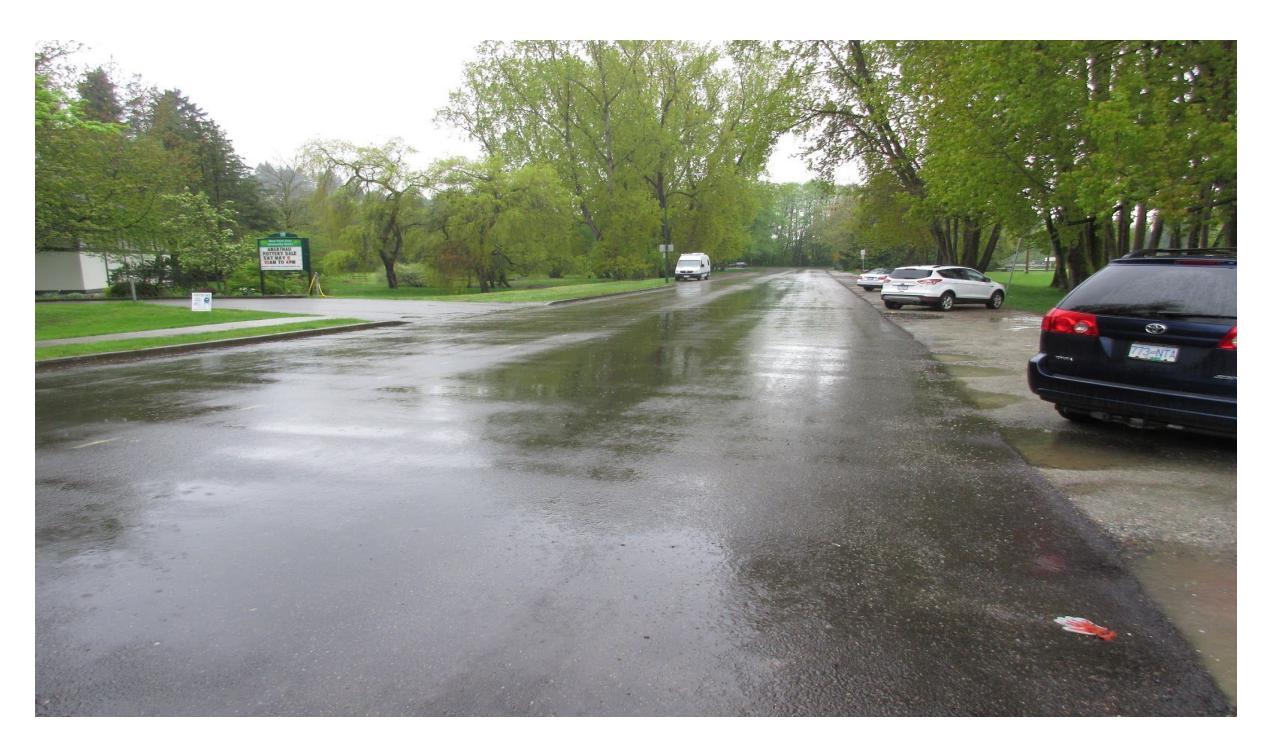
Fig 4 - From Discovery to Trimble, the new pavement is very wide, which appears to encourage higher vehicle speeds. There appears to be sufficient room here for two painted bike lanes in addition to the vehicle lanes. There is no indication (yet) of where to ride. As well, there are two transit stops, and there are vehicles reversing out into traffic. Reversing vehicles were observed to be backing not into the main travel lanes, but into the area where people on bikes were riding.

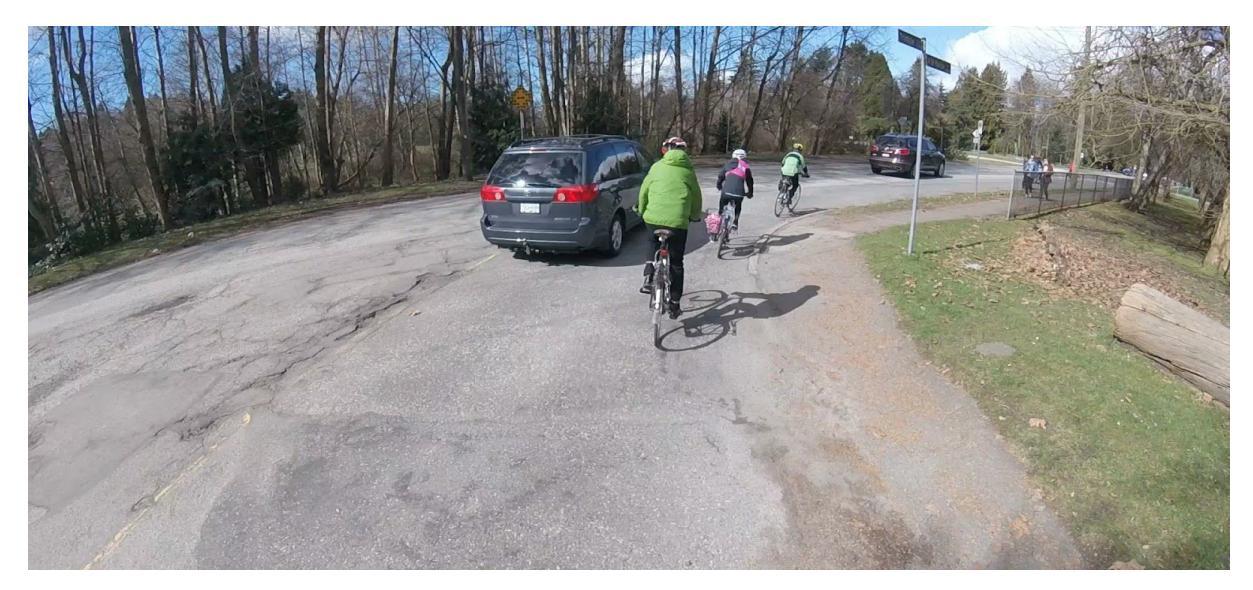
Fig 5 - At the right turn towards the water at Trimble, vehicles were observed passing close to cyclists through the corner, squeezing cyclists into the curb. Signs are required indicating no overtaking.

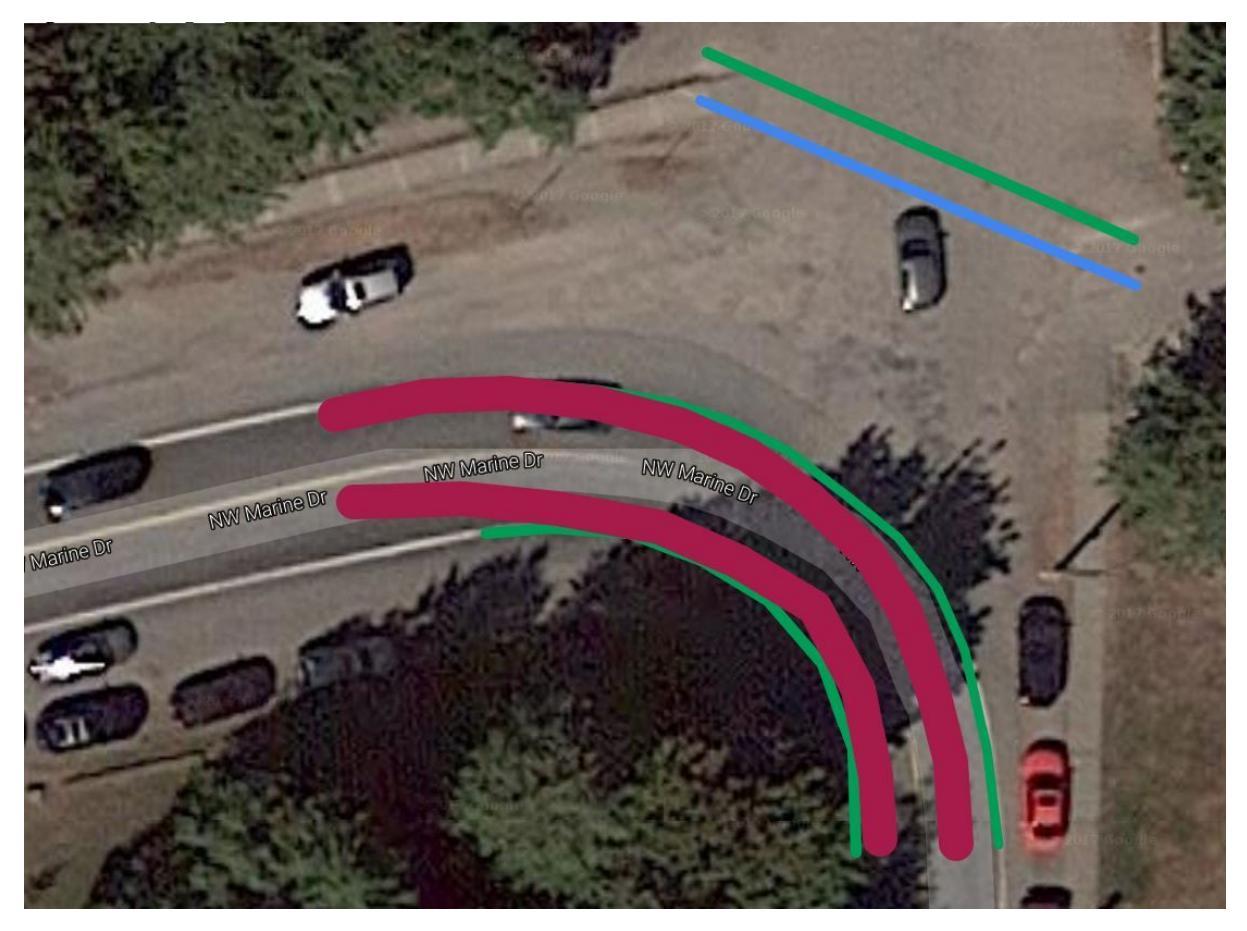
Fig 6 - The corner at the Trimble Street parking lot is sharper than 90 degrees. There is loose gravel on the pavement from the shoulders and parking lot. The shoulder lines are faded and discontinuous. The green lines represent cycling desire lines, either for the MUP in the park, or for riders positioned on the right side of the travel lane. The blue line represents pedestrians using the MUP. The red lines represent vehicles which were observed to swing wide when travelling westbound, and to cut the apex through the shoulder when travelling eastbound. Both of these actions create risk for people on bikes. There are also vehicles entering and exiting the parking lot (from both directions) and parking along the roadway. Conflicts are frequent and potentially dangerous.

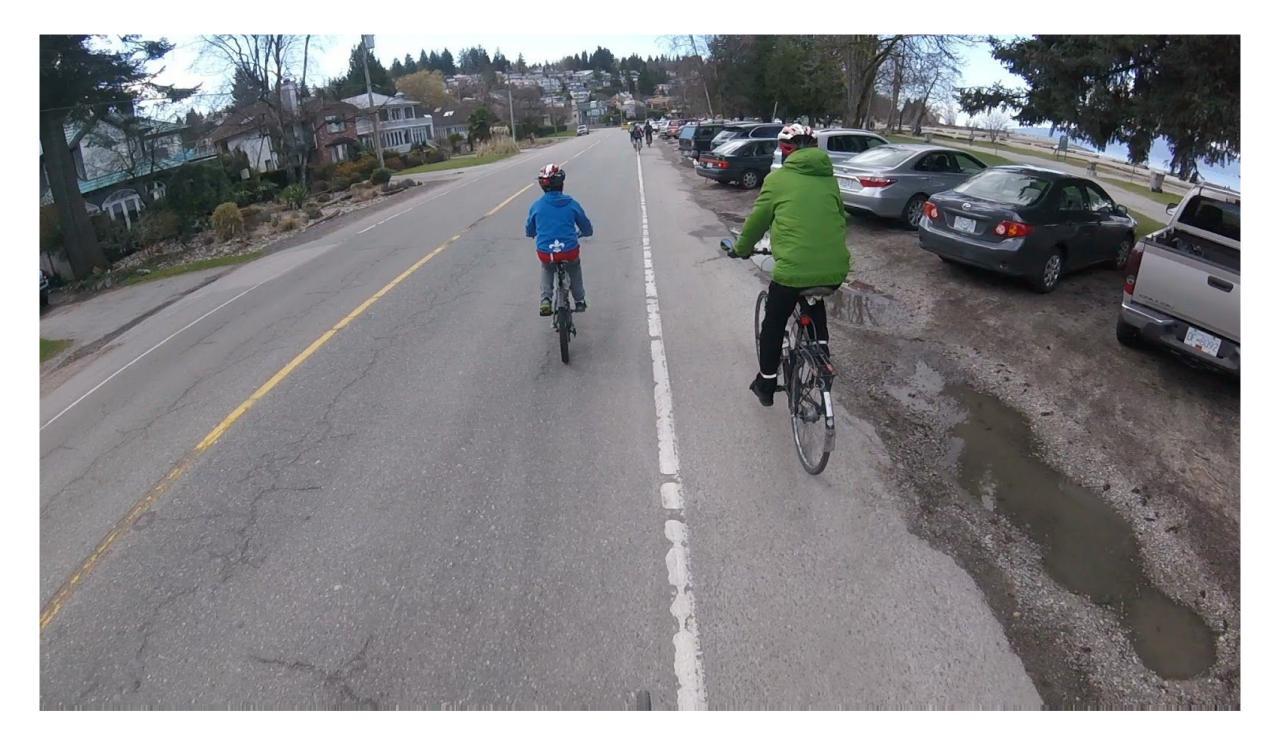
Fig 7 - From Locarno Beach Park to Spanish Bank Creek, the road has discontinuous shoulders of various widths. There are multiple parking lot entrances, and vehicles parked both parallel and nose in. Vehicles were observed backing out into traffic and into the path of oncoming bicycles, as shown here. It is not clear for people on bikes where they should position themselves; out further in the travel lane to be more visible to reversing vehicles, at the right edge of the travel lane, or in the shoulder, which is not marked for bicycle use. What results is bicycles in all of these positions, creating a risk as vehicle operators can not know for certain which line a person on a bicycle will take.

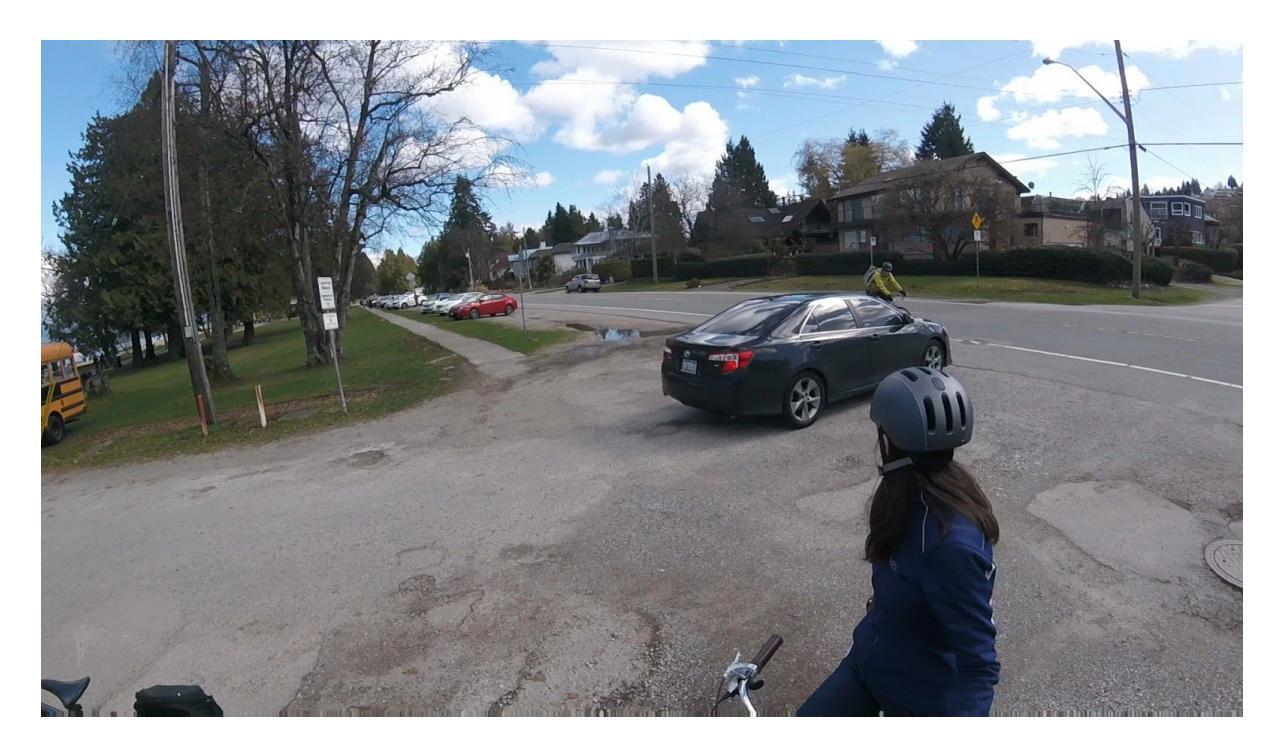
Fig 8 - The vehicle shown exited the parking lot into the path of a cyclist, forcing the cyclist to come to an abrupt stop at the driver's door. This near miss was caught on video. This parking lot exit is not perpendicular to the roadway, and there is a curve in NW Marine further restricting sight lines. The vehicle operator treated the shoulder line as a stop line. In some cases it may be possible to designate separate entrances and exits to parking lots, reducing risks.

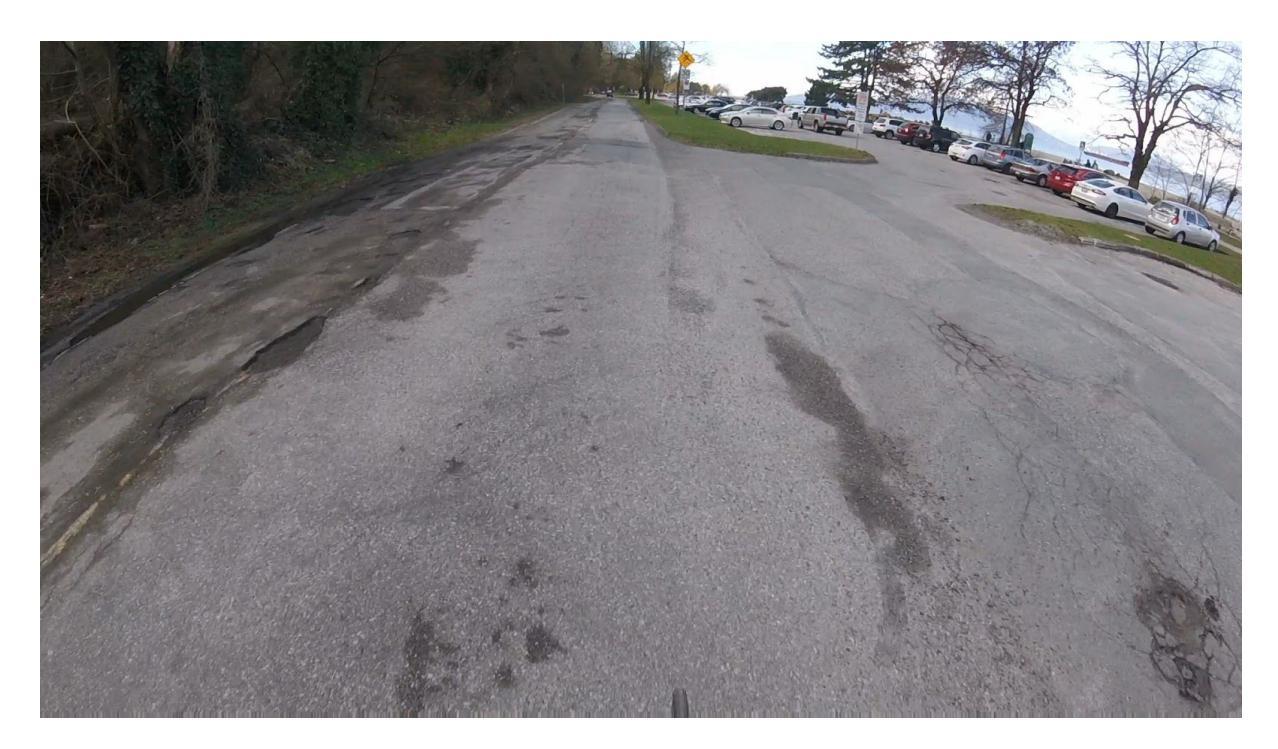
Fig 9 - Proceeding west along NW Marine shows the poor condition of the pavement. The shoulder disappears in this section, without merge signs. This section has subsequently been repaved, although there are still some areas requiring spot improvements.

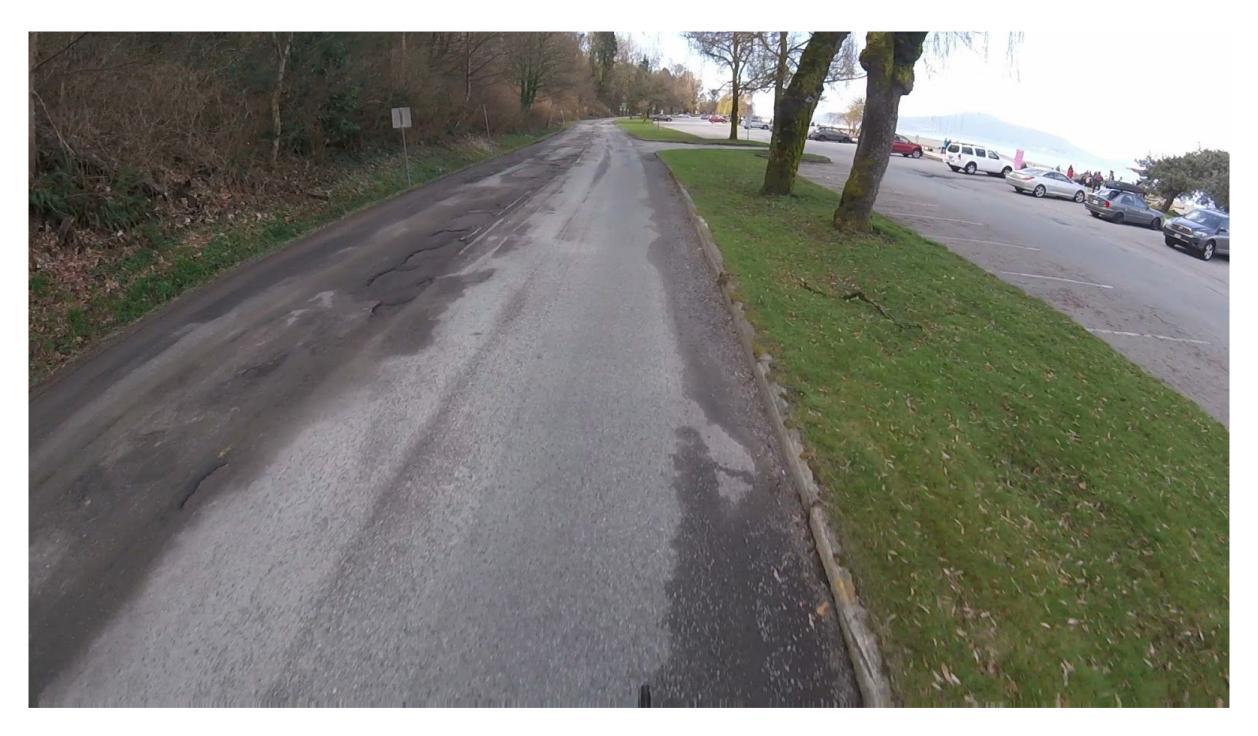
Fig 10 - The pavement being in poor condition caused some vehicles to cross over to avoid potholes. The lack of shoulders results in no escape routes. This section has since been repaved, but the curbs have not been moved so there remains no useful shoulder. The ongoing flooding results in debris along the edge of the roadway.

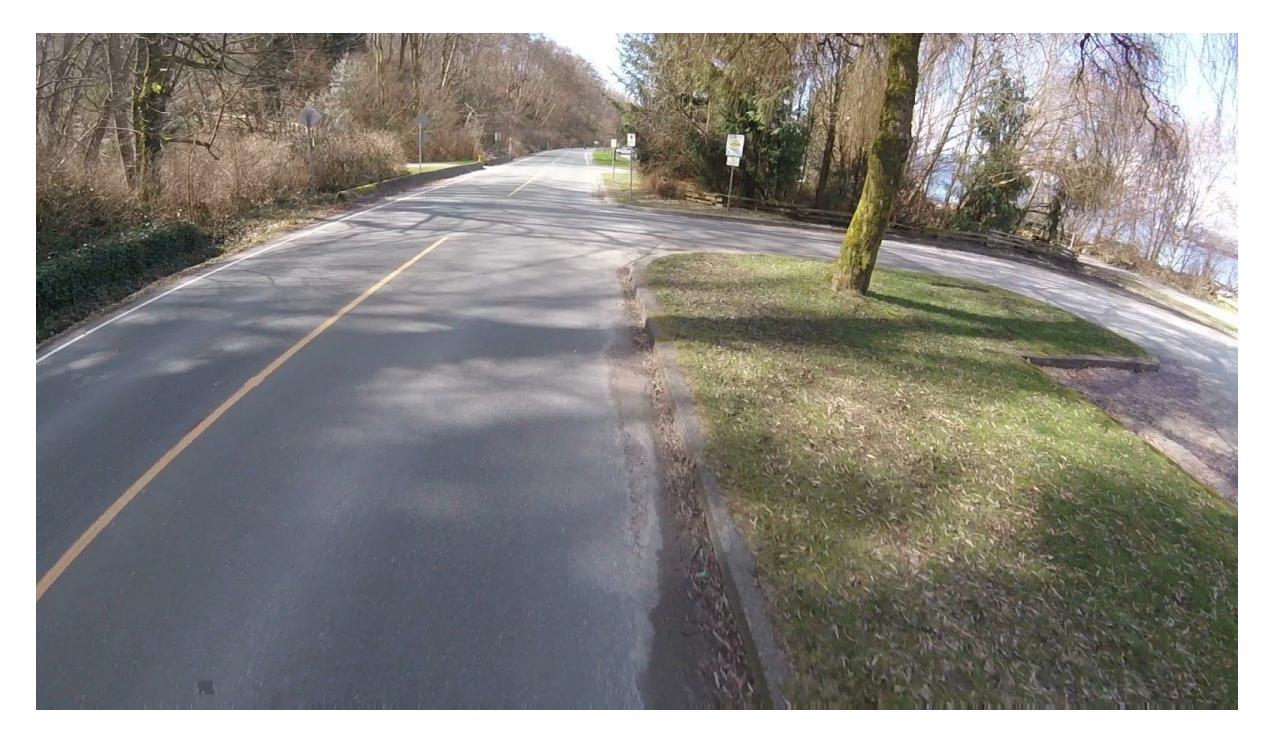
Fig 11 - Further west is the MoTI portion of NW Marine. Here there is improved pavement quality, but still no shoulders. The speed limit increases to 50 km/hr despite the frequent bikes, and the continuous parks between the road and the beach.

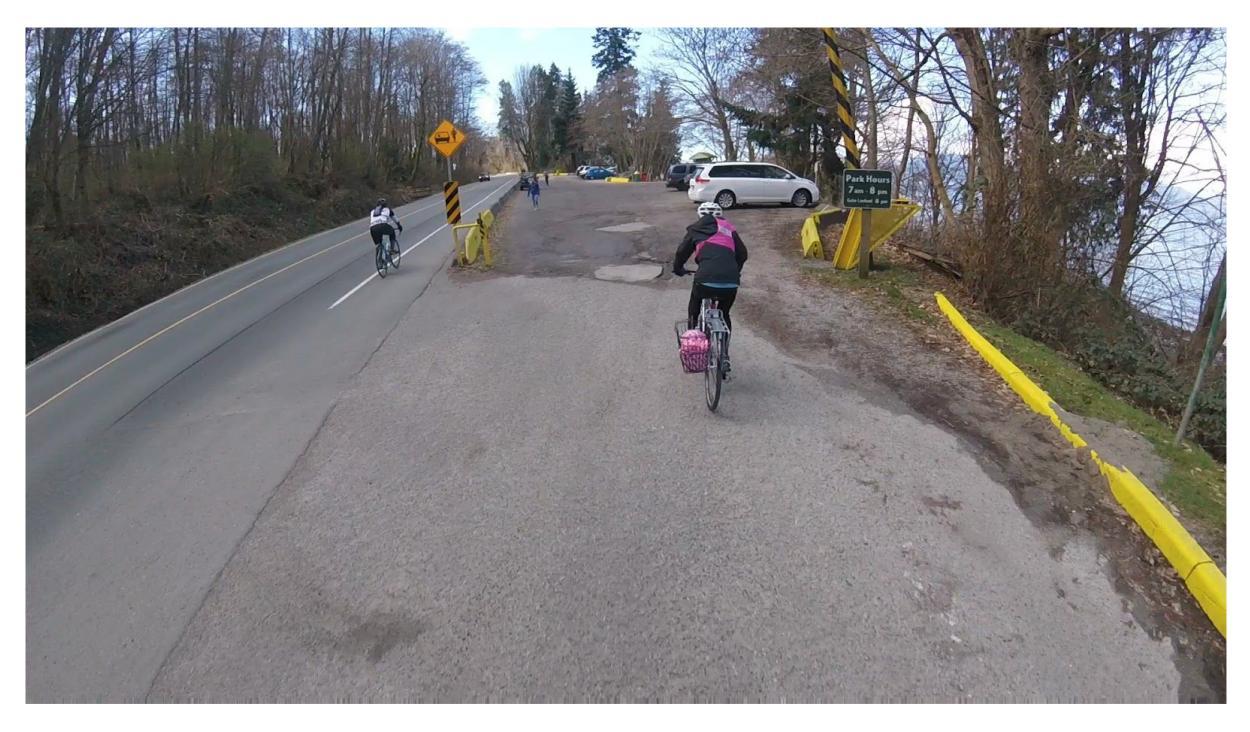
Fig 12 - At the Acadia Beach parking lot, a change agreed to by MoTI resulted in the single new Share the Road sign. Previously, people on bikes were instructed to only use the narrow pavement inside the jersey barriers up the hill to UBC, creating potential conflict with people walking (see Fig 13)

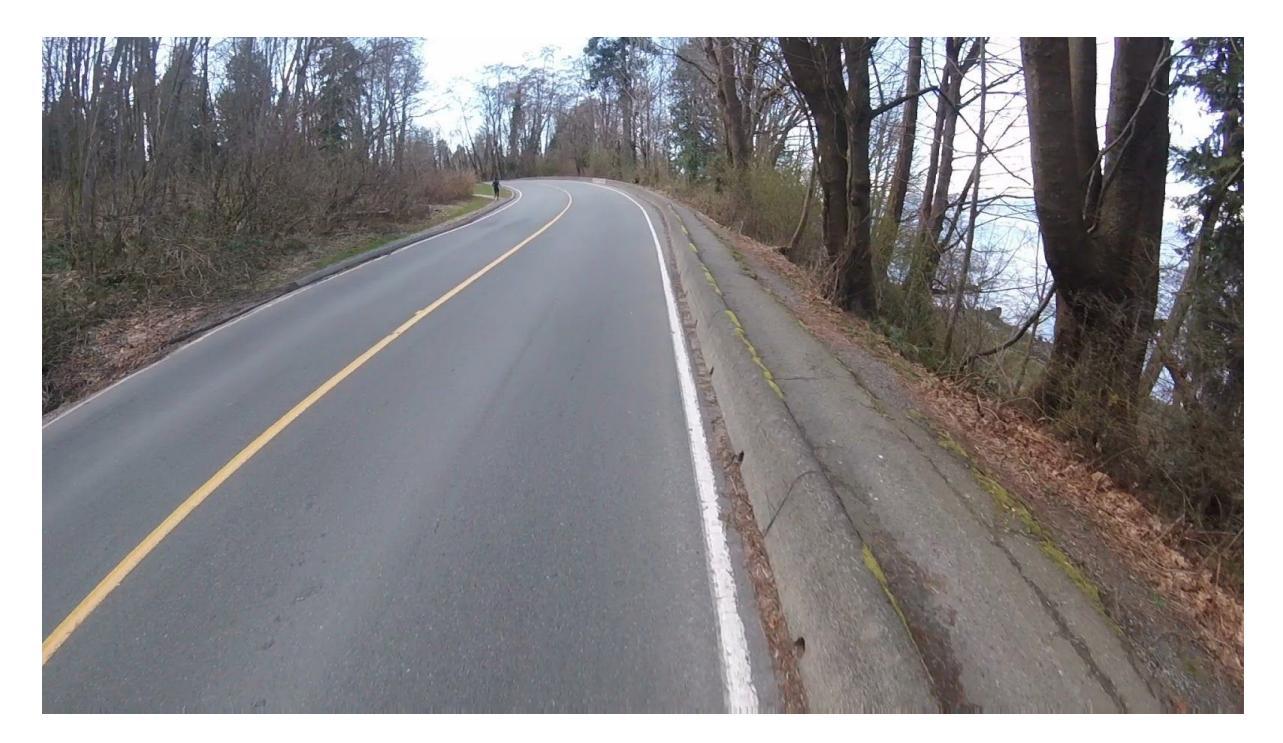
Fig 13 - On the hill up to UBC, there is no shoulder, and only one Share the Road sign before the hill. Most people on bikes are moving slowly due to the grade. The jersey barrier is continuous, with no pullouts or rest stops along the climb, or at the viewpoint, until one reaches the cairn immediately before Chancellor Blvd. Opening the jersey barriers at key locations would provide an opportunity for people on bikes to rest off the roadway. On the return, descending the hill left ride participants nervous due to the lack of shoulders, and the relatively high speed of overtaking vehicles.

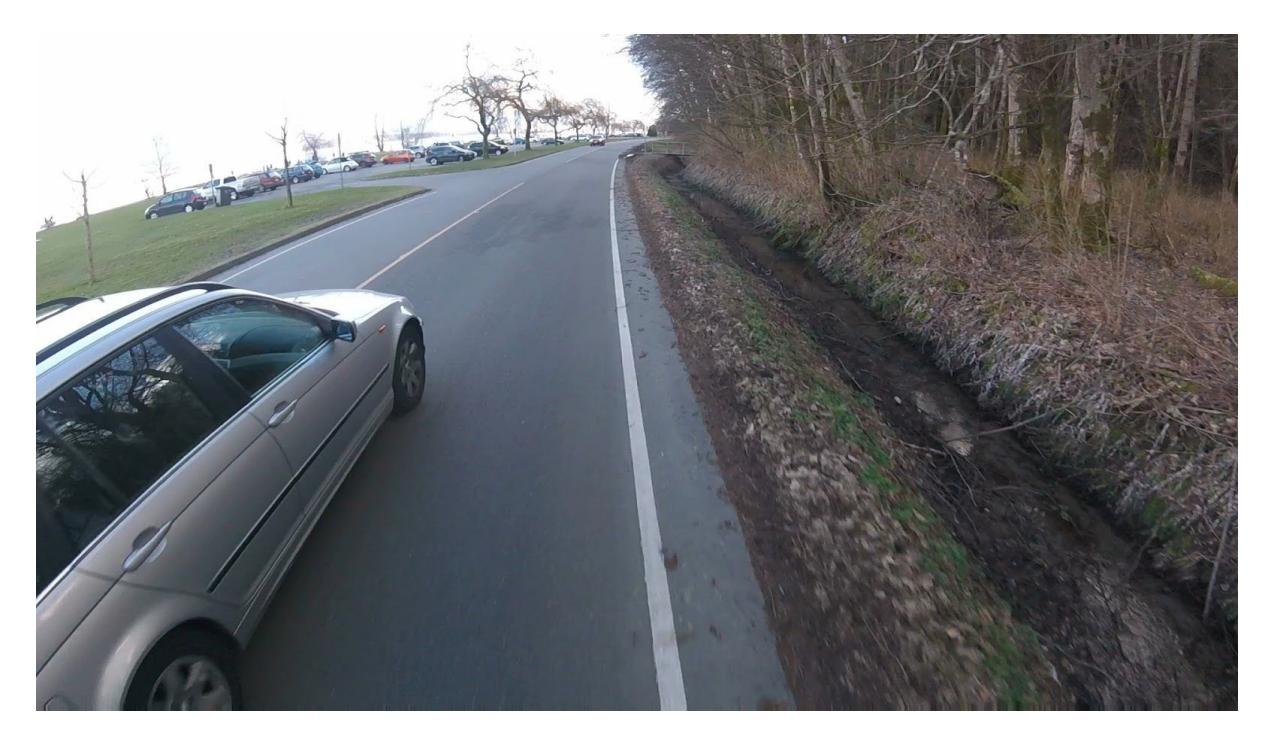
Fig 14 - Eastbound, the hill and the pavement quality appear to cause vehicles to drive more quickly, and vehicles were observed overtaking at high speeds along this section. There is debris in the shoulder. This section was equipped with reflectors in the pavement, which have fortunately fallen off. The reflectors create a crash risk for people on bikes, particularly when covered with wet leaves. More frequent cleaning and sweeping of the shoulder would improve safety for people on bikes.

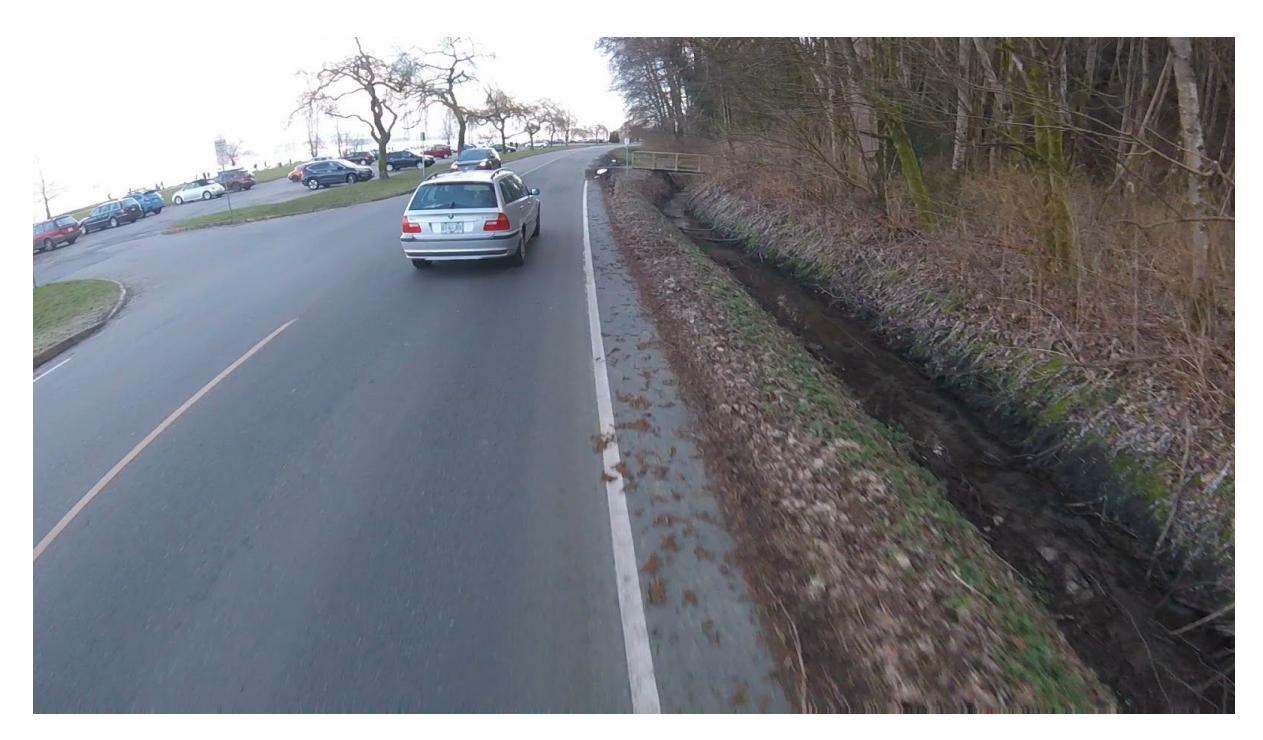
Fig 15 - Overtaking vehicle cutting back in quickly to avoid oncoming vehicle traffic..

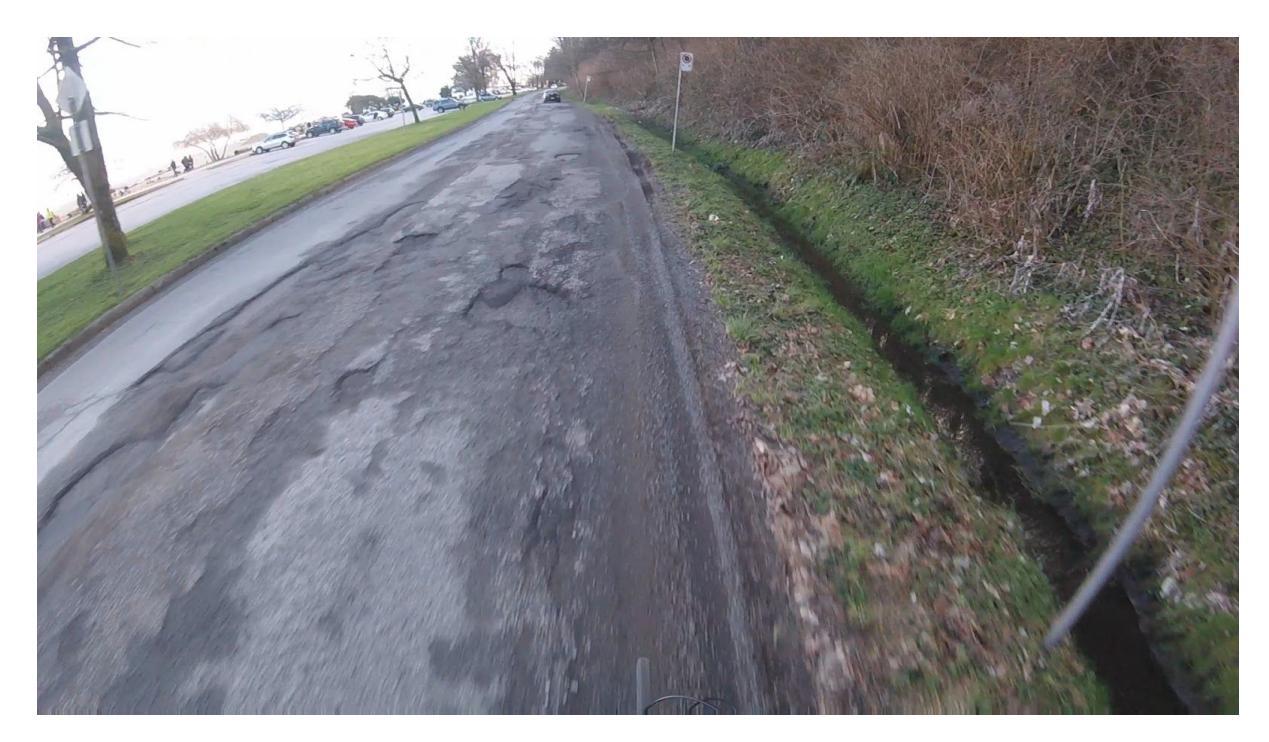
Fig 16 - From Spanish Banks Creek to Locarno Beach had the worst quality pavement along the route. Frequent potholes and cracks in the pavement, combined with a narrow or non-existent shoulder, mean that people on bikes struggle to maintain a straight line, while vehicles regularly overtake close to them. This section has subsequently been repaved by the CoV. As there was not an opportunity to provide shoulders along this section, the opportunity should be taken to decide on the speed limit, and appropriate signage.

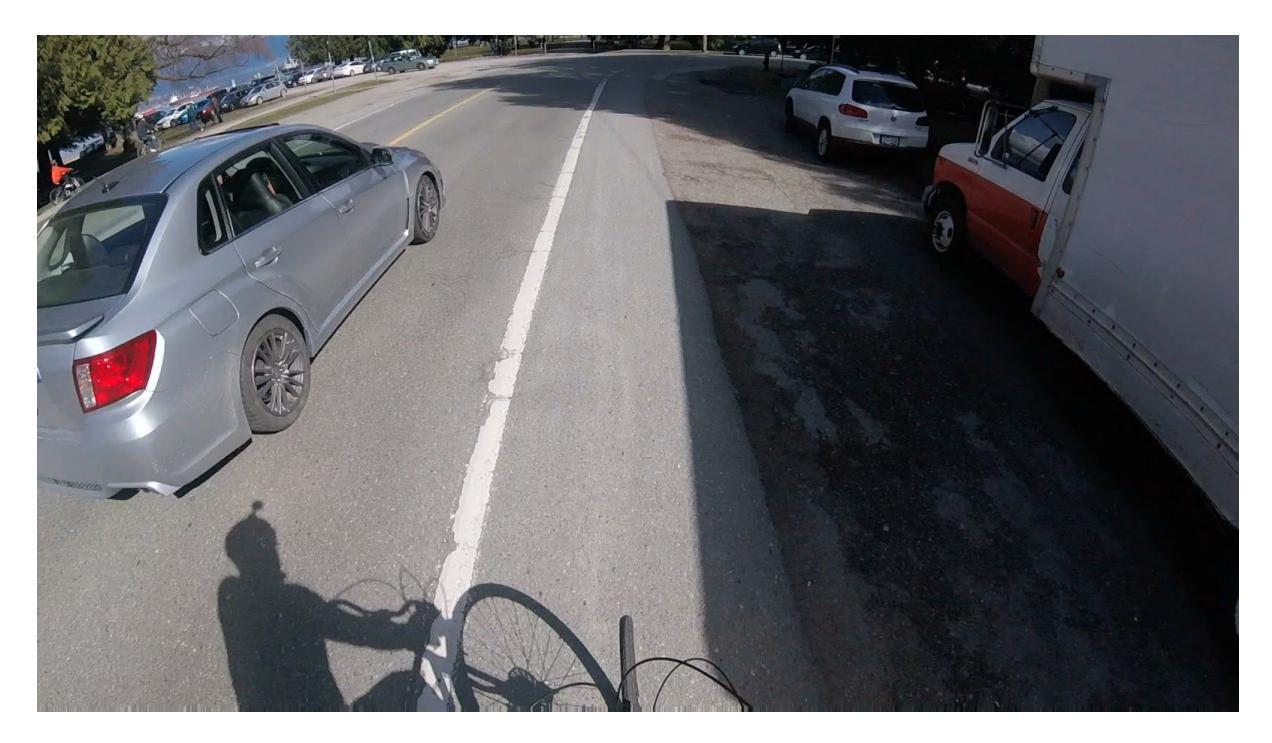
Fig 17 - Approaching Locarno Beach, the pavement quality improves but there are parked vehicles. Approaching the Trimble parking lot, vehicles were observed cutting the corner and utilizing the shoulder, leaving no room for people on bikes.

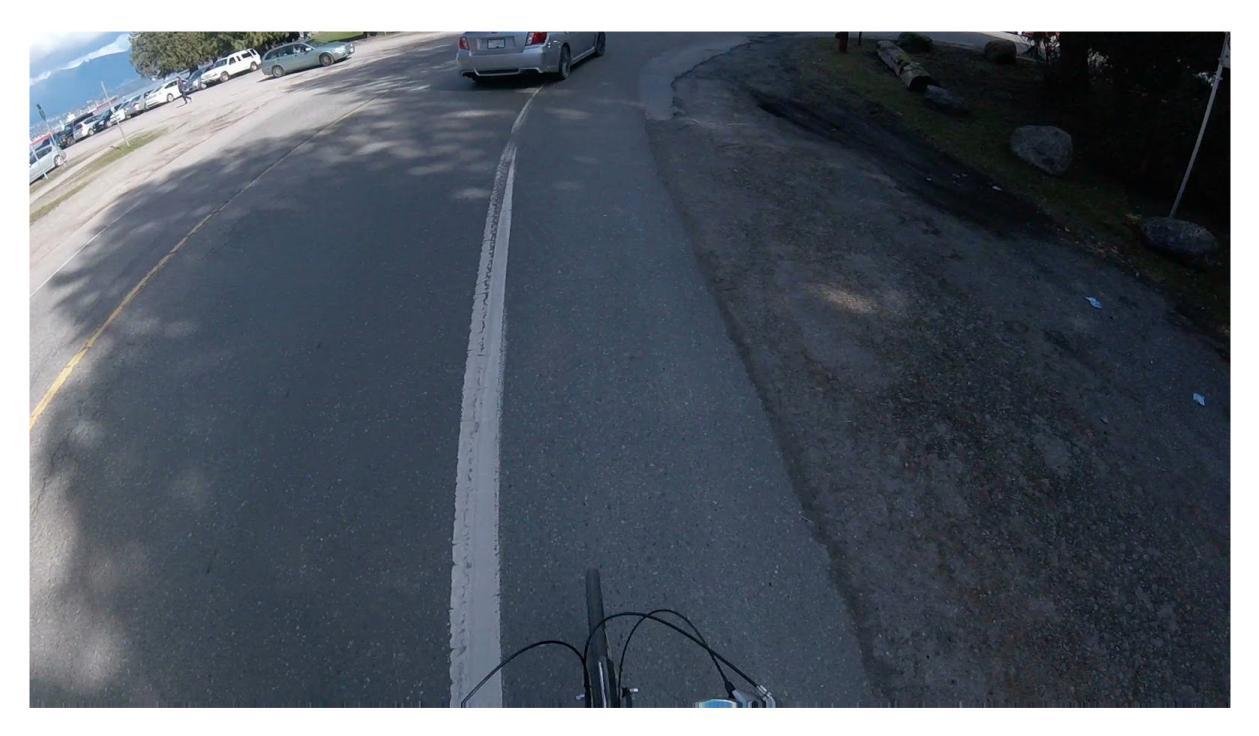
Fig 18 - This and other vehicle drivers were observed cutting the corner through the shoulder at the Trimble parking lot.
