# Burnaby Southeast Bikeway (SEB) and Cariboo Bikeway (CB) Assessment

The Burnaby Local Committee of HUB Cycling conducted an assessment ride of the Southeast Bikeway (SEB) and the Cariboo Bikeway (CB) on Saturday, 30 March 2024.

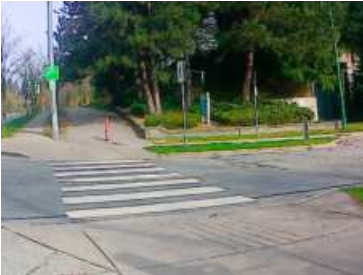
Issue code	Issue description	Photo	Location along bikeway	Safety/ Comfort Level Impact (Very High, High, Medium, Low)
<b>SEGMENT 1 - BC Parkway TO 13th Ave. at 4th St.</b>				
1.01	No crossbike/elephant's feet marked on crosswalk, which makes it illegal for people to cycle across Southpoint Dr. along the BC Parkway.

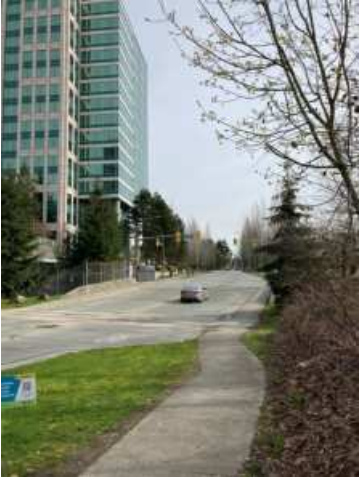
BC Parkway at Southpoint Dr.	Low
1.02	No bike path to connect the BC Parkway to the SEB. Entering the crosswalk and then making a turn inside the crosswalk is not expected by drivers.

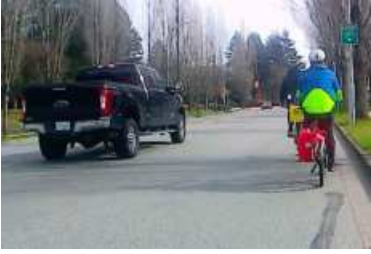
Issue code	Issue description	Photo	Location along bikeway	Safety/ Comfort Level Impact (Very High, High, Medium, Low)
1.04	Space but no physical protection from heavy and fast traffic in both directions.

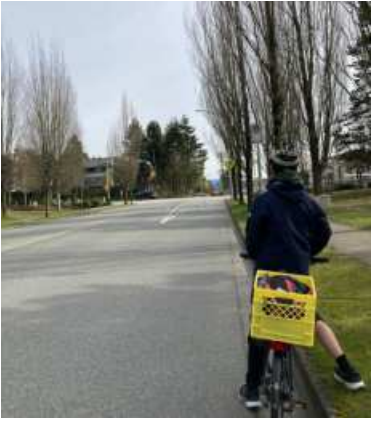
Station Hill Dr. to Griffiths Dr.	High
1.05	No protection, guidance or signage to assist people cycling to get to the center bike lane to cross Griffiths Dr. Also high potential for conflict with right turning vehicular traffic.

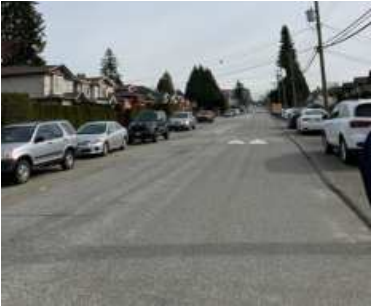
Issue code	Issue description	Photo	Location along bikeway	Safety/ Comfort Level Impact (Very High, High, Medium, Low)
1.07	Faded and missing bicycle stencil road markings.

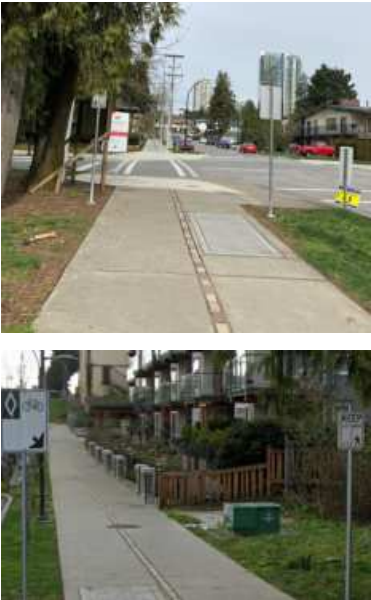
Stride Ave (Griffiths Dr. to 15th St.)	Medium
1.08	People frequently observed walking on the bike path. Insufficient signage and pavement markings to indicate the separate paths. Provide more signage along route to direct users.

<p data-bbox="711 1503 1084 1661">The “Keep Left and Right” sign is misleading, do the pedestrians need to walk on the grass?</p>	15th St.	Low

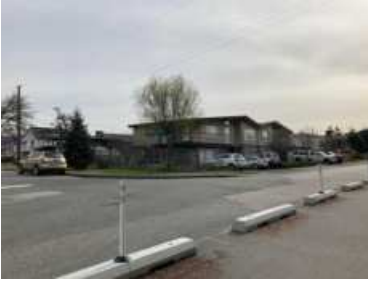
Issue code	Issue description	Photo	Location along bikeway	Safety/ Comfort Level Impact (Very High, High, Medium, Low)
1.09	Unfinished exit from / access to the new 12th St MUP (missing markings, gap in barrier). Pavement markings to direct people cycling onto the bike routes would be helpful such as green paint with crossbike/elephant's feet.

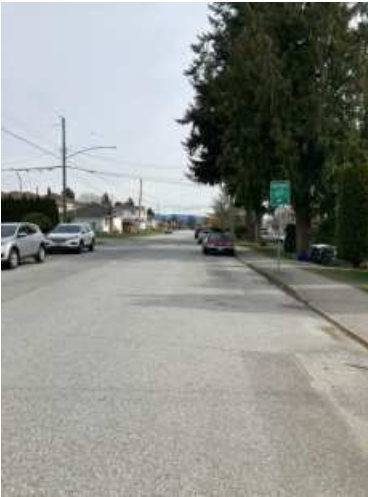
15th St. and 12th Ave.	Low
1.10	No physical protection. Road not suitable for all ages and abilities, especially children going to school.

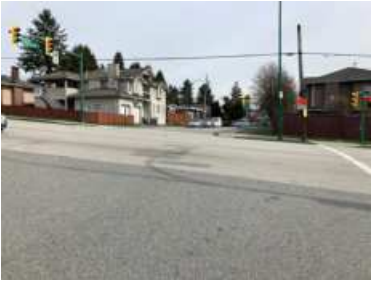
Issue code	Issue description	Photo	Location along bikeway	Safety/ Comfort Level Impact (Very High, High, Medium, Low)
1.11	<p>No markings, crossing not clear. Easy for people cycling to get “squished” at the west side of the intersection when cars and bikes merge to the narrower road.</p> <p>We recommend that modal filters be installed to block traffic from proceeding straight across Canada Way.</p> <hr/> <p>It is difficult for people on bikes to reach the call button during rush hour congestion. There is often a lineup of cars blocking the button.</p>

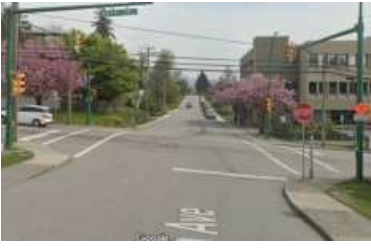
Canada Way intersection	Very High
1.12	<p>We recommend that modal filters be installed to block traffic from proceeding straight across 6th St.</p>

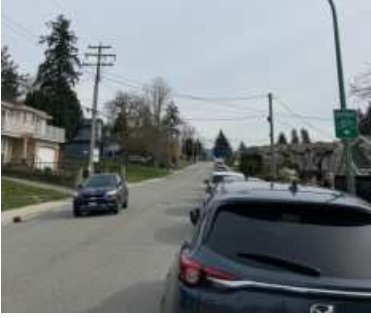
Issue code	Issue description	Photo	Location along bikeway	Safety/ Comfort Level Impact (Very High, High, Medium, Low)
1.13	Narrow road without protection and heavy vehicular traffic especially during rush hour.

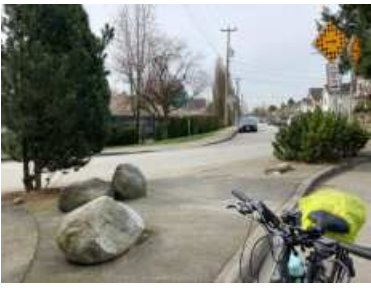
Canada Way to 4th St.	Very High
<b>SEGMENT 2 - 13th Ave. at 4th St. TO Cariboo</b>				
2.01	Missing wayfinding road markings.

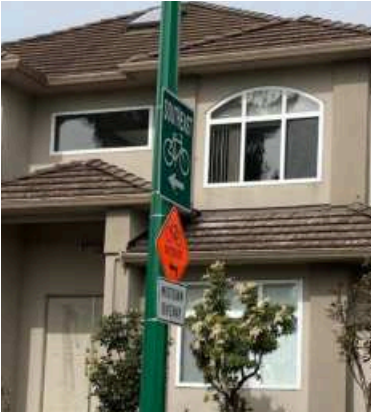
13th Ave. at 4th St. modal filter	Low
2.02	Obsolete "Midtown Detour" signs still up.

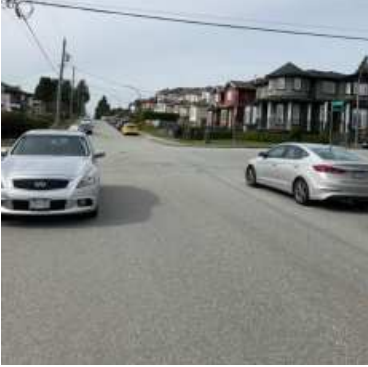
Issue code	Issue description	Photo	Location along bikeway	Safety/ Comfort Level Impact (Very High, High, Medium, Low)
2.03	Missing road markings. Narrow space between parked cars.

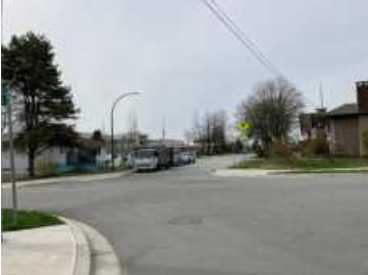
At John Knox School	High
2.06	Road markings (crossbike/elephant's feet/green paint) could aid wayfinding.

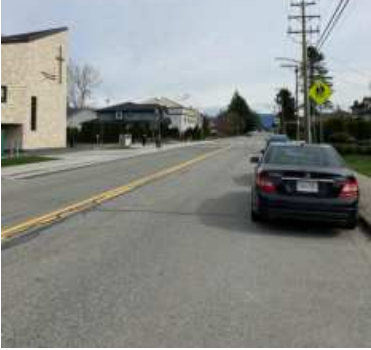
Cumberland St.	High
2.08	<p>Little space with parked cars - have to take the lane. Difficult for faster traffic to pass safely.</p> <p>Road is a Local Collector and is busy during the day; it is also a bus route.</p>

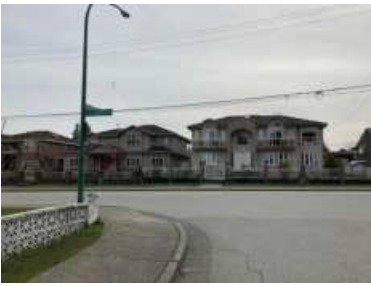
Armstrong Ave.: Cumberland St. to Cascade St.	High
2.09	Missing wayfinding signs to/from Cariboo.

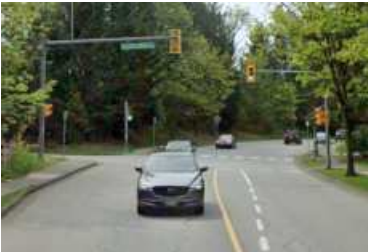
Issue code	Issue description	Photo	Location along bikeway	Safety/ Comfort Level Impact (Very High, High, Medium, Low)
<b>SEGMENT 3 - Cariboo Bikeway</b>				
3.01	<p>“Left turn bay” is very uncomfortable for people cycling. There is a high potential for conflict with vehicles in this segment.</p> <p>A safer alternative would be to continue the painted bike lane to an expanded sidewalk or bike box near the traffic light, so that people cycling can activate the traffic lights and cross the street.</p>

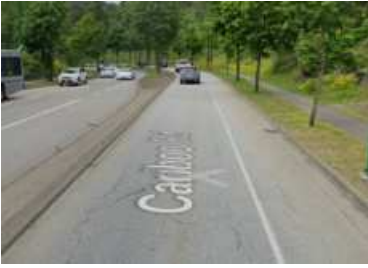
Issue code	Issue description	Photo	Location along bikeway	Safety/ Comfort Level Impact (Very High, High, Medium, Low)
3.03	Northbound painted bike lane is narrow and not protected, with fast moving traffic.

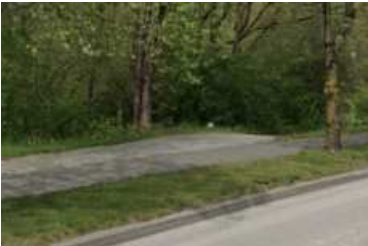
Cariboo Rd.	Very High
3.04	<p>The Cariboo Rd. MUP on the west side of the road between Cariboo Dr. and 16th lacks signage indicating that it is a MUP.</p> <p>Cariboo Dr. is a quiet road and would be a safer alternative also for northbound bike traffic on the CB. There is no signage for people cycling northbound to take Cariboo Dr. instead of Cariboo Rd. as an alternative to going downhill/northbound on Cariboo Rd.</p>

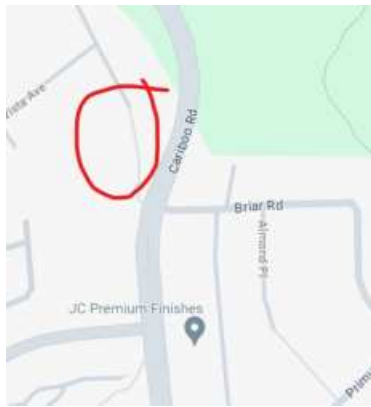
Issue code	Issue description	Photo	Location along bikeway	Safety/ Comfort Level Impact (Very High, High, Medium, Low)
3.05	Roots buckling pathway.

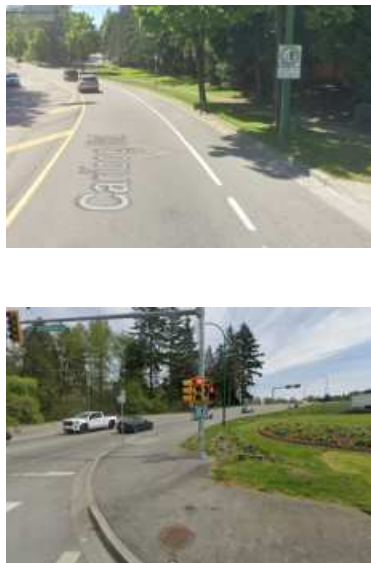
Path between Cariboo Dr. and Cariboo Rd.	Medium
3.06	<p>Dismount and walk signs - could widen the sidewalk to extend the MUP so that it connects Cariboo Dr (quiet street section). and Stormont Ave intersection.</p> <p>At Stormont Ave and Cariboo Dr., there is a dismount and walk sign on the path that is clearly designed as a MUP and safer than taking the painted bike lane, we recommend removing the dismount and walk sign here and making this officially a MUP.</p>

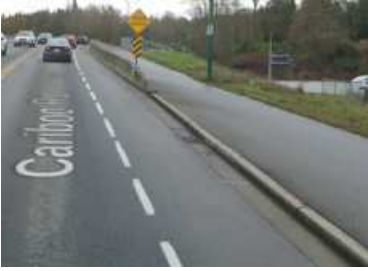
Issue code	Issue description	Photo	Location along bikeway	Safety/ Comfort Level Impact (Very High, High, Medium, Low)
3.07	Narrow unprotected bike lane. Sidewalk could be labelled a MUP.

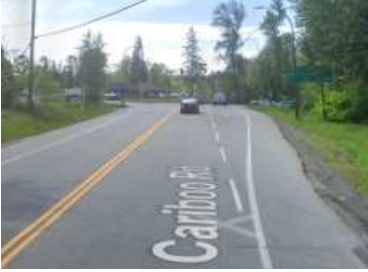
Cariboo Rd southbound near Highway 1 crossing	High
3.08	For people cycling southbound on the CB at the Cariboo Rd. and Cariboo Rd./Stormont Ave. intersection, the bike lane ends in the shoulder and there is often heavy vehicular traffic going into the right turn bay, making it unsafe for people cycling to make the left turn from Cariboo Rd. onto Cariboo Rd. to continue along the CB.
