September 14, 2024

Re: Street Modifications on 16th Ave at Wallace St (Lord Byng School)

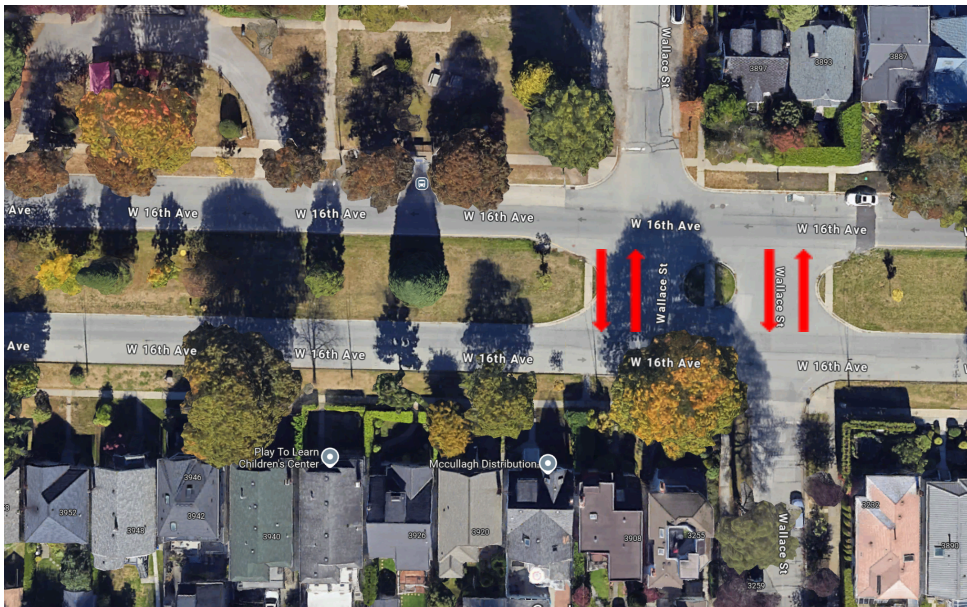
Firstly, we commend the City for the modifications to close the centre boulevard area to vehicle traffic, normalizing the intersection at Wallace. The offset intersection, shown in Figure 1 below, previously had traffic moving in two directions on both sides of the centre island (red arrows), and was a major issue. Closing the boulevard to vehicles crossing 16th was one of our recommendations, and it is a great step forward. That said, we think the implementation could be further improved with some adjustments.

Figure 1 - 16th Ave at Wallace, showing the offset intersection and centre island

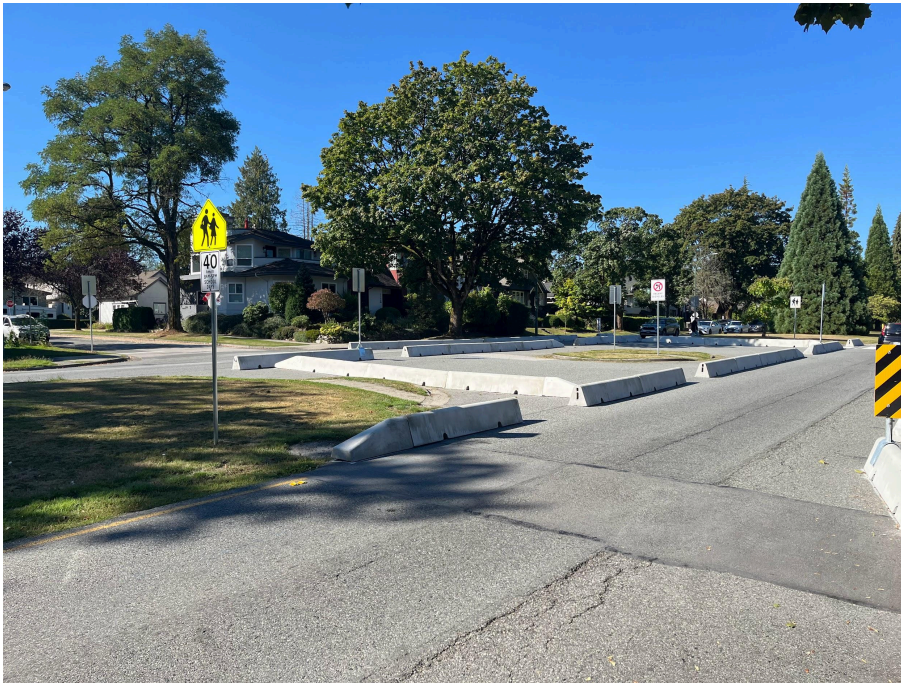
The concrete gravity barriers closing the boulevard have too many openings for people walking and cycling to cross. There is an unmarked crosswalk at the eastern end (Figure 2). There is a marked crosswalk at the western end (Figure 3). There are also openings at the corners on the western end, shown in Figure 3, which can encourage people walking to cross diagonally. There are four openings for people on bikes to cross (Figures 2 and 4), two of which are marked, but we observed people moving by all modes using these openings, and crossing diagonally as well as directly across. This results in four places for people crossing 16th Ave to encounter westbound vehicle traffic, and only one is marked as a crosswalk. We recommend that only two crossings be created for people on bikes, and the other openings in the middle section be closed. The two crossing points for people on bikes should have elephant feet and green paint. The bike crossings should be adjacent to the pedestrian crossings, and not aligned with the centrelines of Wallace either north or south of 16th.

Figure 2 - Unmarked crossing at the eastern end of the gravity barriers on 16th Ave at Wallace

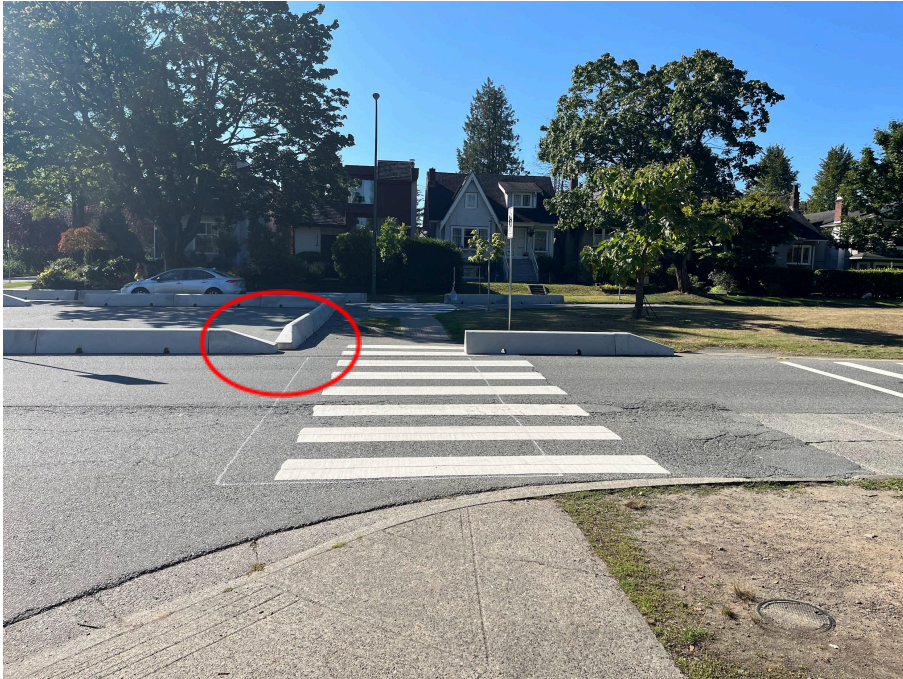
Figure 3 - Marked crossing at the western end of the gravity barriers on 16th Ave at Wallace

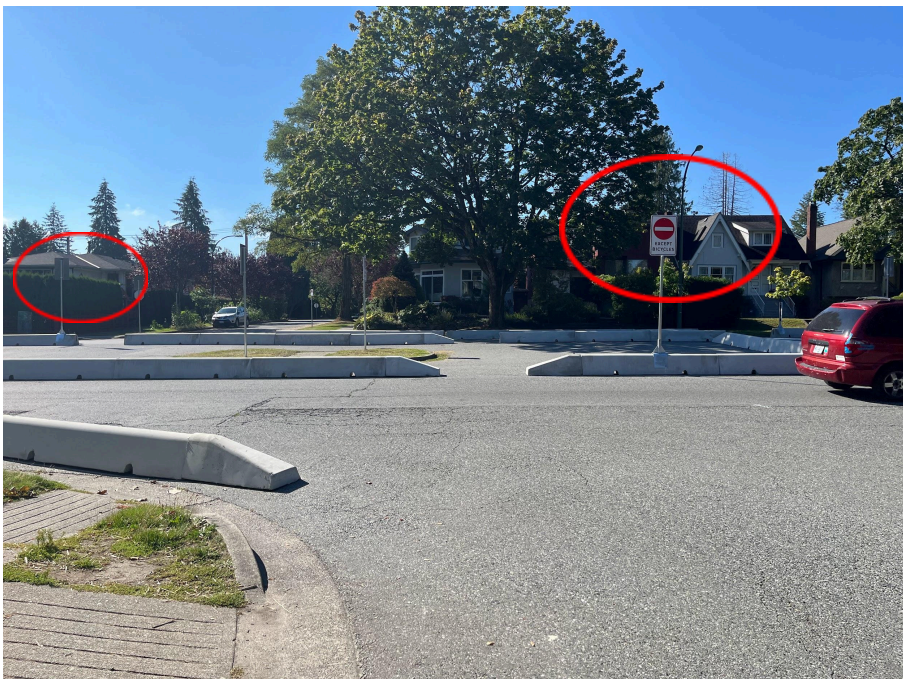
Figure 4 - Openings have been left in the gravity barriers for people cycling to cross, but these are marked at only two points; they are aligned with the centrelines of Wallace St. north and south; and they allow diagonal crossings.

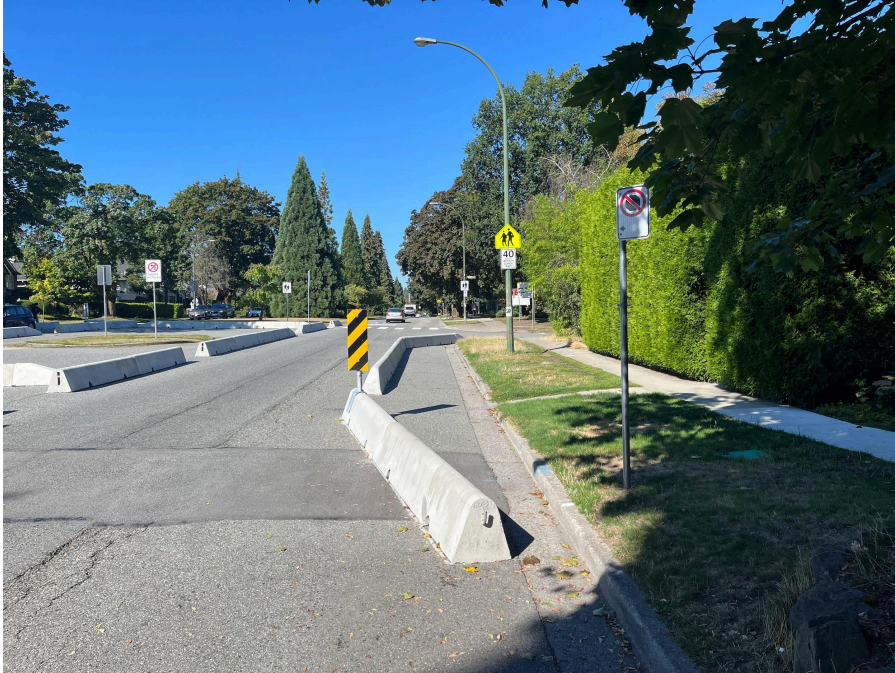
The gravity barriers used to narrow the roadway to a single lane in each direction will work to slow vehicle traffic. However, they have been set up without sufficient space (or pavement markings) for people on bikes to continue closer to the curbs. This requires people on bikes to merge with vehicle traffic at two different points, at a point where vehicles are already merging from two lanes to one.

Figure 5 - Gravity Barriers on 16th Ave westbound at Wallace have no accommodation for people cycling

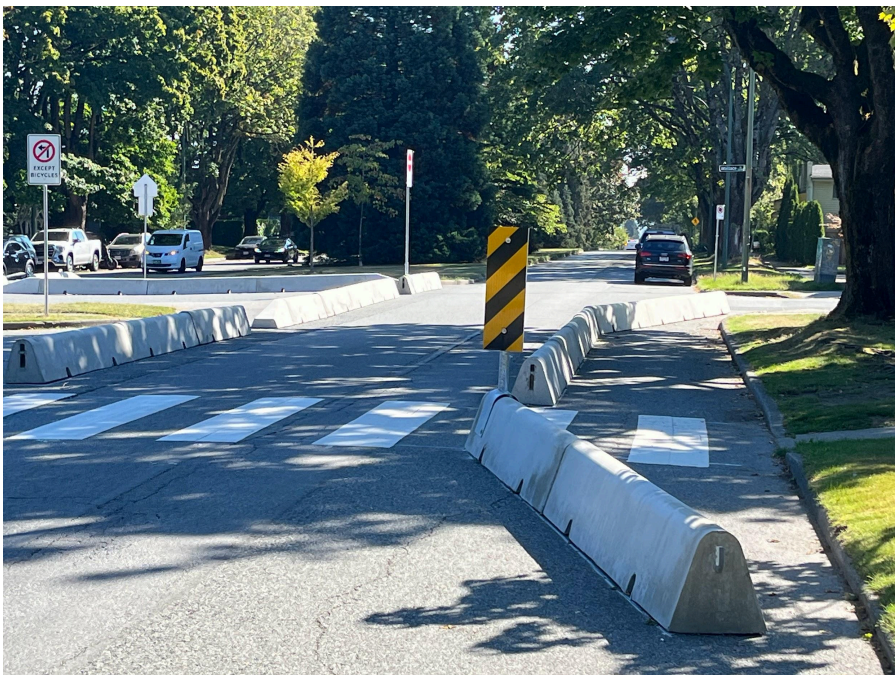
Figure 6 - Gravity Barriers on 16th Ave eastbound at Wallace have no accommodation for people cycling

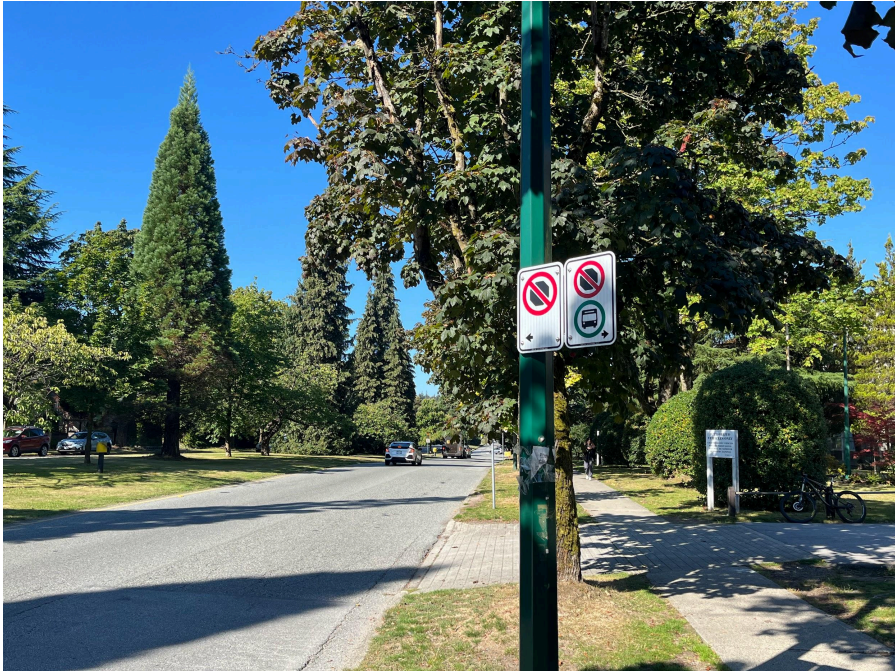
Figure 7 - In front of the school is a no stopping zone after the transit stop Gravity barriers on 16th Ave could be continued through this zone to create a protected lane

The protected bike lane that could be created on 16th Ave westbound immediately before Wallace could be continued on the west side of Wallace, through the vehicle no stopping zone, shown in Figure 6. There is a transit stop, then a no stopping zone, and then a drop off and pick up zone. People driving have been observed stopping at other than the designated drop off and pick up zone. A continuation of the protected lane westbound through the no stopping zone would help with this situation.

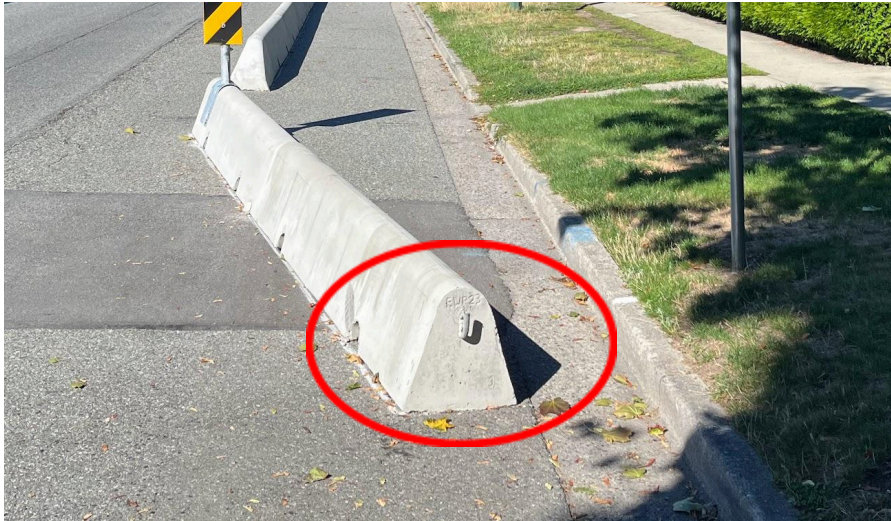
The gravity barriers have been installed without bullnose sections on the leading edges in many cases. Metal attachment hooks have been left protruding, and can cause injuries. Bullnose sections have been used in many places on the trailing edges, which are less critical. The leading edges should also be painted yellow, as has been done on many other similar installations by the CoV.

Figure 8 - Gravity Barriers do not have bullnose sections on the leading edges
