Assessment Ride Report - Stanley Park Protected Cycling Lanes

The implementation of the temporary protected cycling lanes has been a tremendous benefit for people cycling in Stanley Park. The Vancouver UBC Local Committee of HUB Cycling completed an assessment ride of the 2021 temporary lanes implemented in Stanley Park, in October 2021. The following recommendations are intended to inform the discussion around permanent traffic calming measures to be proposed by staff in early 2022. The assessment ride followed the route indicated in Figure 1, with stops indicated from labels 1 to 11.

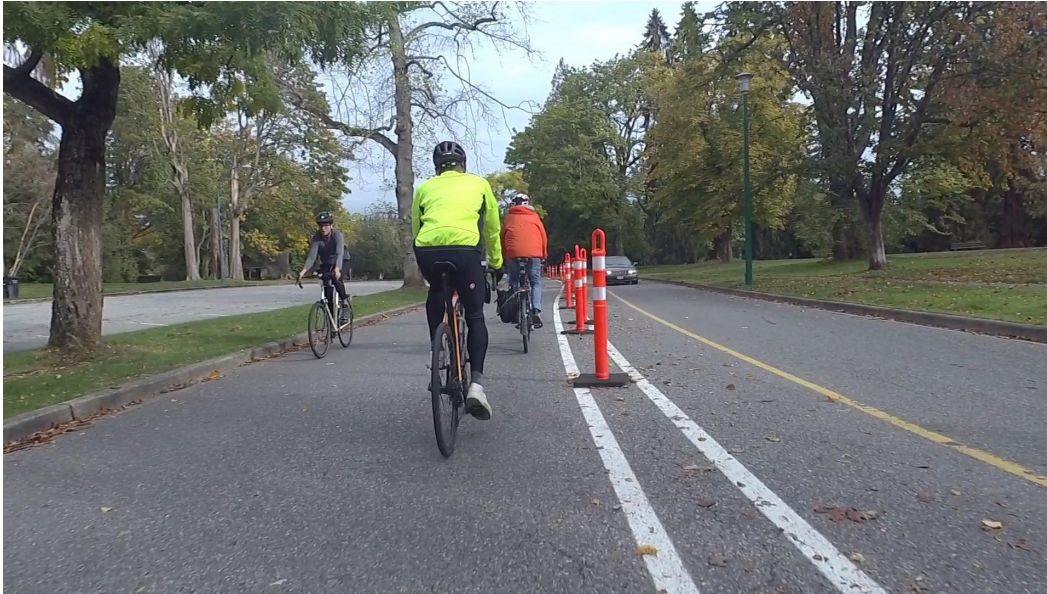
Figure 2 - Park Drive bidirectional lane from Park Lane to North Lagoon Drive

The cycling lane here, shown in Figure 2, is bidirectional and the section from Park Lane to north of the Lawn Bowling club should be wider, with a painted yellow centreline to emphasize that it is bidirectional.

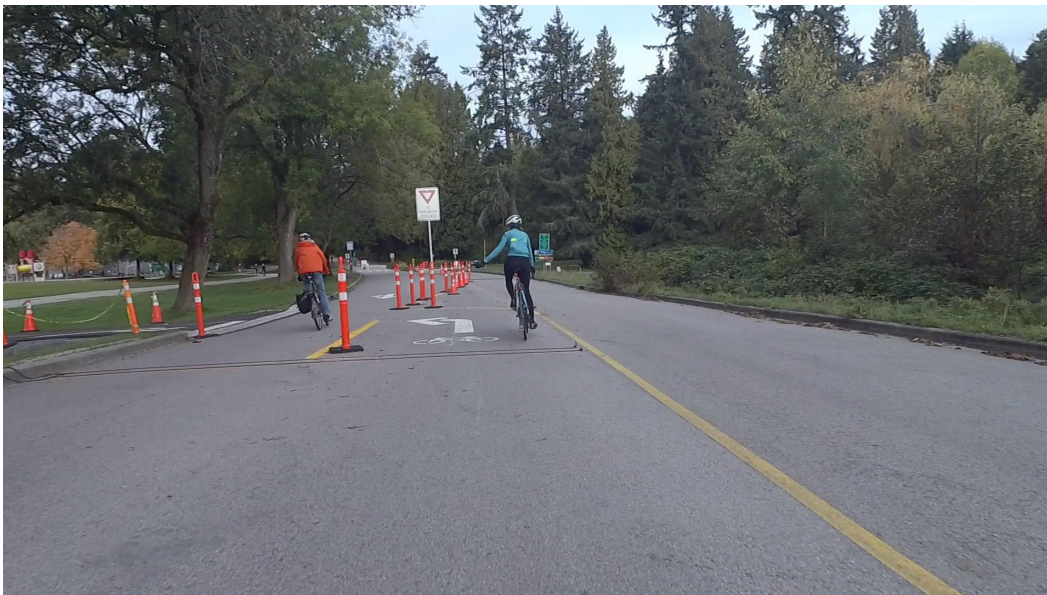
Figure 3 - Turn from Park Drive at Ceperley Park to the new connecting path to the South Lagoon route

The turn-off Park Drive to the new connecting path to the South Lagoon path, shown below in Figure 3, can be confusing to path users.

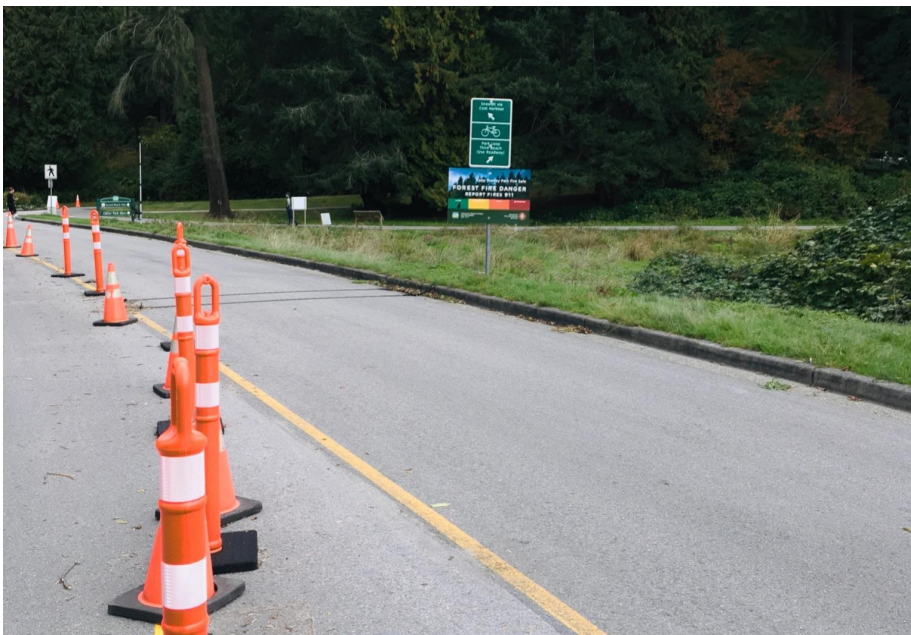
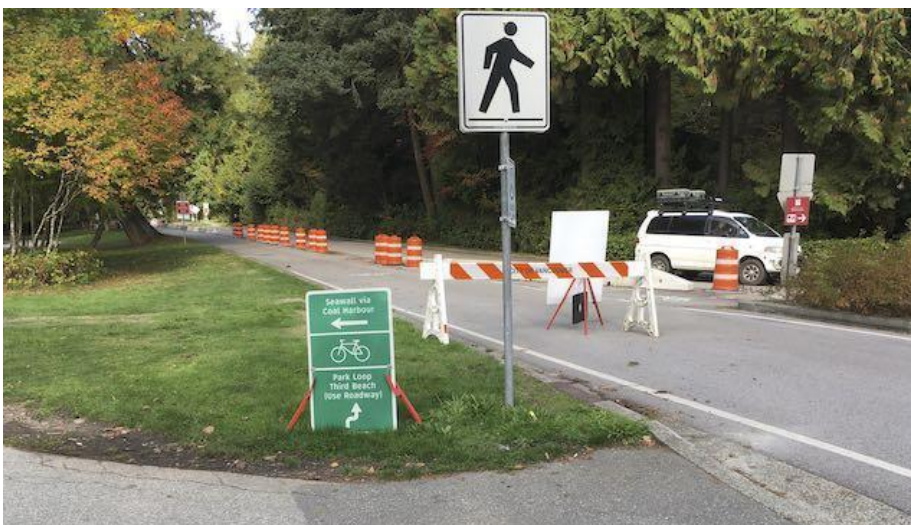
There are multiple small signs in this area, as shown in Figures 4 and 5. The signs indicate that people cycling are to keep left even though it is necessary to enter the right (shared vehicle) lane to proceed to North Lagoon Drive. There are no clear route markings for the trail route to 3rd Beach. Consequently, many cyclists end up taking the on-road bike path, riding counterflow to bike to 3rd Beach. It is not clear how to continue around the park on the protected lanes, there are just signs for the Coal Harbour exit. There are no clear signs that the new bike lane that goes to the west towards the concession will end at the side of the pool. Multiple groups were observed trying to figure out how to proceed, and other groups who rode through the exit became flummoxed at N. Lagoon Drive.

Anecdotally, an approximate 50:50 split was observed on the day of our assessment ride, between people cycling on the temporary route and N. Lagoon Drive.

Figure 4 - Park Drive at North Lagoon Drive

Figure 5 - Park Drive at North Lagoon Drive

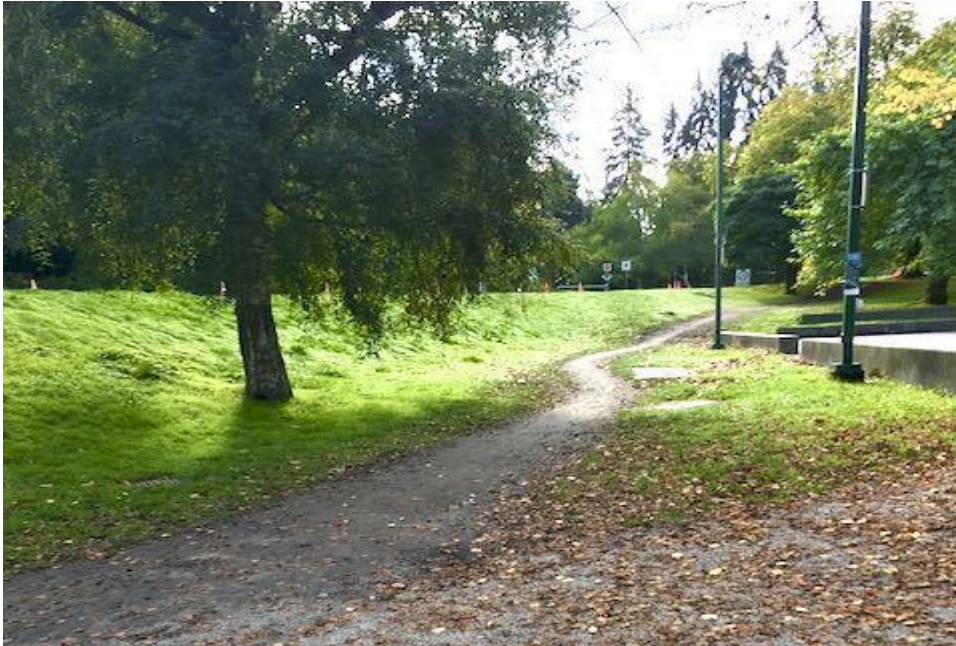
Figure 6 - Desire Line from Stanley Park Drive to the playground and Ceperley Tunnel

There is a desire line connecting Stanley Park Drive to the playground and Ceperley Tunnel, shown in Figure 6. Consideration should be given to paving this path.

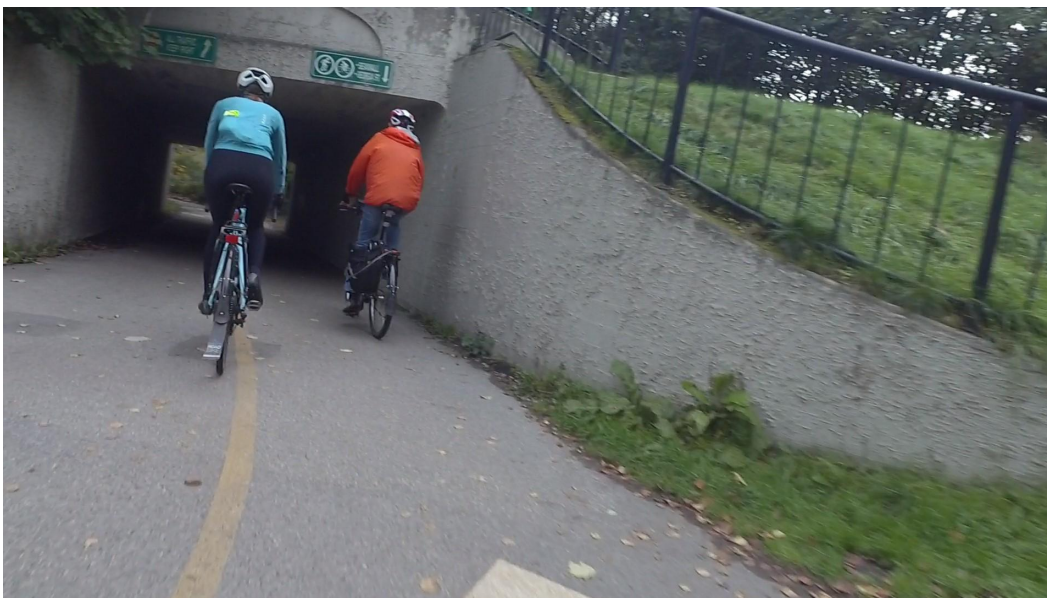
Figure 7 - Ceperley Tunnel

Ceperley Tunnel, shown in Figures 7, is narrow and it is often used by people walking

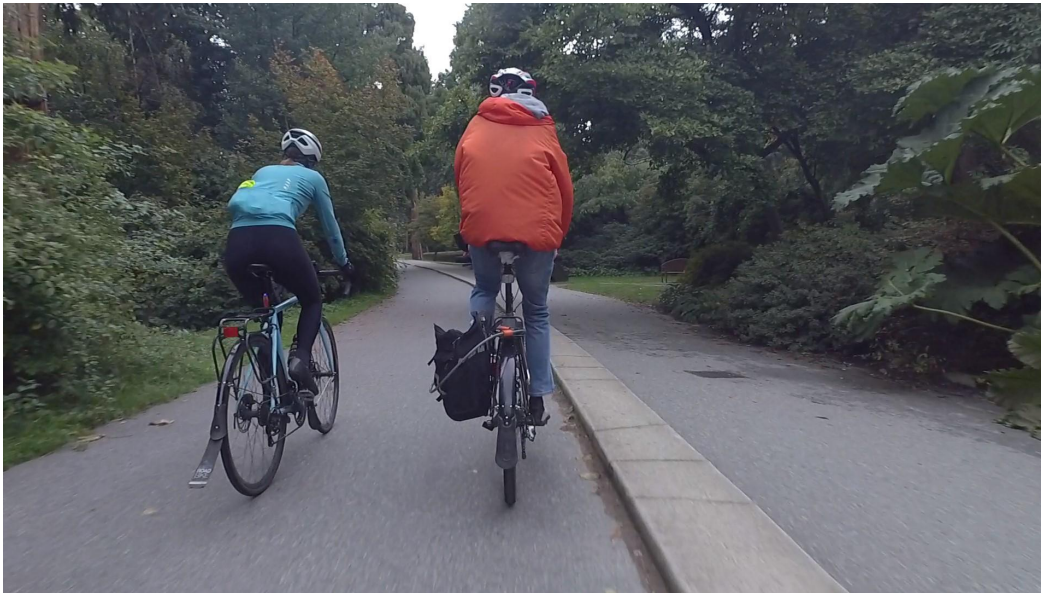
Figure 8 - Bike path from Ceperley Tunnel to Lost Lagoon

The cycling path east of Ceperley Tunnel, shown in Figure 8, is not sufficiently wide, and lacks stencils or markings to indicate where people should cycle, and where people should walk.

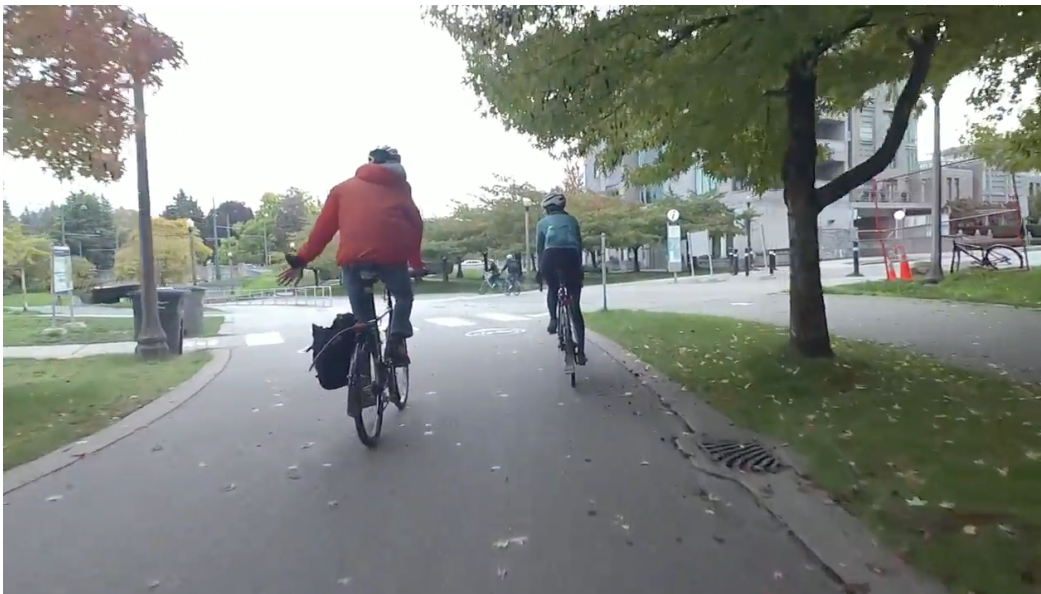
Figure 9 - South Lagoon Path

At the end of the South Lagoon path, approaching the underpass at Chilco and Georgia, as shown in Figure 9, the path directionality is confusing and it appears that people cycling should stay to the left of the guard rail. Stencils and signs would help. This is also a heavy traffic area for people both walking and cycling. This will also be the location of upcoming construction work by Metro Vancouver for the water supply tunnel, and additional attention should be paid to signs when the tunnel shaft construction detour is in place.

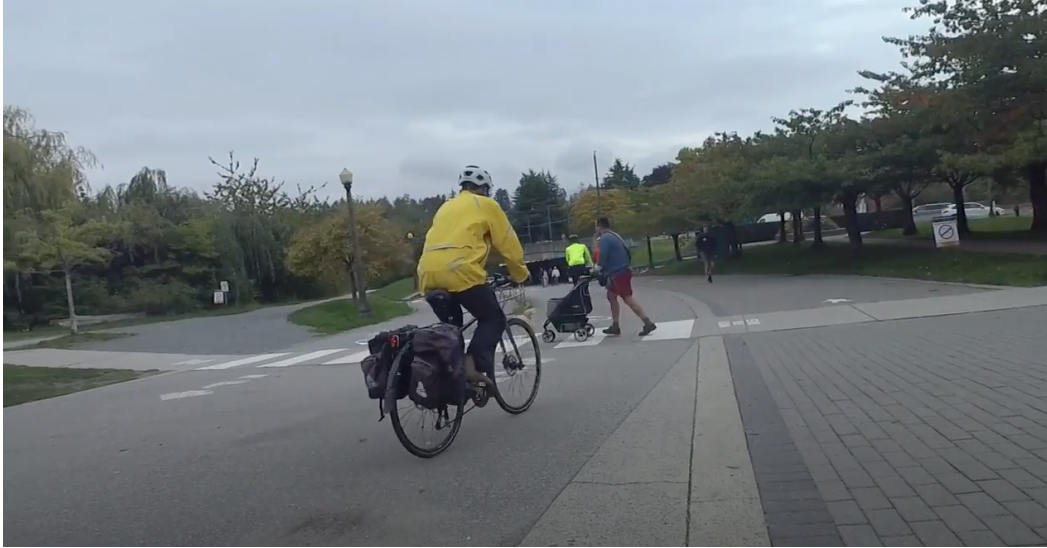
Figure 10 - Approaching Chilco Tunnel

Improved signage could reduce conflict between people walking and people cycling, as shown in Figure 10.

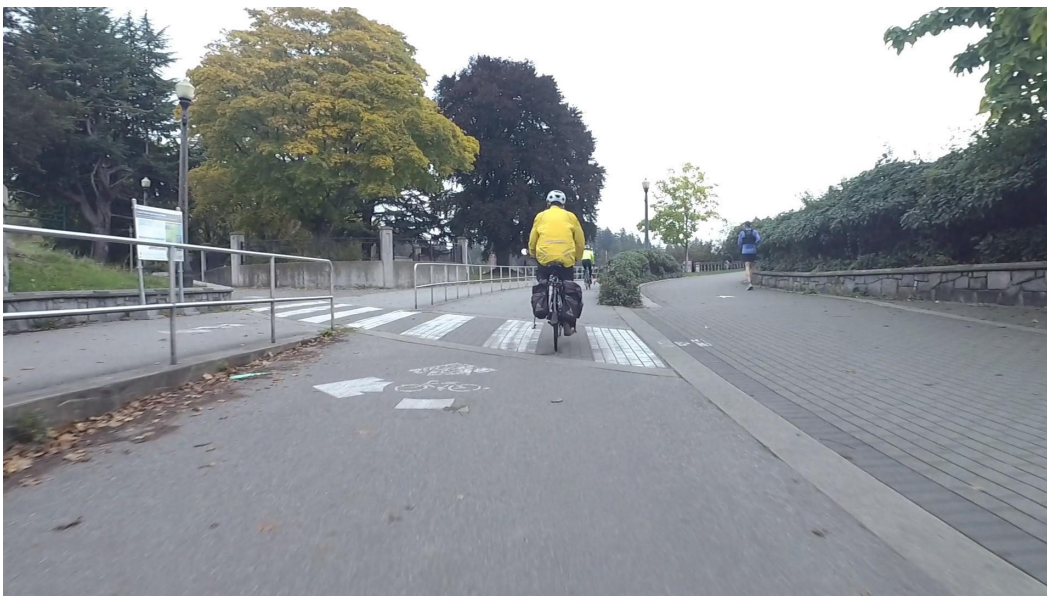
Figure 11 - Coal Harbour Entrance Hub

After going through the underpass, along the path to Coal Harbour shown in Figure 11, there is no indication that a sharp left must be taken to continue on to the temporary bike lanes on Park Drive. Instead, people cycling end up at the seawall at Coal Harbour. Signage and stencils would help. The current crosswalk marking does not show that cycling is permitted, despite the arrow stencil on the path.

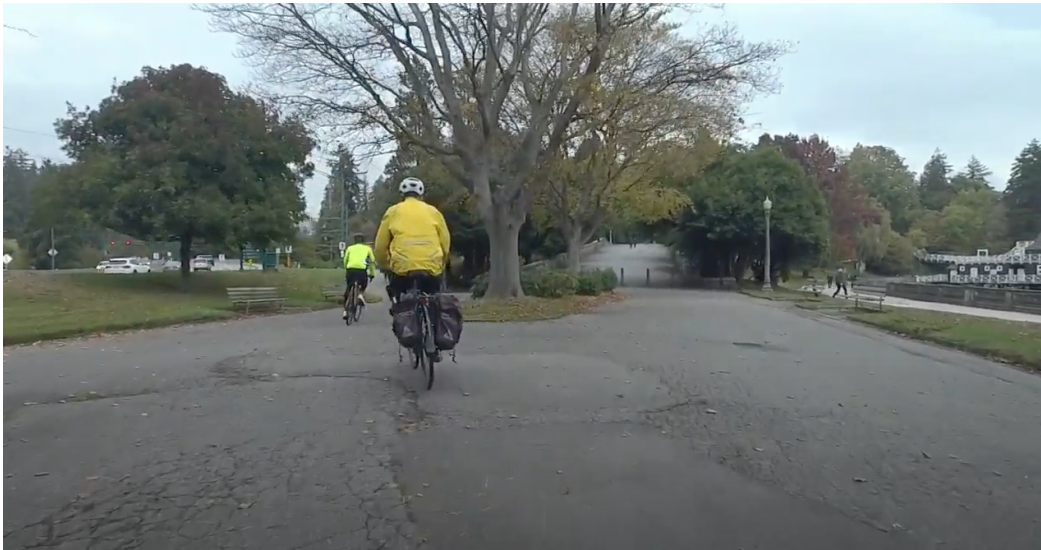
Figure 12 - Connecting from the Coal Harbour Entrance Hub to the protected bike lanes

There are few markings on the connecting path shown in Figure 12, running from the Coal Harbour Entrance Hub towards both the Causeway paths and the protected cycling lanes on Park Drive. The pavement along here is very wide, and could easily have a painted cycling lane along the west side, for the comfort and safety of people walking as well as people cycling.

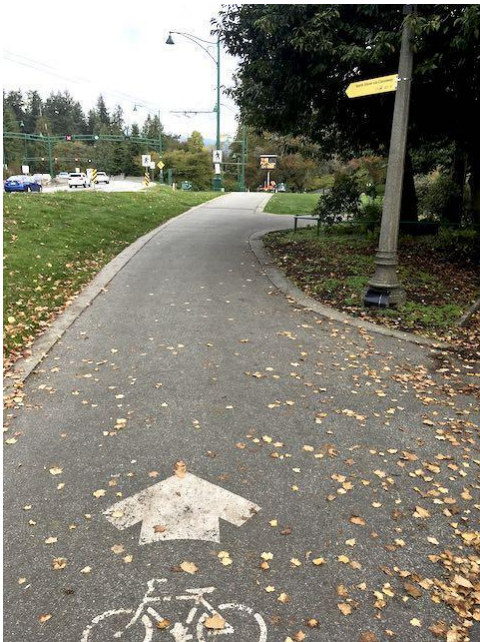
Figure 13 - Connecting from the Coal Harbour Entrance Hub to the protected bike lanes

The stencils that do exist, shown in Figure 13, direct people cycling towards the Causeway bike paths, which is good, but not also to the protected lanes on Park Drive, which should be remedied.

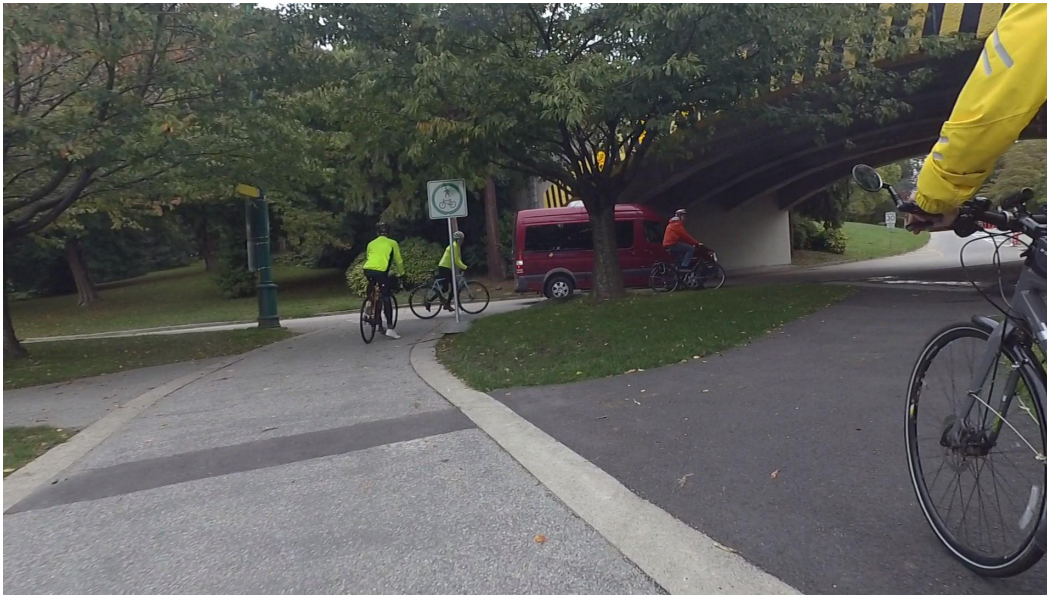
Figure 14 - Connecting path from the Coal Harbour Entrance Hub at Stanley Park Drive

At the north end of the connecting bike path to Stanley Park Drive, shown in Figure 14, there is an unmarked hard right turn to get back on the protected paths.

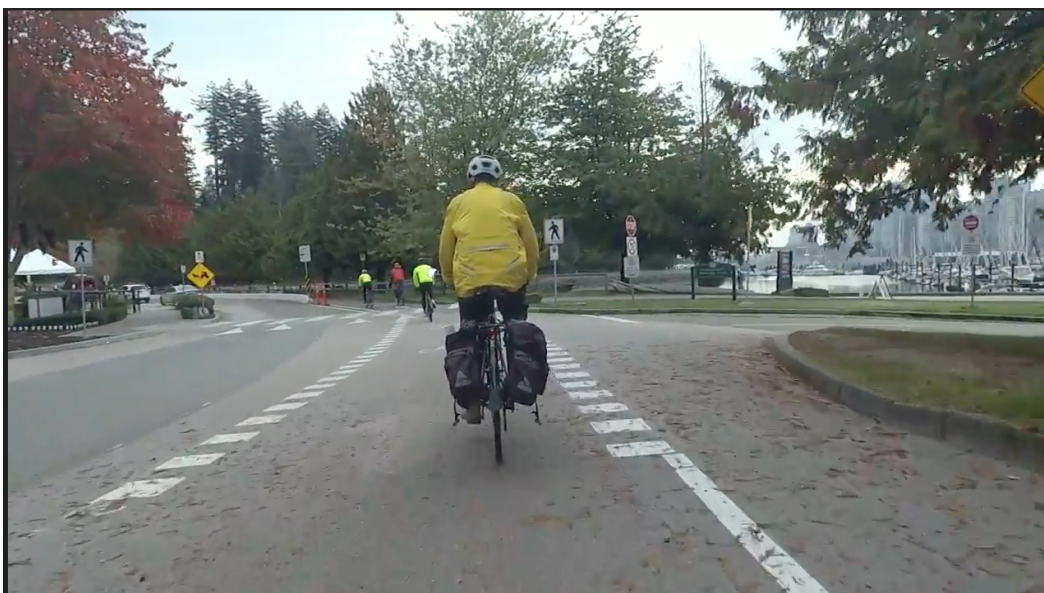
Figure 15 - Stanley Park Drive at the Information Booth

The protected cycling lane narrows significantly just before the Information Booth, as shown in Figure 15. This is understandable as it is a high traffic area for people walking, but it should be clearly signed to indicate that the lane narrows. As this is at the bottom of a small hill there are some path users moving more quickly here.

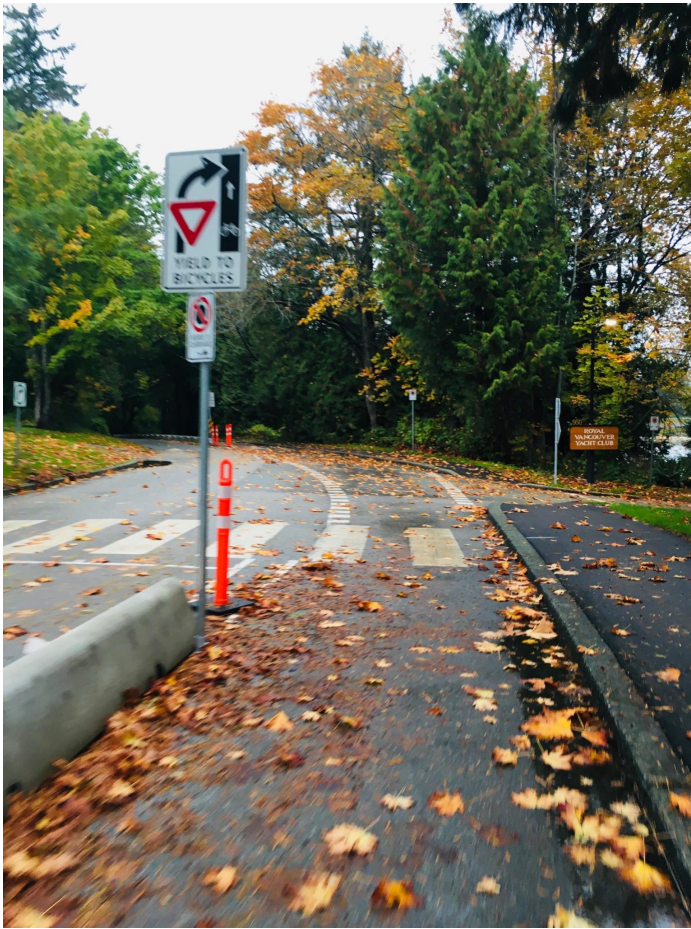
Figure 16 - Bike lane at the Royal Vancouver Yacht Club

There are two vehicle crossings of the bike lane at the Royal Vancouver Yacht Club, with one shown in Figure 16. Both crossings should be marked with green paint to indicate conflict zones.

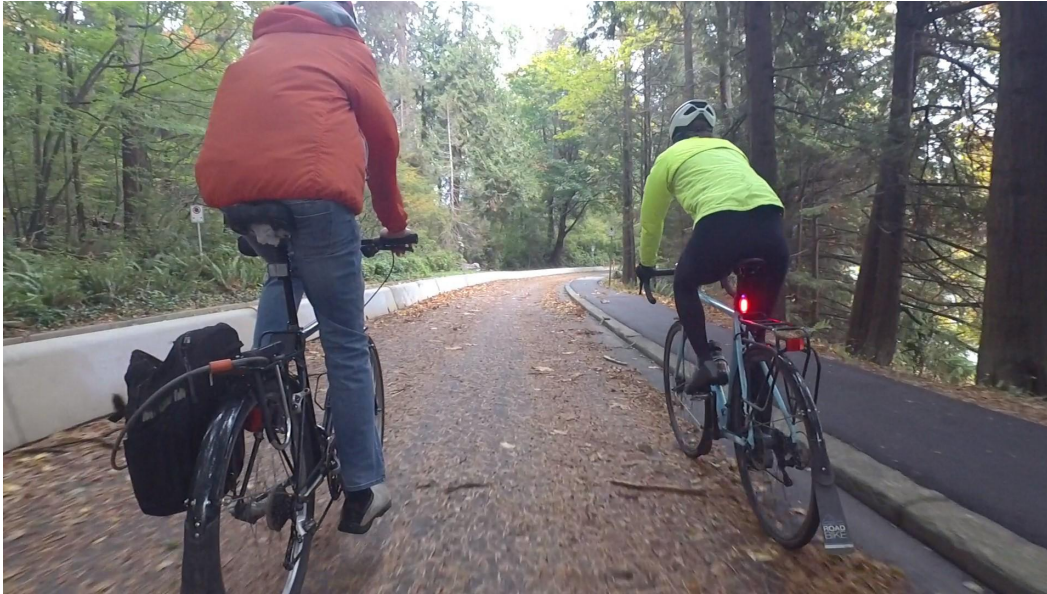
Figure 17 - Bike lane with debris

Leaves and other debris can make the bike path slippery and dangerous. This is illustrated in Figure 16. The route requires regular maintenance with sweepers, especially in the fall.

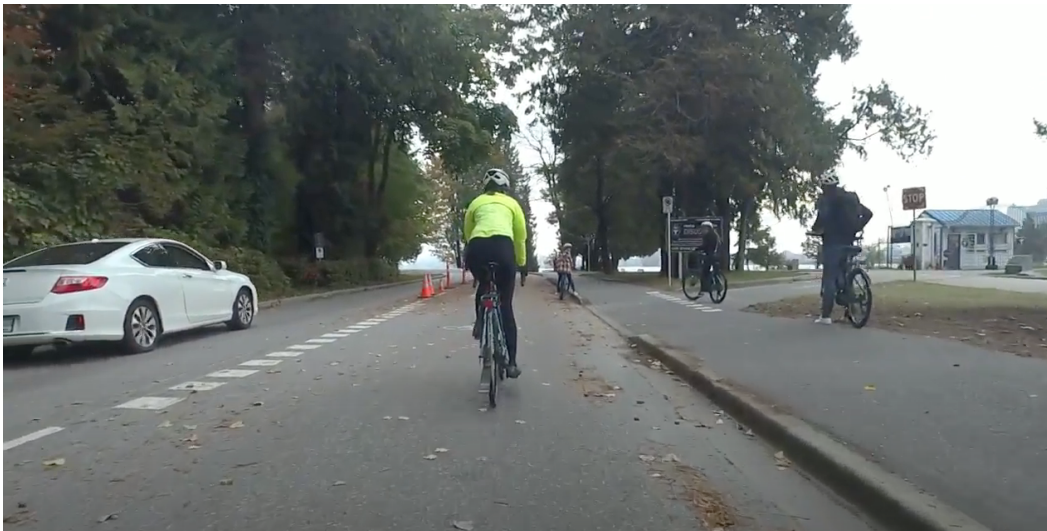
Figure 18 - Bike lane at HMCS Discovery

Where the seawall route and the temporary cycling lanes converge at HMCS Discovery, shown in Figure 18, people cycling can be confused as to where to ride, and seawall path users were observed inadvertently entering the temporary lanes on the roadway.

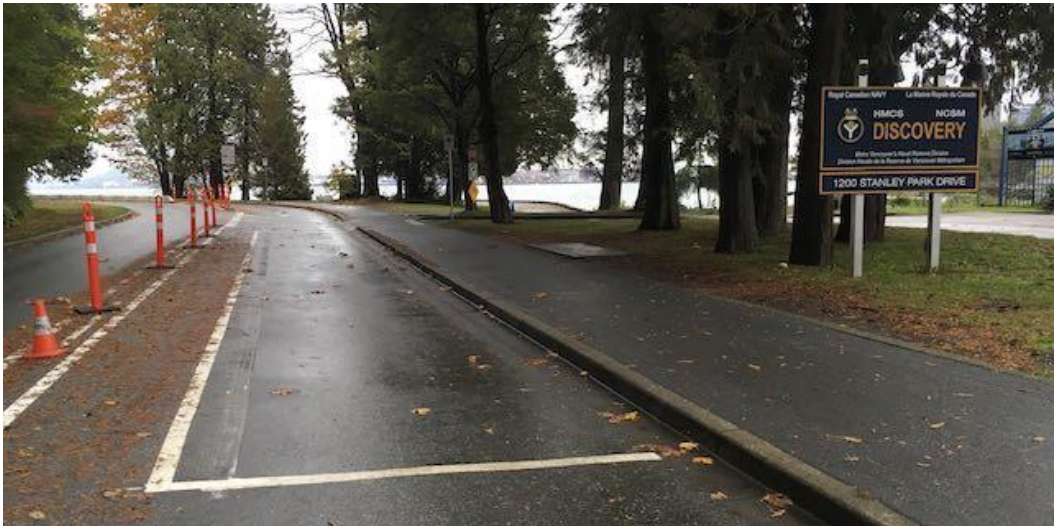
Figure 19 - Bike lane at the Royal Vancouver Yacht Club with Horse Carriage stop

There is a horse carriage stop placed in the bike lane, shown in Figure 19. This is unsafe for people cycling, and should be relocated out of the cycling lane.

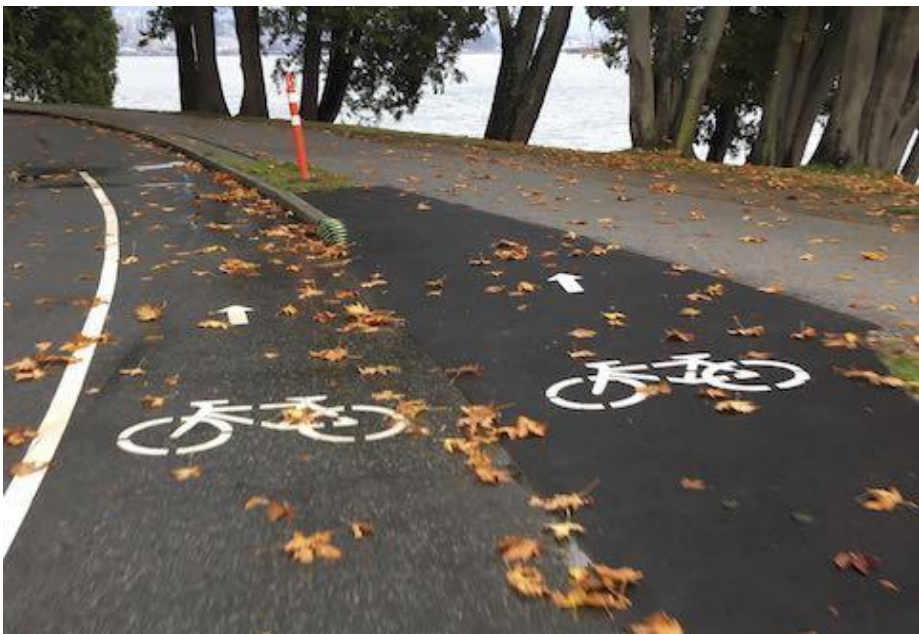
Figure 20 - Bike lane splits at the 9 O'Clock Gun

At the Harry Jerome statue, the bike lane merges with the vehicle lane. There is a single share the lane sign. This requires additional attention. Figure 20 shows a new ramp from the temporary route up to the existing seawall bike path. People cycling are given two options here, to share the road with vehicles or take the existing raised path, but this creates conflict with vehicle operators who squeeze past, apparently believing that people cycling should not be on the roadway here.

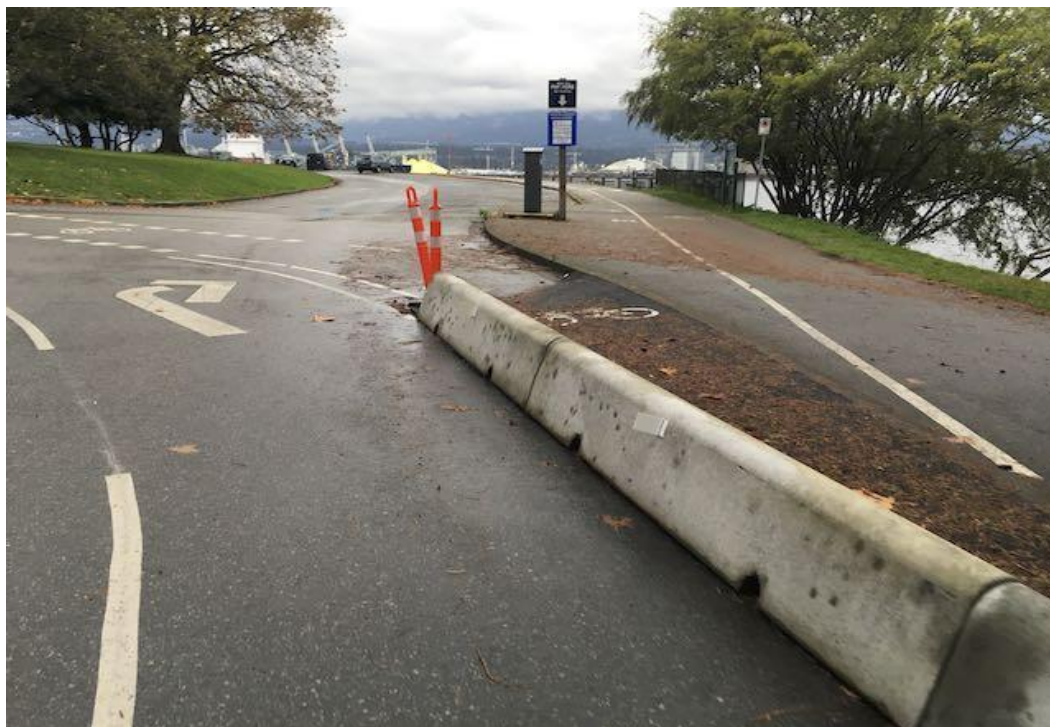
Figure 21 - Entrance to the Brockton Point parking lot

Those people cycling who chose to take the existing raised path are directed back onto the roadway where vehicles can be turning right into the parking lot, as shown in Figure 21.

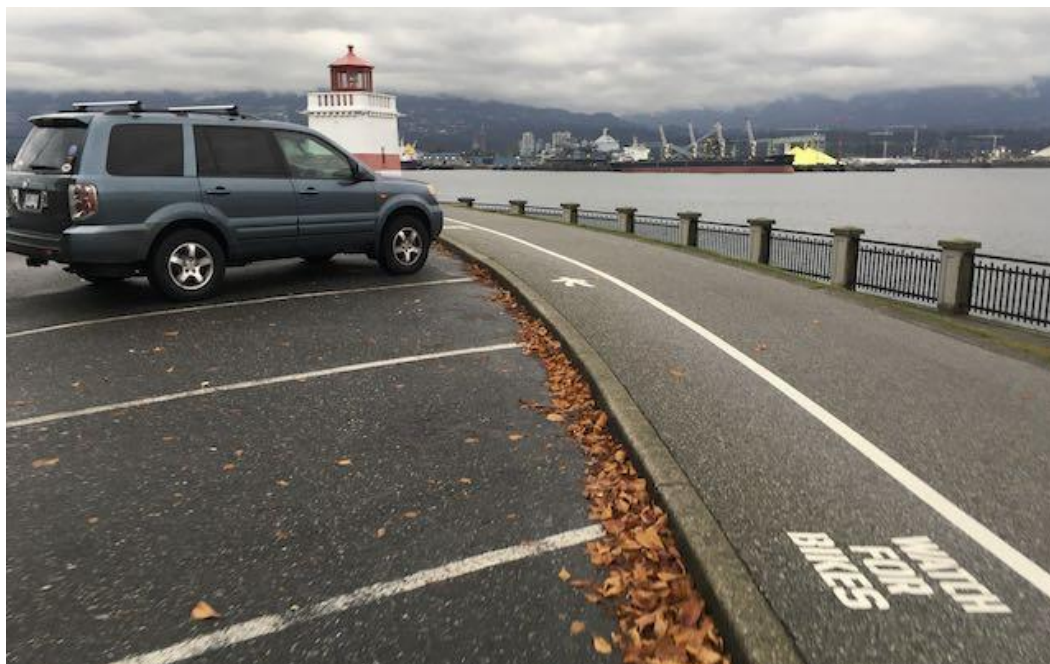
Figure 22 - The Brockton Point parking lot showing the narrow bike path

The existing seawall path, shown in Figure 22, is very narrow and runs in front of parked vehicles, in the area where people are standing, and exiting and entering their vehicles. This is a high conflict zone.

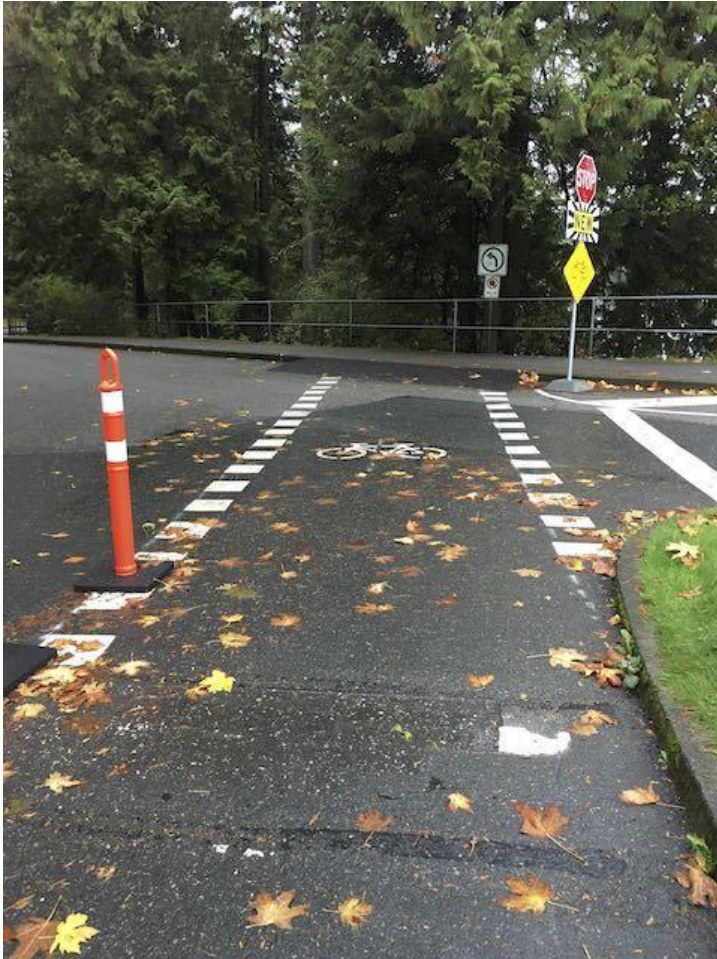
Figure 23 - Exit from the Brockton Point parking lot, with a new cycling ramp

At the exit of the Brockton Point parking area there is another ramp taking people cycling back up to the existing raised path, shown in Figure 23. This is not clearly signed. Many people cycling will choose to stay on the roadway here instead of riding on what appears to be a sidewalk, and not switch back and forth between the roadway and the raised path.

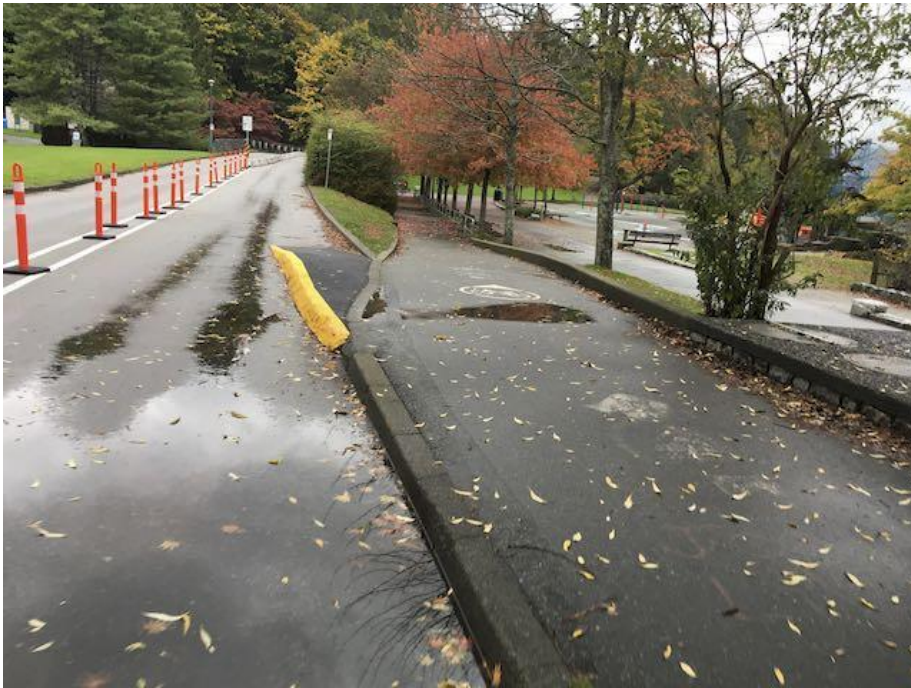
Figure 24 - Ramp from the existing raised bike path at Lumberman's Arch

The ramp back down to the protected lane on the roadway near the water park, shown in Figure 24, needs improved markings. There are also problems with water drainage on the roadway here.

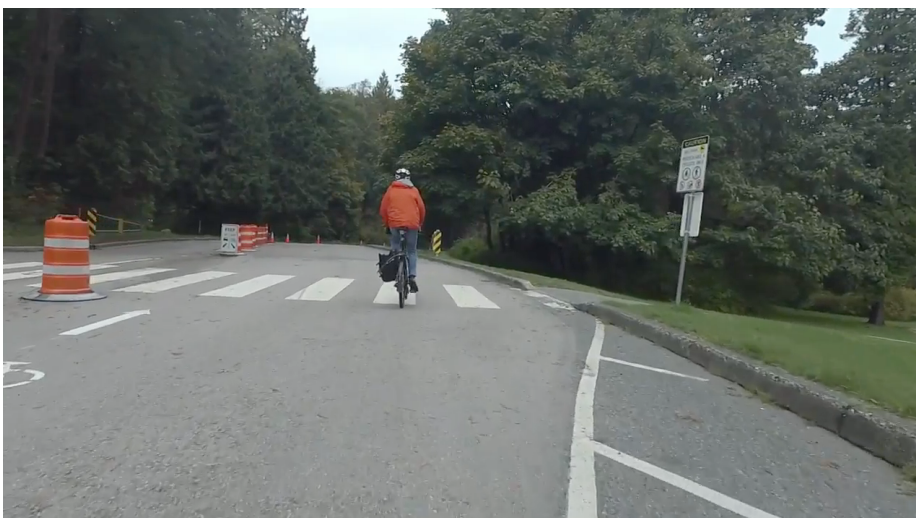
Figure 25 - Protected bike lane at access path to seawall to avoid the Prospect Point hill

This section works well. The lane back down to the seawall at the north foot of the Prospect Point hill, shown in Figure 25, should be better marked, especially to assist those people cycling who wish to avoid the hill. Clearer signage should be erected to indicate to path users that they can return to the park entrance along Pipeline Road, thus avoiding the hill.

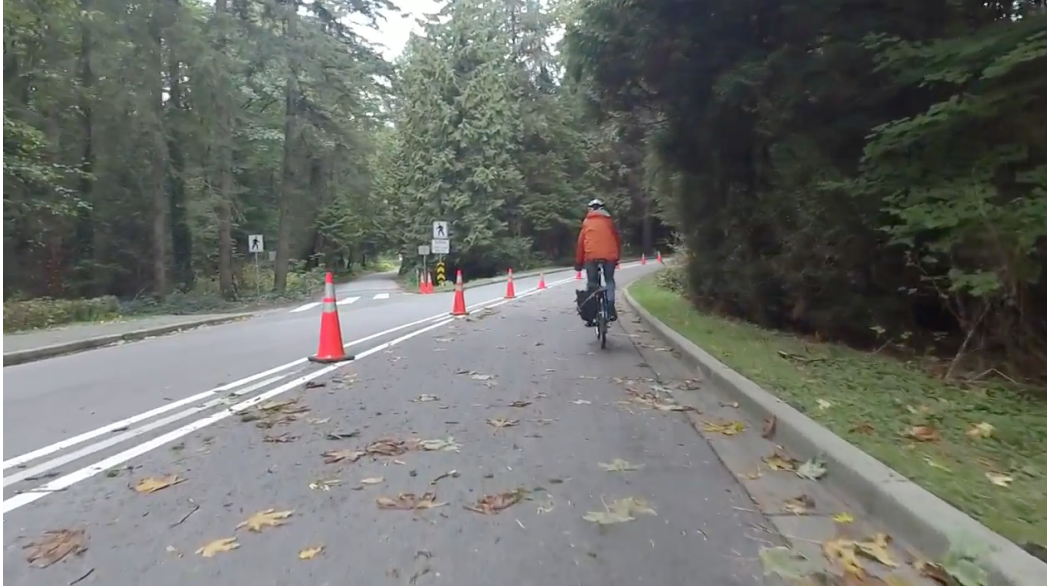
Figure 26 - Cone-protected bike lane at the Prospect Point Hill

The well-spaced cones that are along here, shown in Figure 26, make it easy for people cycling more quickly to overtake slower riders. The cones have been shifted at the hairpin turn, likely after being hit by vehicles. On the hill, we observed that slower riders stayed to the right side for the most part. This section should have concrete dividers, but with openings to allow changing lanes for overtaking.

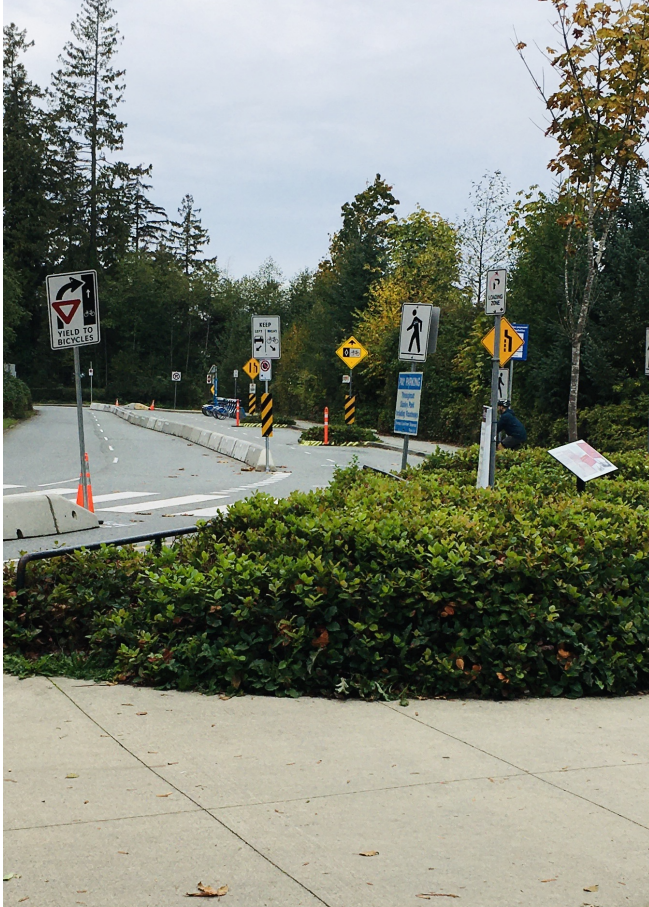
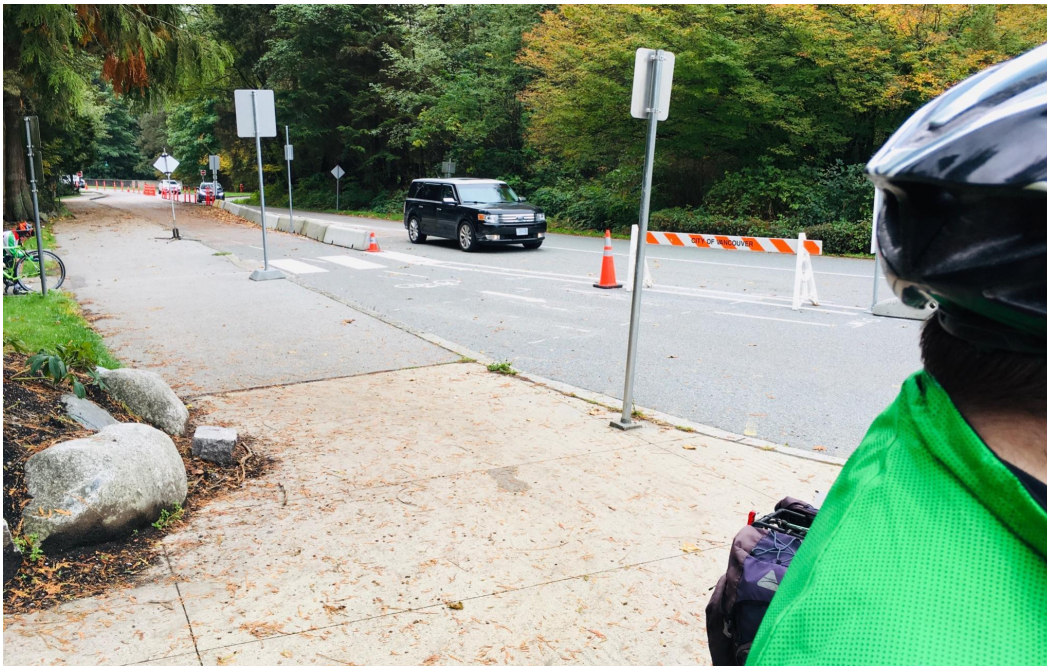
The entrance to Prospect Point, shown in Figures 27 and 28 on the following page, can be very confusing for people driving, and this can make it dangerous for people cycling. The markings are poor in terms of traffic flow lanes. Vehicle operators were observed stopping in the right turn lane, unsure of how to proceed. While the general layout can work, the temporary nature of the implementation appears to be a source of the confusion. Raised pedestrian crosswalks would help slow traffic here, as well as elsewhere in the park.

Figure 27 - Bike and vehicle lanes, with parking lot entrance, at Prospect Point

Figure 28 - Bike and vehicle lanes approaching Prospect Point

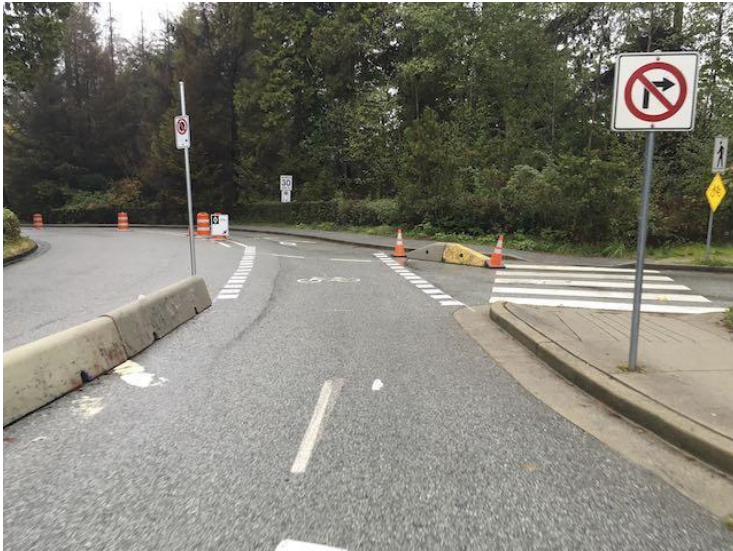
Figure 29 - Bike lane at the exit of the Prospect Point parking lot

The exit from the Prospect Point parking lot, shown in Figure 29, is a frequent conflict zone. Green paint should be used to indicate that people driving are crossing a cycle lane. The barriers installed to normalize the intersection geometry have been pushed back by vehicle operators, creating a slip lane. A concrete island should be installed on the left side of the bike lane to help people driving to do so safely when they are exiting the parking lot.

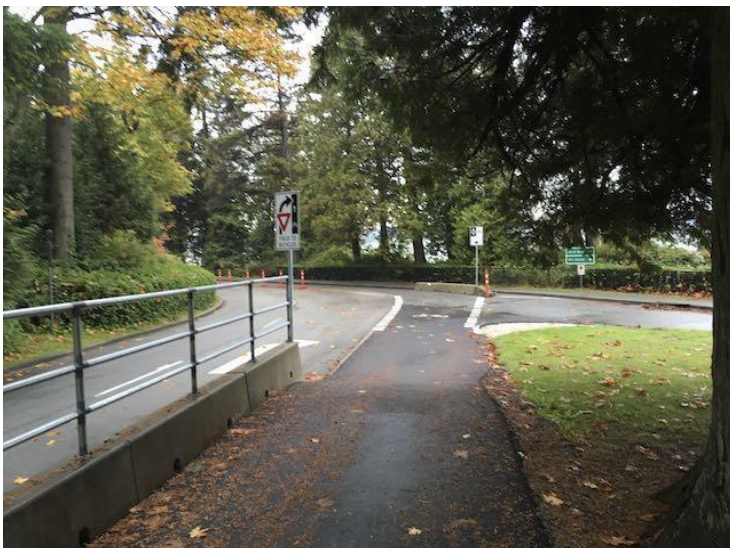
Figure 30 - Parking lot entrance at Ferguson Point

At Ferguson Point, the parking lot entrance relocation has been successful, with the closure of the first access eliminating a significant conflict zone for people cycling. The new turn into the parking lot, shown in Figure 30, should be demarcated with green paint. We have heard requests for additional signage from those using Rawlings Trail to access the beach here.

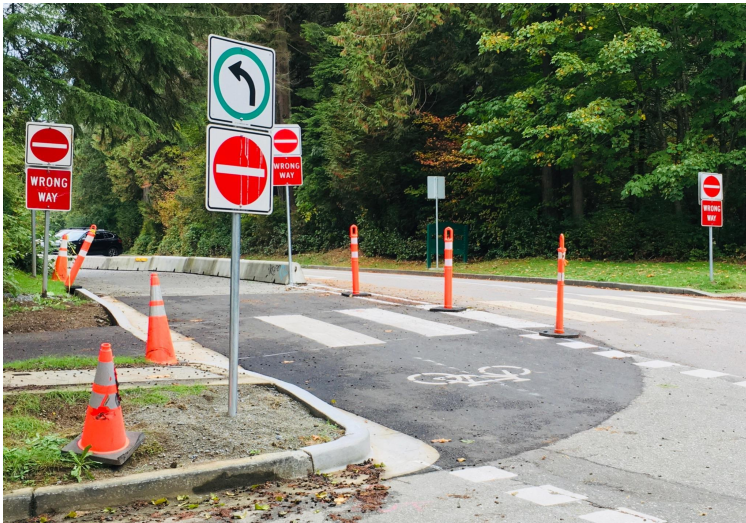
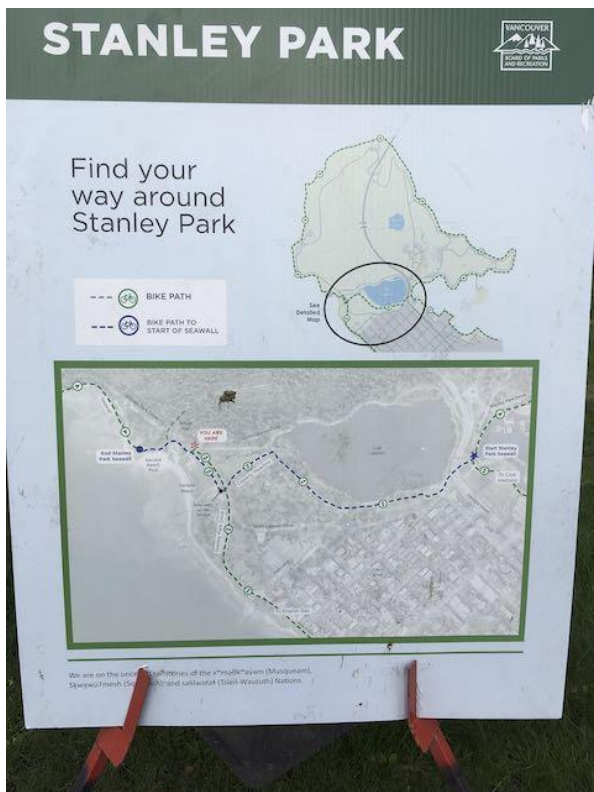
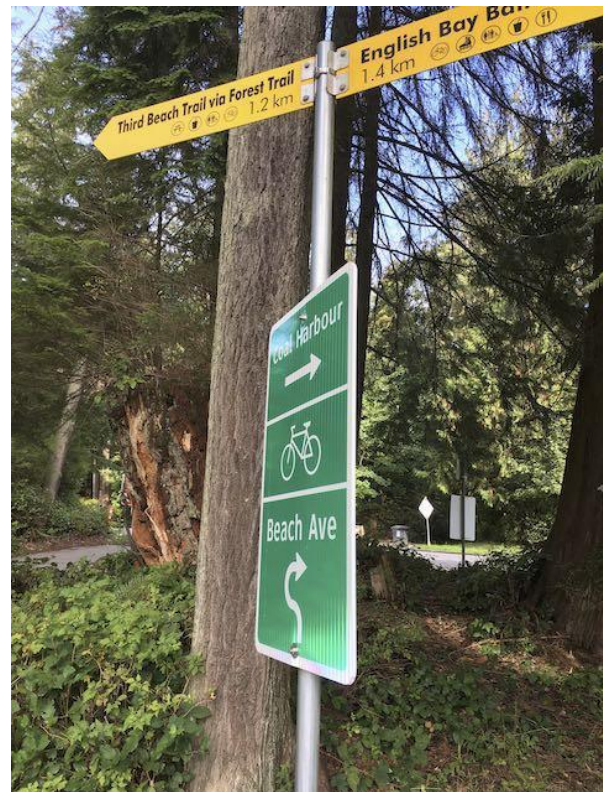
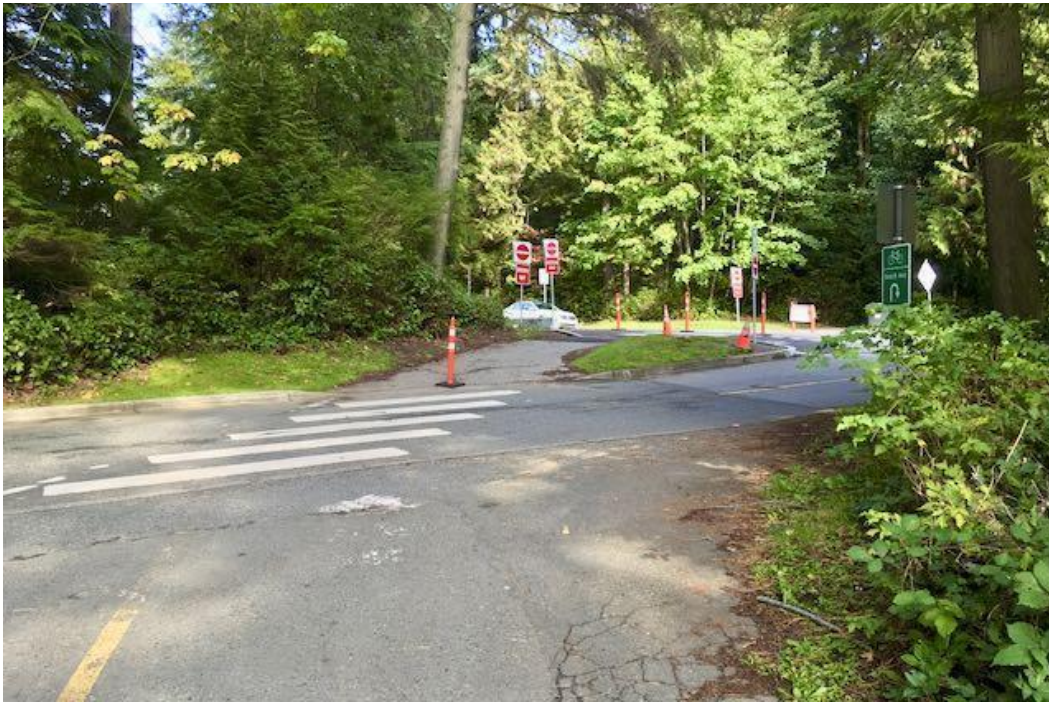
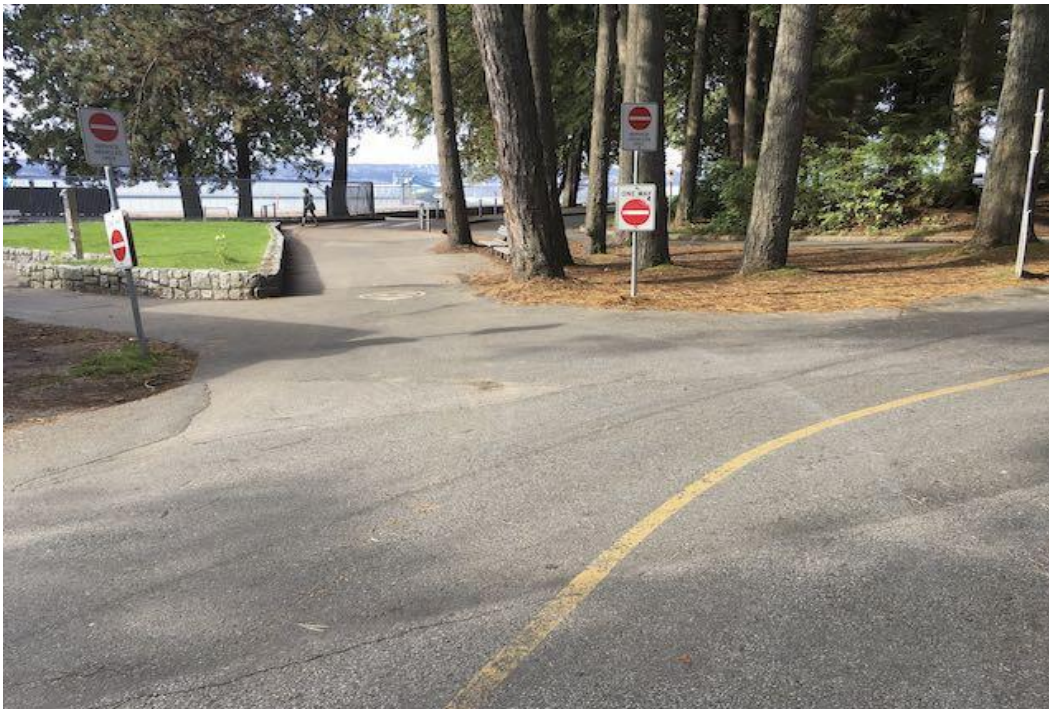
The area around North Lagoon Drive, Stanley Park Drive, the exit of the seawall bike path near the concession, the access to Rawlings Trail, and the access to the South Lagoon bike path is very confusing for users. There are a lot of signs, shown in Figures 31 to 36, but they do not appear to deliver a consistent message.

Figure 31 - Signage at the exit of the protected bike path from Prospect Point

Figure 32 - Temporary signage

Figure 33 - Additional signage

Figure 34 - Second Beach parking lot crossing

Figure 35- Signage at the exit of the seawall bike path
