Assessment Ride Report - Stanley Park Protected Cycling Lanes

The implementation of the temporary protected cycling lanes has been a tremendous benefit for people cycling in Stanley Park. The Vancouver UBC Local Committee of HUB Cycling completed an assessment ride of the 2021 temporary lanes implemented in Stanley Park, in October 2021. The following recommendations are intended to inform the discussion around permanent traffic calming measures to be proposed by staff in early 2022. The assessment ride followed the route indicated in Figure 1, with stops indicated from labels 1 to 11.

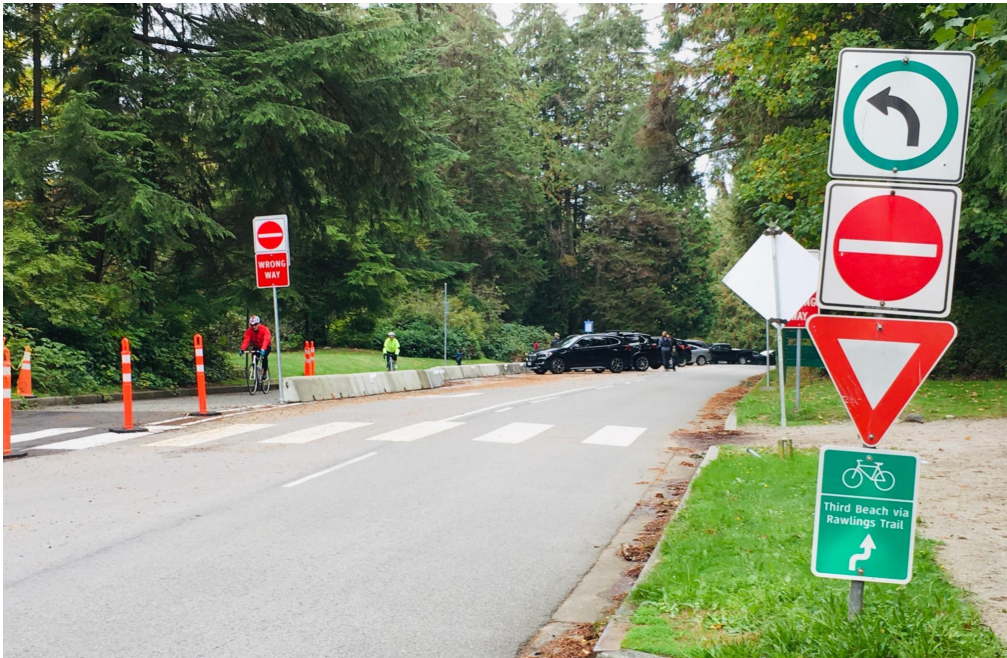
Figure 36 - Signage at the exit of the protected bike path from Prospect Point, directing people to Rawlings Trail

The sign for the trail route to 3rd Beach, shown in Figure 36, is positioned on the road and not where cyclists are, on the path to the left.
