**CYCLING  
COALITION**

**Re: Deficiencies in cycling infrastructure on Golden Ears Bridge and approaches**

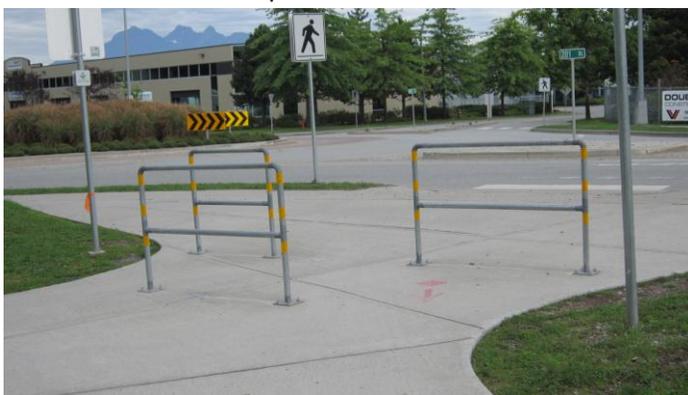
- Contrary to what we had expected, there are no designed transitions for cyclists from the roadway that constitutes the only cycling access on the south side of the bridge to the multi-use paths on the bridge structure. Rather, cyclists are channelled to a pedestrian wheelchair ramp and crosswalk.
- A set of baffles has been installed near the crosswalk. Even though they have been adjusted once, these baffles are spaced in such a way as to make passage by bicycle trailers and tandem bikes difficult if not impossible.

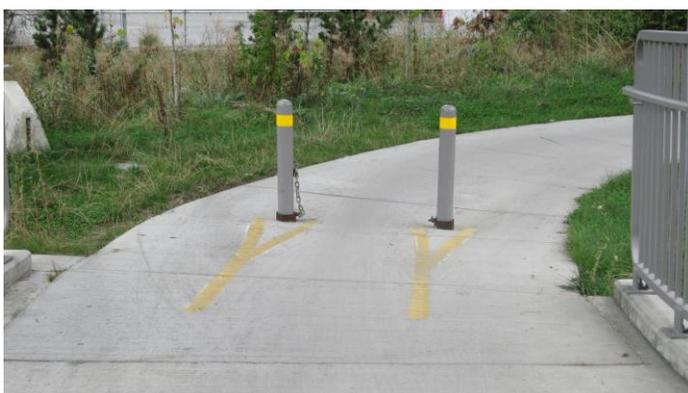
- A set of two bollards spaced less than 90 cm apart has been installed on each of the immediate approach and departure to the bridge sidewalks. These bollards are improperly located, spaced and marked. One of our members suffered serious bruising when crashing into one of the improperly placed bollards. We question the need for both baffles and bollards at this location. Surely one or the other, properly designed in accordance with contemporary guidelines, would suffice.

With regard to bollard placement, recognized best practices include the following:

- Bollards and baffles should only be installed where needed. If there is uncertainty it is better to leave them out and install them later only if the need is established.
- Bollards should be installed in odd-numbered groups (preferable one, but 3 or more if needed), with one bollard on the centre of the two way path.

- The centre bollard should be marked with a yellow line on both approaches, and an elongated diamond marking should be placed around the bollard in order to guide users around it. Depending on circumstances, it may also be appropriate to mark any additional bollards with similar white lines.
- Bollards should be located well back of conflict points. Bollards constitute a potential hazard to cyclists and as such will focus their attention. While cyclists are focused on negotiating bollards they are less able to attend to other conflicts.
- There should be a minimum of 1.5 m, and preferably 1.8 m, clear space between bollards (and between bollards and other obstructions such as utility poles, railings or walls).
- Bollards that are designed to be removable should not have protruding bases (i.e. bases should be flush with the surface so as not to create a hazard when bollards are removed).

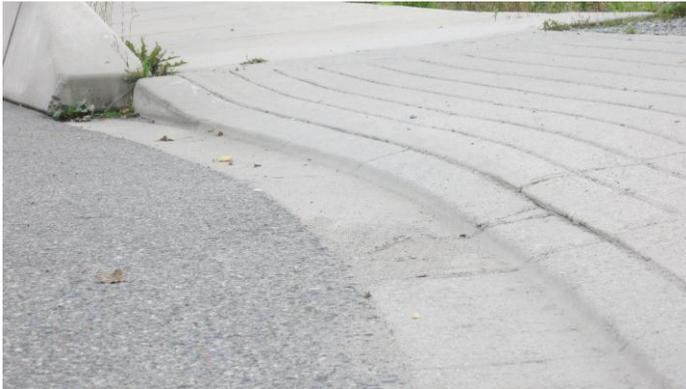
- The ramps that provide cycling access to and from the bridge paths on the north side appear to have been designed as “sidewalk crossings” (i.e., reinforced, ramped sidewalk sections designed for the passage of motor vehicles). These are less than ideal for cyclists transitioning from the bridge path to the roadway shoulder and hazardous for cyclists transitioning from the roadway

shoulder onto the bridge path due to the need to cross a raised lip at an oblique angle. This condition is known to cause falls when cyclists' front wheels are diverted by the lip.

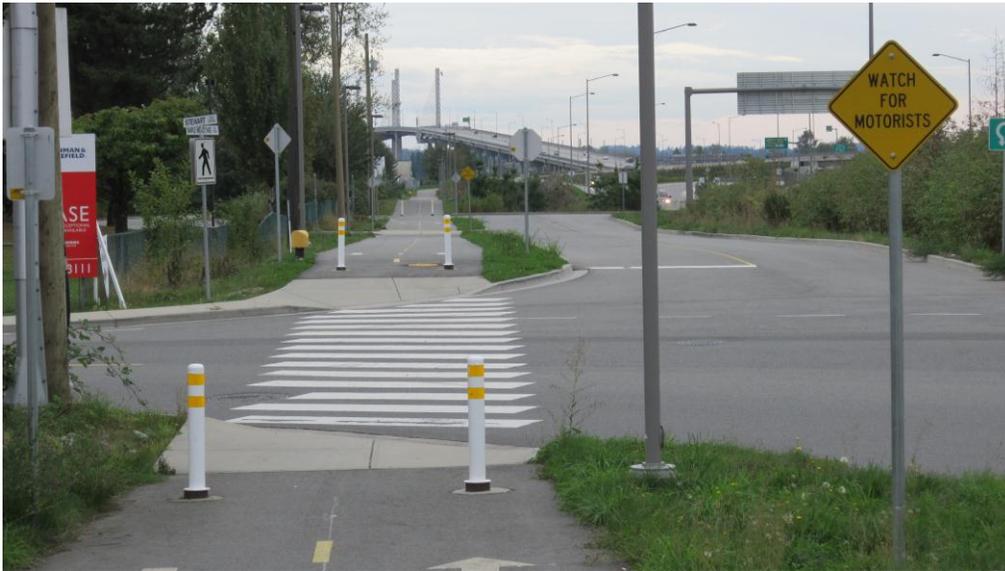
- The multi-use paths approaching the north side of the bridge are plagued by issues similar to those mentioned above. The paths are provided with a centre-line dividing directions of travel, a welcome measure. However, bollards have been placed in the centre of each directional “lane” rather than on the centre-line. Ambiguous transitions for cyclists exist at street crossings and at a traffic circle. More guidance signing is needed and some that exists is confusing. An unusual intersection bears warning signs for path users to “watch for motorists” but no warnings at all for motorists approaching what is essentially an uncontrolled blind corner.

- Apart from the improper placement of bollards we are also concerned about the design of the bollards. All appear to have a base which is raised above the level of the path. If bollards are knocked out or removed this raised lip remains as a virtually invisible hazard.
