Vancouver UBC Local Committee - HUB Cycling Assessment of the Central Valley Greenway Intersections

Vancouver, British Columbia, Canada

Saturday, January 24, 2014

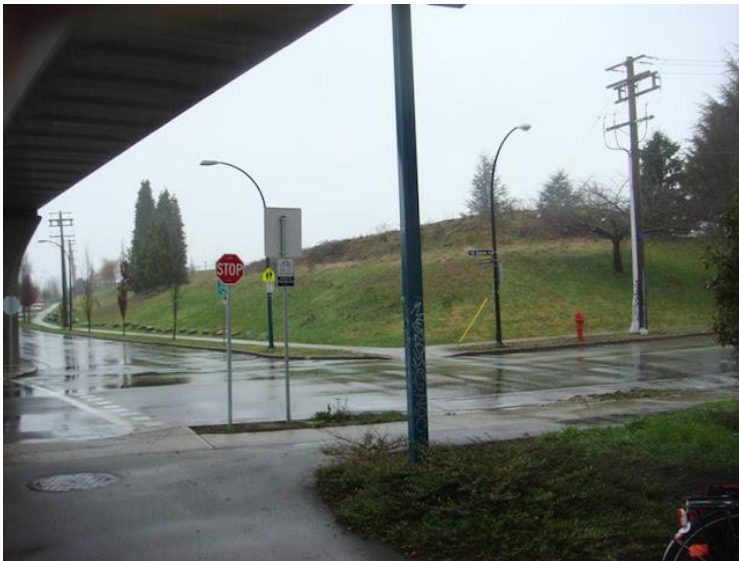
A potential hazard was also identified at this intersection where motorists who turn off South Grandview Highway encounter train tracks and encounter what appears to be only a pedestrian crosswalk. They may not be expecting cyclists. Although there are markings ('elephant's feet'), not all drivers will see or understand these.

Needs: The bike route and crosswalk should be marked in a clear manner for

motorists, pedestrians, and cyclists. Clear signage is needed to indicate how cyclists should transition between the separated pathway and roadway. It should also be clear to motor vehicles that they are approaching a shared crosswalk.

- An unmarked dip in the curb grade allows those cycling to travel directly into their westbound lane on North Grandview Highway. Move the bike path between Slocan St. and Renfrew St. to the north side of the SkyTrain tracks. This would align the CVG route across Slocan St. and avoid confusion over how to continue westbound along the CVG. It would also avoid the awkward turn in front of eastbound traffic that cyclists must currently make.
- Alternatively, indicate with clear signage that westbound cyclists may travel directly across Slocan St. onto North Grandview Highway.
- Add signage warning motor vehicle traffic to yield to both pedestrians and cyclists in the crosswalk, as well as those merging between the separated pathway and roadway. (This is also applicable at other crossings without traffic lights on the CVG.)

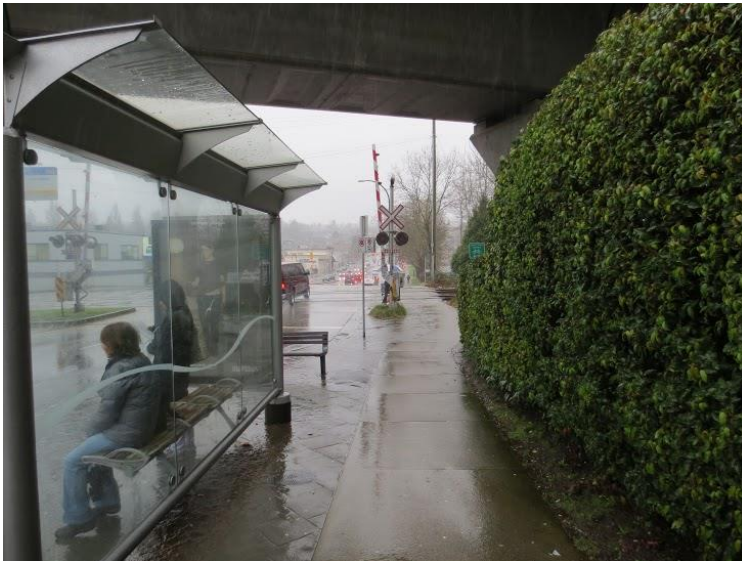
Intersection 4: Rupert SkyTrain Station

Assessment: On the west side of Rupert St., where the CVG meets the street, there is a dangerous meeting of pedestrians and cyclists. For those heading east, it is difficult to see around the concrete column of the Skytrain tracks. This creates a blind spot for all CVG users heading toward the westbound pathway. The pathway is also not visible (aside from a small sign peeking out from the bush).

On the west side of the Rupert St. intersection, a bus stop placed between the CVG and the crosswalk presents another hazard. The CVG continues as a narrow path behind the bus shelter,

and this path is shared by those waiting for the bus.

Both of these hazards (the blind spot and the bus stop) are exacerbated by the large ornamental bushes on the corner property of the BC Liquor Distribution Branch Building. The bushes further obscure the blind corner and encroach on the CVG path, pushing cyclists closer to the bus shelter.

The large crosswalk across Rupert St. is adequate for reducing conflicts between users in the crossing, but its location just north of where the CVG intersects Rupert St. creates the problems previously noted. Additionally, the button for the pedestrian-controlled crossing on the west side of the intersection is on the wrong side of the crosswalk, encouraging cyclists to travel on the left side of the road (contrary to the City of Vancouver bylaws).

Needs: For all users, the blind corner on the west side of the intersection is a hazard, as is the pinch point of cyclists and pedestrians. This intersection needs a significant improvement of its shared facilities.

- Request the BC Liquor Distribution Branch to trim back, or ideally remove, the bushes on the east side of the intersection.
- Remove the blind corner by making the other side visible or perhaps by allowing cyclists to travel through.
- More clearly mark that the pathway is shared.
- Move the pedestrian/cyclist-activated crosswalk button to the right side of the crosswalk on the west side of the intersection.
- If bushes are removed, widen pathway or separate cyclists from pedestrians.
- Alternatively, add a second crosswalk that would run diagonally from CVG on east side of the street to CVG on west side.
- Improve signage marking the bicycle route as it passes under the SkyTrain so pedestrians know where it is.
