June 28, 2023

# Burnaby Midtown Bikeway Assessment Ride

The Burnaby Local Committee of HUB Cycling conducted an assessment ride of Burnaby's segment of the Midtown Bikeway on Saturday, May 6th, 2023. In its current form, Burnaby's portion of the Midtown Bikeway is lacking or missing features that make it an "All Ages and Abilities (AAA)" bike route.

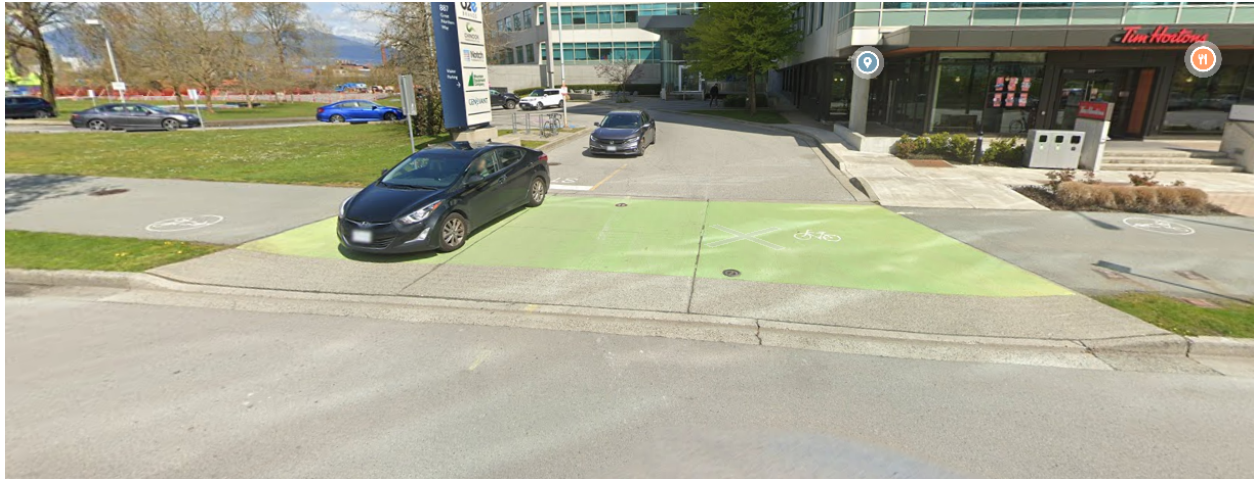
**Figure 2.** Example from Great Northern Way in Vancouver of green paint at conflict zones.

Notwithstanding City of Burnaby's current standard limiting use of green conflict paint to bike-only paths, the assessment team suggests that paint be used to highlight conflict zones at crossings and driveways on official bike paths and multi-use pathways (MUPs). This is how paint is used in other municipalities, with effect (Figure 2).

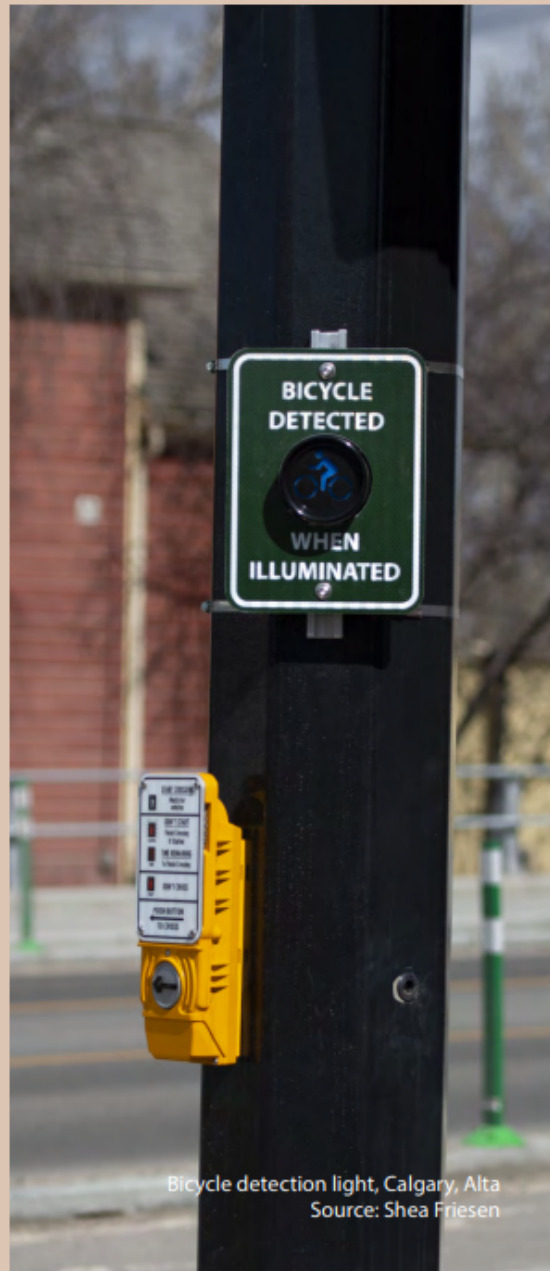
Bicycle detection light, Calgary, Alta  
Source: Shea Friesen

**Figure 5.** Excerpt from the BC Active Transportation Design Guide 2019. These would eliminate the need for people cycling to dismount to push the call button. This system is used at Eighth St and 8th Ave in New Westminster.

People riding bikes and people walking as well as using wheelchairs could enjoy better and safer travels if, instead of using call buttons, a crossing phase was built into every cycle. The City can also consider using ground-activated call buttons like what is used in New Westminster (Eighth St and 8th Ave intersection), Victoria, Calgary, and Edmonton. Figure 5 shows a case study of this system.

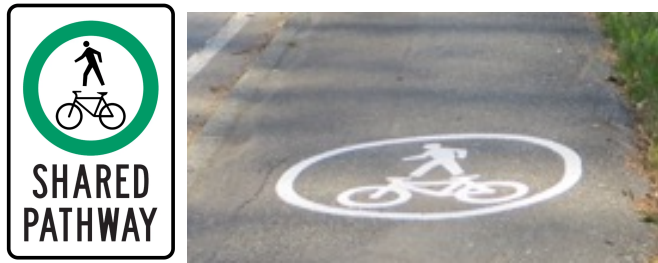
**Figure 6.** Example signage that would be suitable to mark the MUP along Moscrop.

For example, the MUP on the north side of Moscrop St is not marked. As such, it is unclear this is actually bike accessible and not just a sidewalk. Improved markings in the form of paint and/or vertical signage would help indicate to people cycling, walking and using wheelchairs that this is a shared path and help reduce conflict between different modes. The signage currently used on the Sea-to-River bike route would be suitable (Figure 6).
