Inspection Ride Report for the 47a Avenue/River Road West Cycling Route by Kathy Bossort, February 21, 2015

Introduction

This report describes inspection rides for 47a Avenue and River Road West, the east-west connector from Ladner to Delta Municipality's western border at Roberts Bank. (See Map 1 for outline of route marked in red)

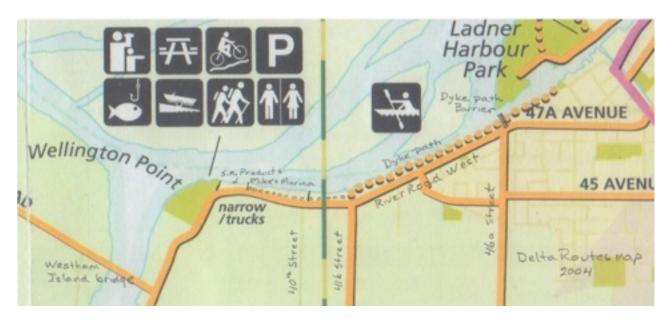
River Road West is not designated a bike route (in any category) on the Translink cycling map. The 2004 Delta Routes map (below) shows a "community" bike route, but has a warning label at Wellington Point: "narrow/trucks".

For cyclists using River Road West the crux section is at the Wellington Point curve, one that deters many from using this route.

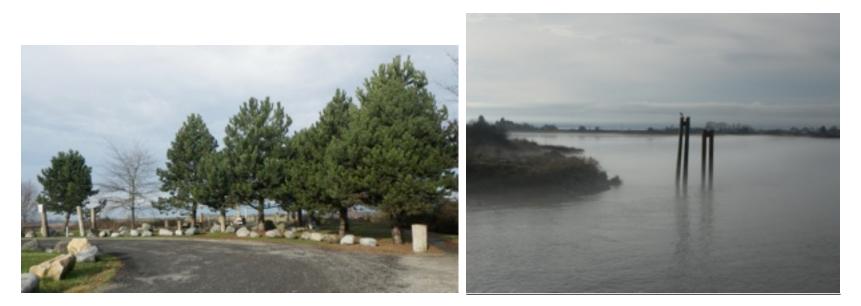
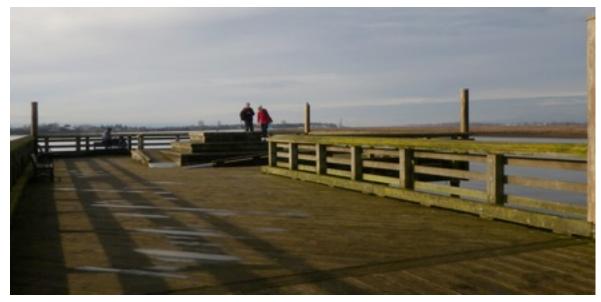
Photos 15a, 15b & 16: Wellington Point Park is a lovely park with wonderful views of river and farmland that should be more convenient and safe to cycle and walk to from Ladner.

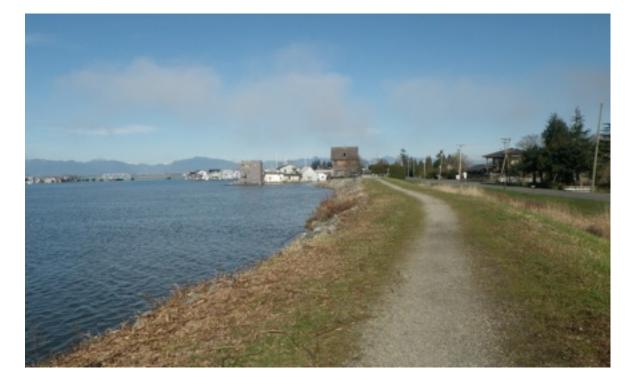
Photo 21: Fraser River dyke and trail with River Road West on its right, looking east towards dyke trailhead. (Public access on dyke trail starts in front of brown building; 34th Street intersection is to right center of photo.)

Westham Island bridge is in the background at left.

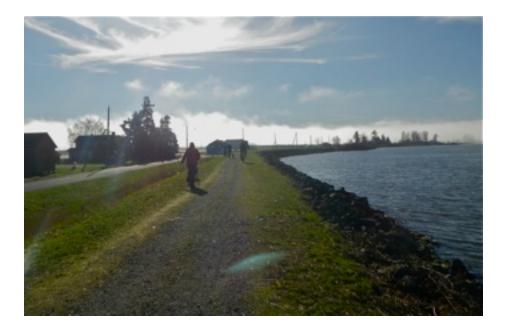
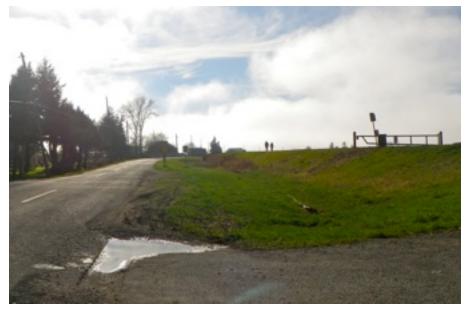
Photo 22: Cyclist on mountain bike, and walkers (and dogs) share the dyke trail. River Road West is on the left, Fraser River at right, and Brunswick Point in distance at right.

The trail is broad and easily shared by walkers and slow cyclists. Although River Road now has light traffic, the dyke gives the best views and cyclists often opt to use the dyke. (Cyclists on road bikes use the road).

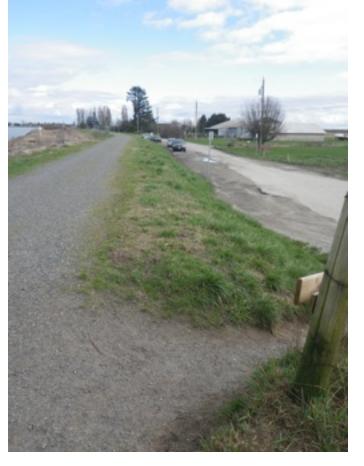
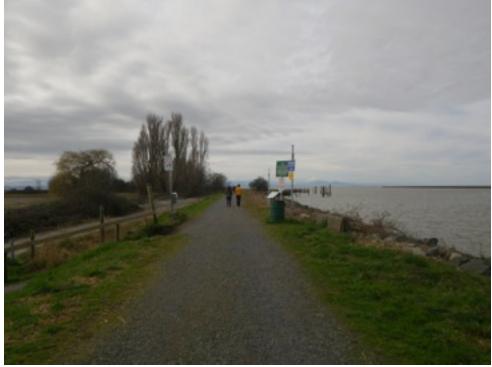
Photos 25 & 26: (Left) Parking area at end of River Road West, often used to capacity on weekends. (Right) The trailhead for Brunswick Point (Roberts Bank) dyke trail.

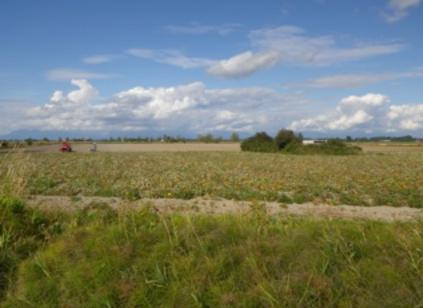
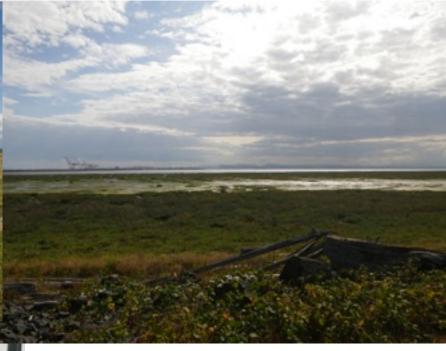
Photos 27 & 28 (above): Views from Brunswick Point (Roberts Bank) dyke trail: a 360 degree panorama of mountains, sea, sky and farmland. The trail is particularly popular with bird watchers as Roberts Bank is an important way station for migrating birds.
