## Proposal for Improvements to the Midtown and Ridgeway Bikeways

**March 5, 2019**

**Vancouver-UBC Local Committee**

**HUB Cycling**

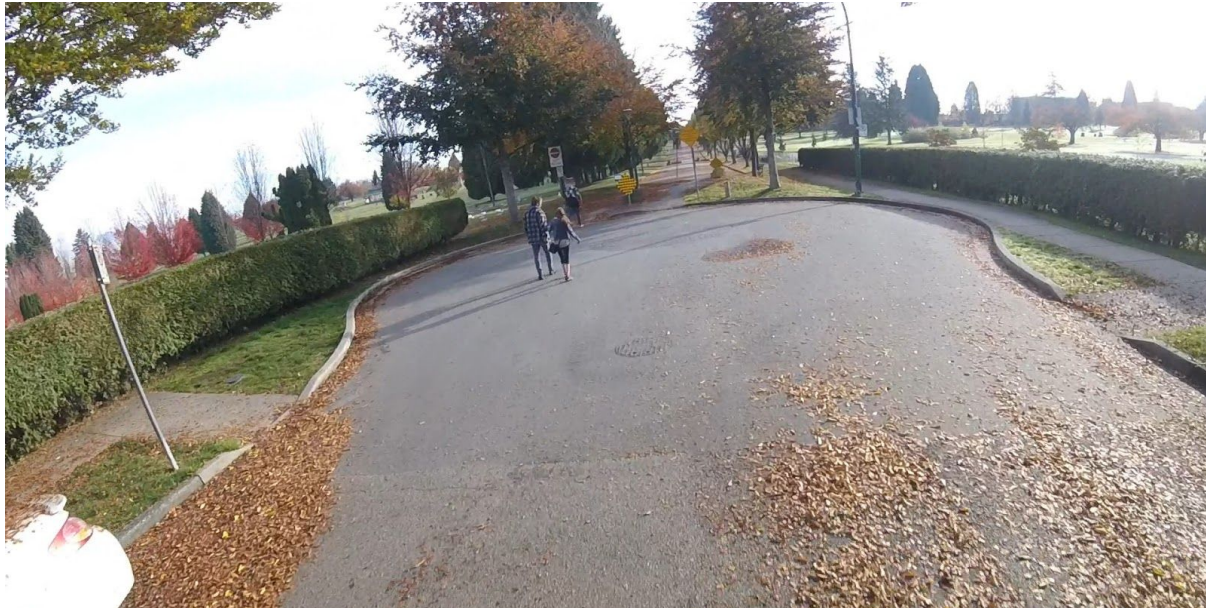
Figure 4 - 37th at Mountain View Cemetery showing the Multi Use Path (MUP)

We observed relatively low vehicle volumes along this stretch, making it comfortable for people on bikes. The traffic circle at Prince Edward has lowered Keep Right signs, but has had a tree planted on the centreline of the two roadways which will impact sightlines. At Mountain View Cemetery, the road is closed to motor vehicles. There is a path through the parklet to carry on along 37th, but this path is not marked for people on bikes and people walking, there is simply a Bikes Only (Vehicles do not enter) sign (figure 4). As there is no continuous north crosswalk on 37th, people walking were observed to be proceeding along the bike path instead of the sidewalk. It is not clear whether this is intended to be a multi use path or not; it should be so marked to direct users, and consideration should be given to directing people walking to the sidewalk that runs parallel to it, especially as it is at the bottom of two descents and people on bikes may be moving more quickly. Through the cemetery there is a wide paved road closed to vehicles (apart from cemetery use). At Fraser St, 37th is not aligned, but is offset to the south. The connector along Fraser St is situated on a widened sidewalk, with little separation of modes (figure 5). There are multiple signs at tree level indicating that people on bikes should ride next to the vehicle lanes, and people walking should be next to the cemetery, but there are few markings at ground level where people will see them, and there are no indications when turning into this lane as to where a person on a bike should position themselves. Painted lines for people on bikes, with the turn lanes marked with arrows, would improve safety here for all users. There is a crosswalk and cross bike on Fraser St. An east-facing bike route sign on the west side of Fraser at the crossing, with an arrow pointing right would be helpful. Similar for EB cyclists when they get to Fraser (if there is not one already).

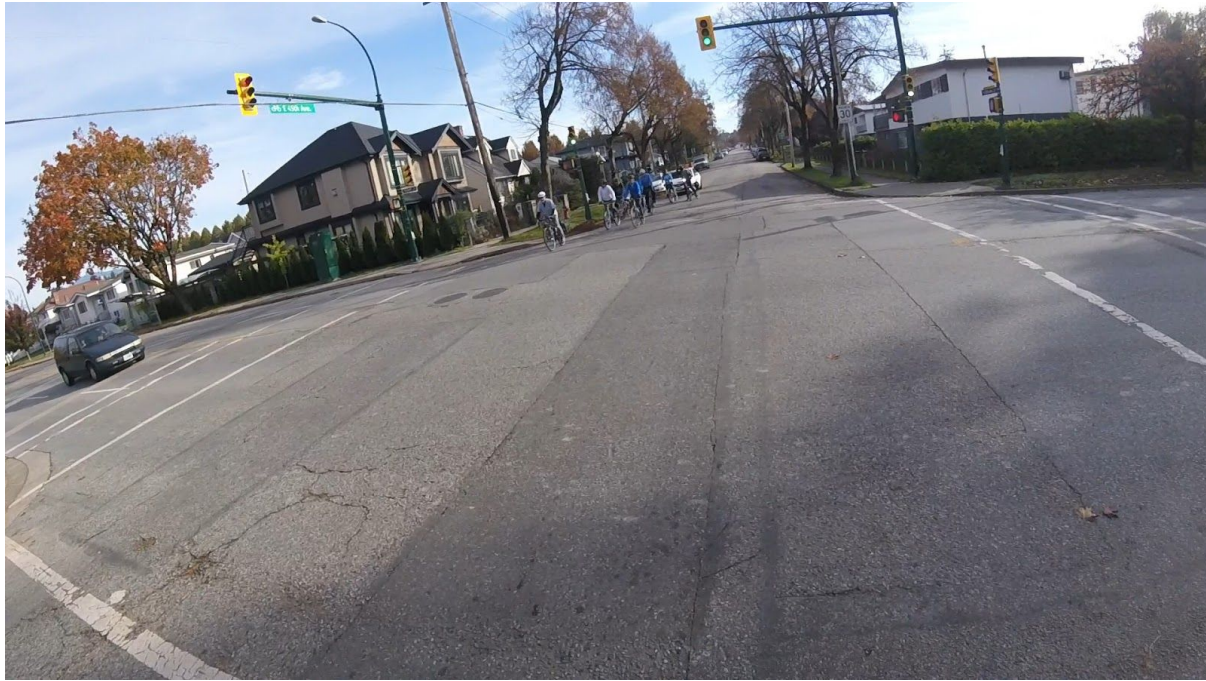
Figure 19 - 45th Ave at Rupert

through the intersection as the vehicles blocked it. Consideration should be given to adding protected bike lanes on each side of 45th up to the intersection, and altering the curb bulges at Rupert to make them permeable for bikes, possibly maintaining them as pedestrian refuges. (figure 19). People on bikes were observed trying to squeeze through on the right of the left turning vehicles, despite the curb bulge blocking the way.

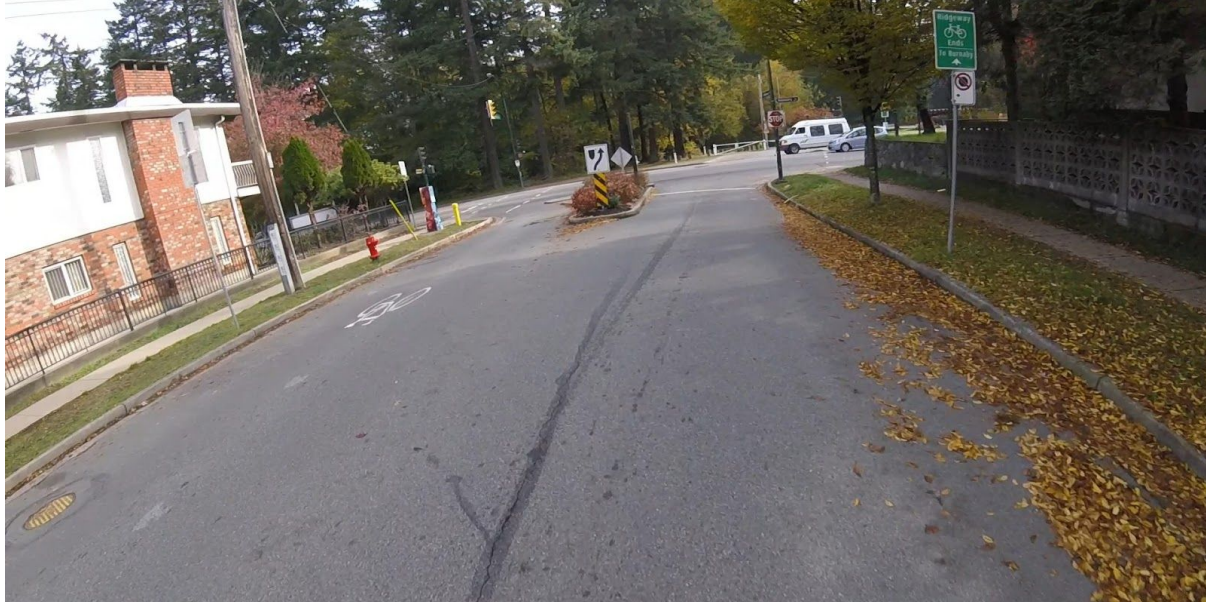
Figure 20 - 45th Ave at Boundary Road

At Boundary Road, there is a signalized crossing to reach Central Park (figure 20).

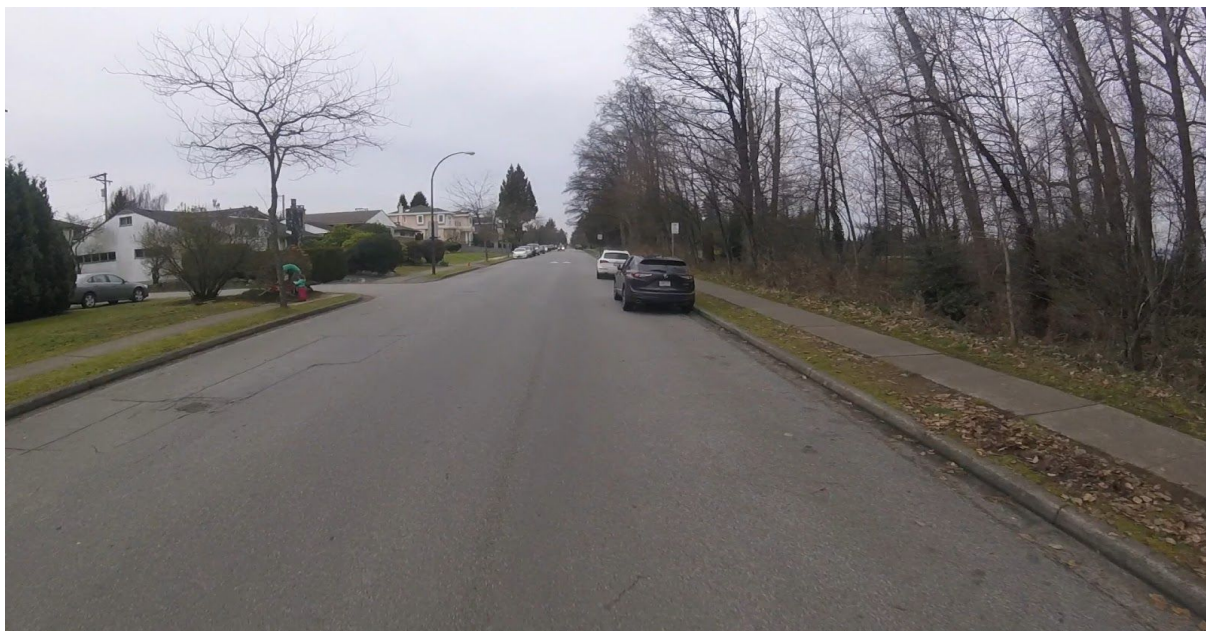
Figure 26 - 37th Westbound between Cambie and Oak

- Sections of 45th near Rupert (figure 17)
- 37th east of Knight (figure 9)
- 37th between Cambie, Oak, Granville, and Arbutus (figures 26, 28, 30)

Along this section there is a centre boulevard island (figure 25). This creates narrow lanes that are not wide enough for overtaking. Signage (at least some of which should be on the street) is required indicating where people on bikes should be positioned in the lane, preferably in the centre. Redevelopment in this area has significant potential for impact on traffic patterns. Portions of this section are wide and straight, leading to higher vehicle speeds (figure 26).

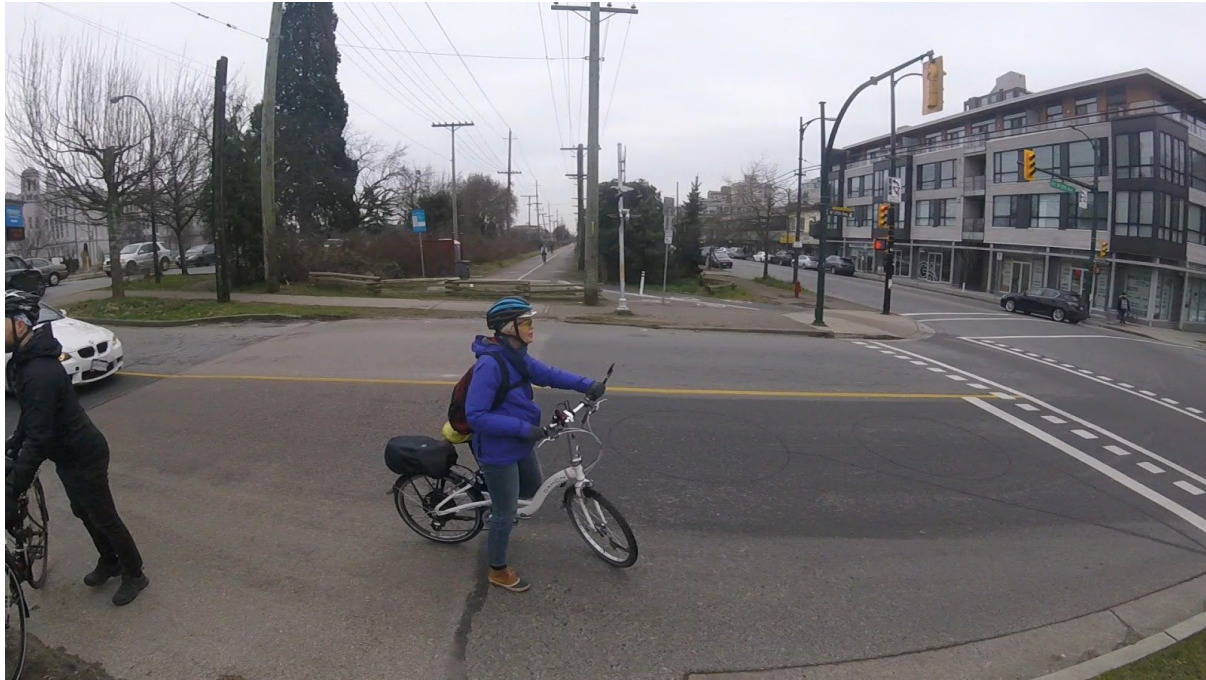
Figure 34 - 37th at the Arbutus Greenway temporary path crossing (West Blvd)

includes two schools (Quilchena and Point Grey Secondary) and East Boulevard, which was observed to be used as a bypass for the light at 41st and Arbutus at West Boulevard), in both directions (figure 35). These vehicle turning movements also create additional danger at the Arbutus Greenway crossing of 37th (figure 36). Repeated conflicts were observed at this intersection with cyclists and cars making left and right turns. It was not comfortable to get off the Arbutus Greenway and onto 37th, to travel in either direction.

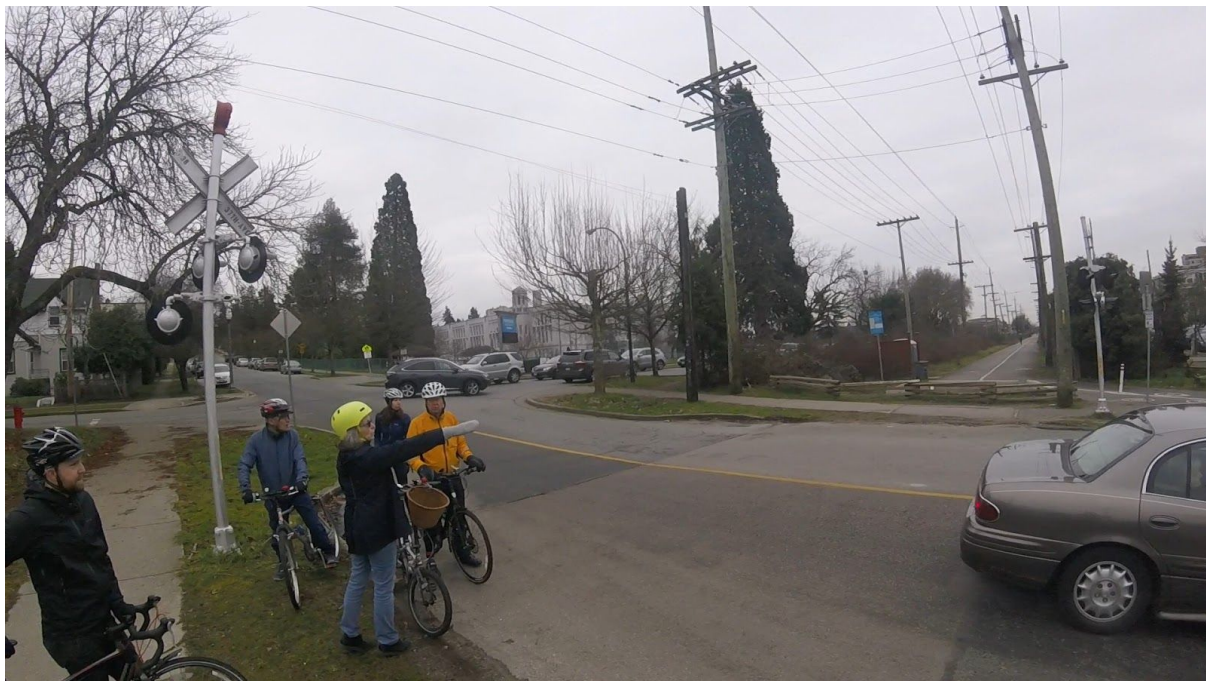
- Sections of 45th east of Nanaimo (figures 16, 18)
- 37th near Arbutus (figures 35, 37)

Figure 35 - 37th at the Arbutus Greenway showing East Blvd traffic

Where the roadway is sufficiently wide, consideration should be given to implementing protected bicycle lanes, including along parts of 45th. Given the constrained width of

some sections, consideration should be given to implementing one way streets, particularly for the blocks immediately west of Arbutus. Vehicle counts contained in Appendix 3 support the need for reductions in vehicle volumes. The section of 37th from Arbutus to Larch was observed to have the highest number of motor vehicles during the assessment rides, and combined with the narrow roadway and parking permitted on both sides of the street, was the most uncomfortable section assessed related to vehicle volumes.

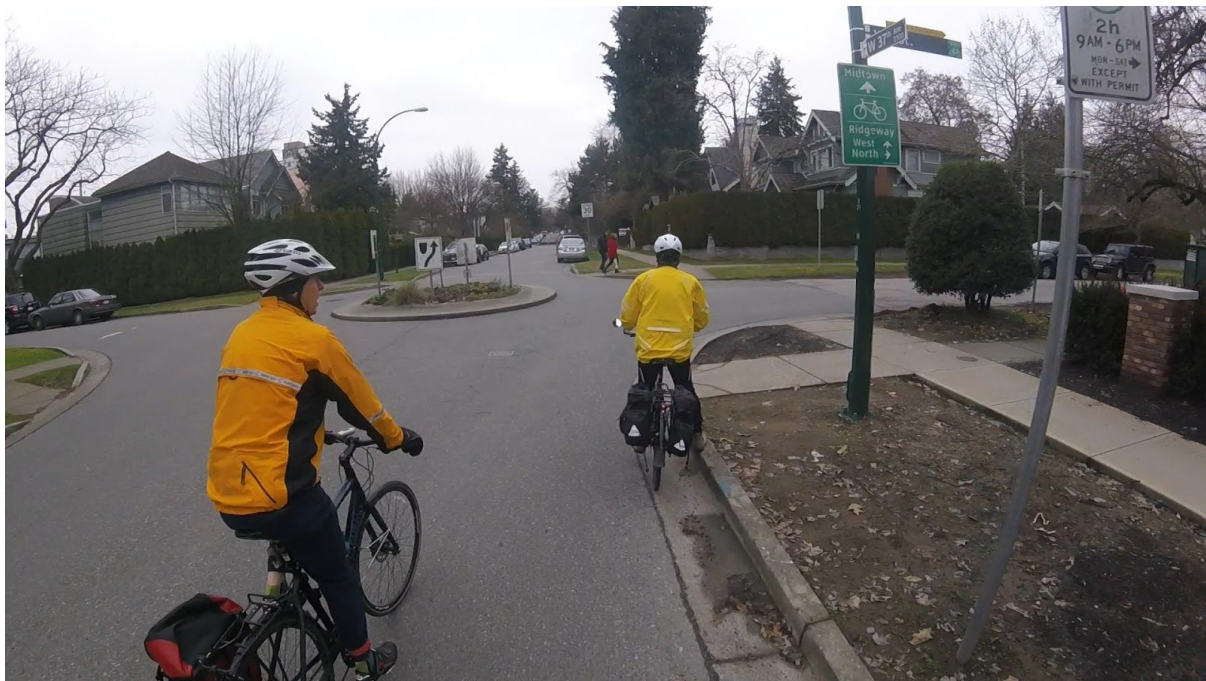
Figure 38 - 37th Westbound at Yew

At Yew, a northerly option for the Ridgeway Bikeway begins (figure 38)

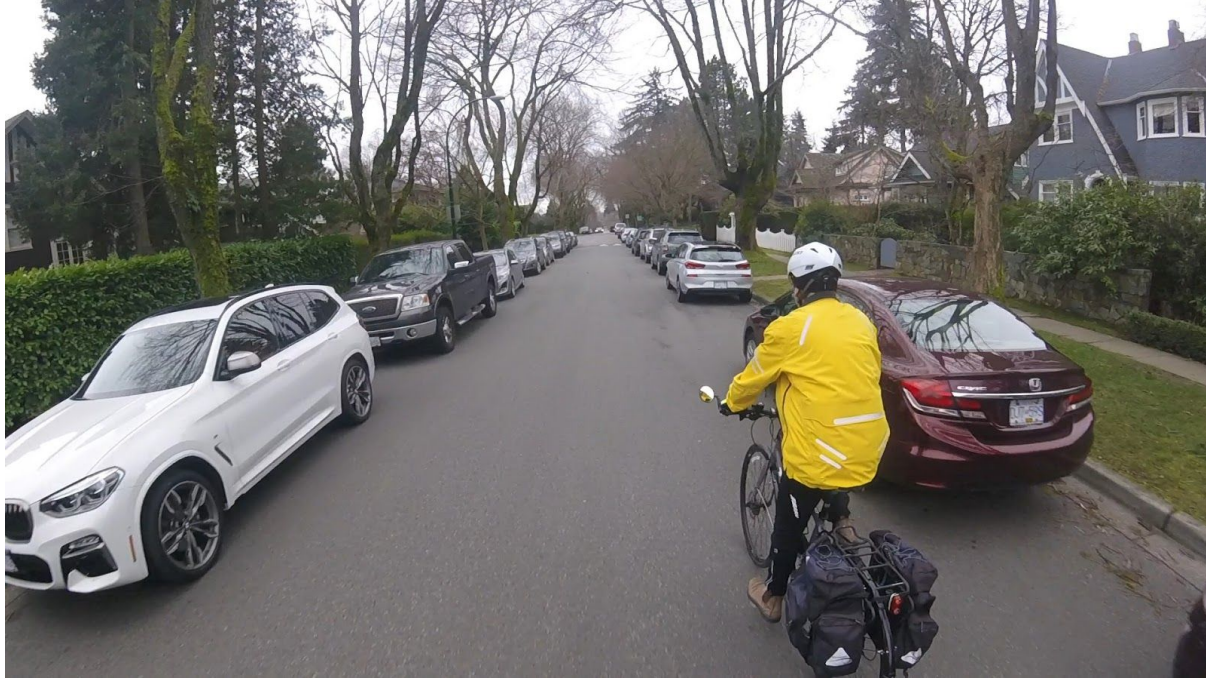
Figure 39 - 37th Westbound from Larch

Very heavy vehicle traffic was observed on the stretch of 37th from Arbutus to Yew (figure 37), and heavy vehicle traffic on the stretch from Yew to Larch (figure 39). The roadway is narrow, with vehicles parked on both sides of the street. Consideration should be given to implementing traffic diversions, allowing parking on only one side, or implementing a one way street.

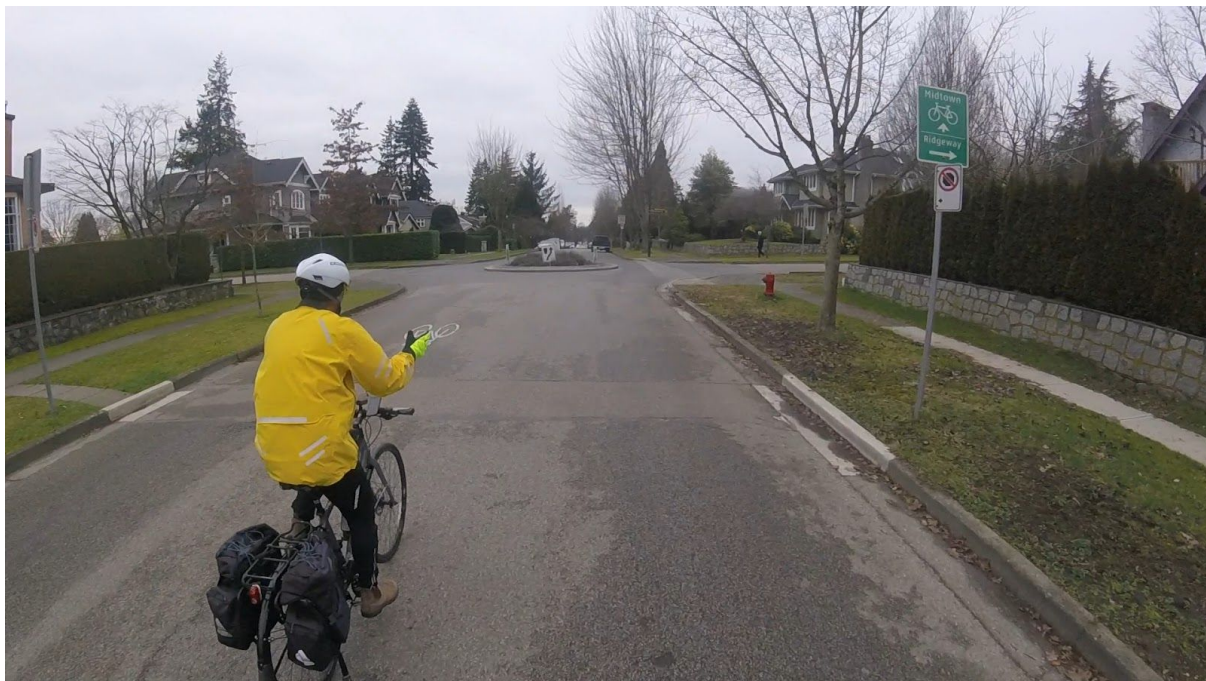
Figure 42 - 37th Westbound at Balaclava

At Carnarvon, there is a sign for the Balaclava bikeway, which crosses 37th (figure 41). There is confusion because it is not on Balaclava St. At the next intersection, Balaclava, there is a sign for the Ridgeway bikeway heading north (figure 42). This section is discussed subsequently. It is not clear why there are two bikeways located on adjacent streets, with one of them being discontinuous at 31st. It is recommended that bikeways be assigned unique names, and that there not be multiple options for routes with the same name.

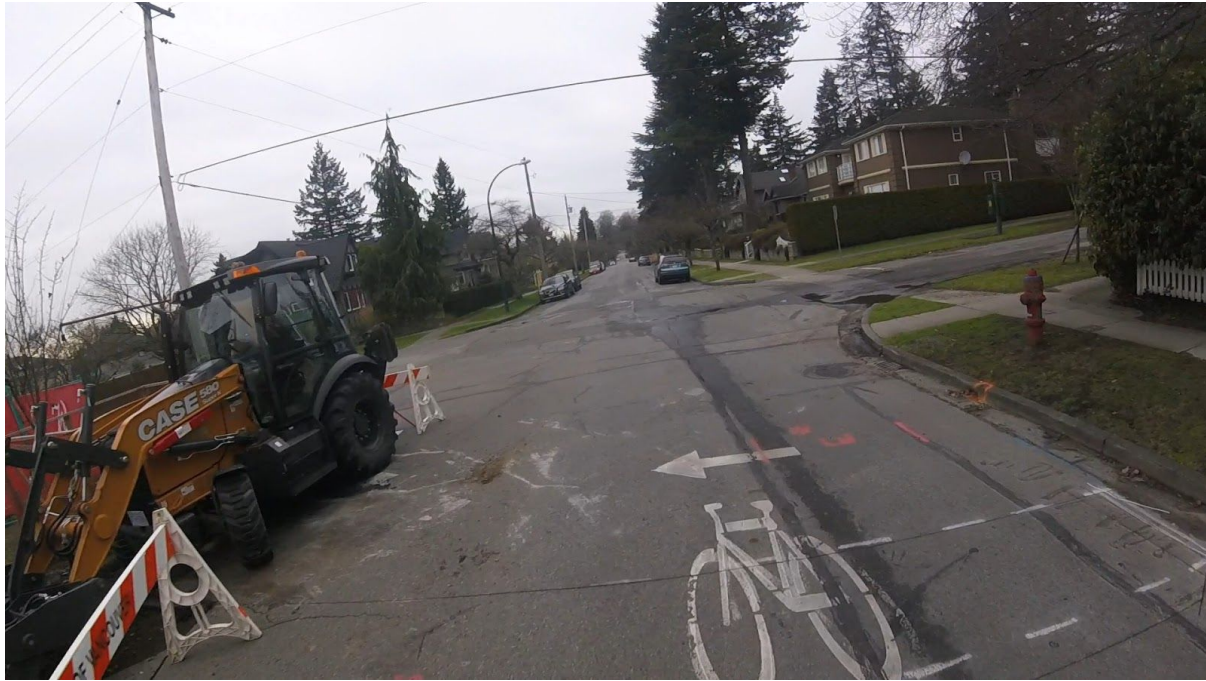
Figure 45 - 37th Westbound at Collingwood

At Collingwood the Midtown Bikeway heads south towards 39th (figure 45) The pavement is rough at this intersection.
