HUB Cycling Accessibility Assessment Ride

May 10, 2023

təmtəxw̓tən/Belcarra Regional Park and Village of Belcarra

The purpose of the ride was to assess cycling accessibility for varied types of people cycling in the park and through the village.

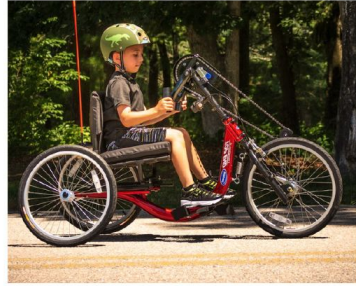
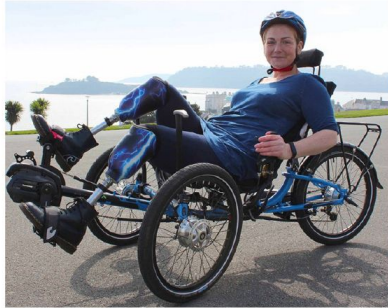
**They need a straight entry
as they do not turn easily
and a gap 2" wider than the wheel span.
These range from 33" to 36" or more.**

**The current gap restricts the use of the trail, is an
accessibility issue and needs to be rectified to
provide access for users of all ages and abilities.**

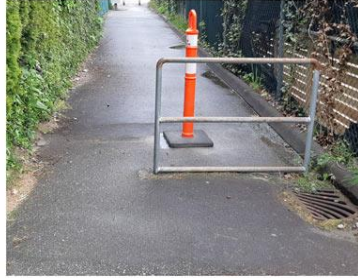
BEFORE

- Maze gates are being removed in Coquitlam, Surrey, North Van and other communities

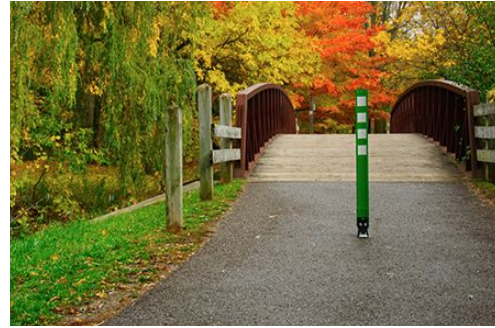
AFTER

- Rigid bollards are being replaced with flexible delineator posts

- We suggest Metro Vancouver Parks consider removing one or both sides of the maze gates and where needed, consider flexible delineators or signage.

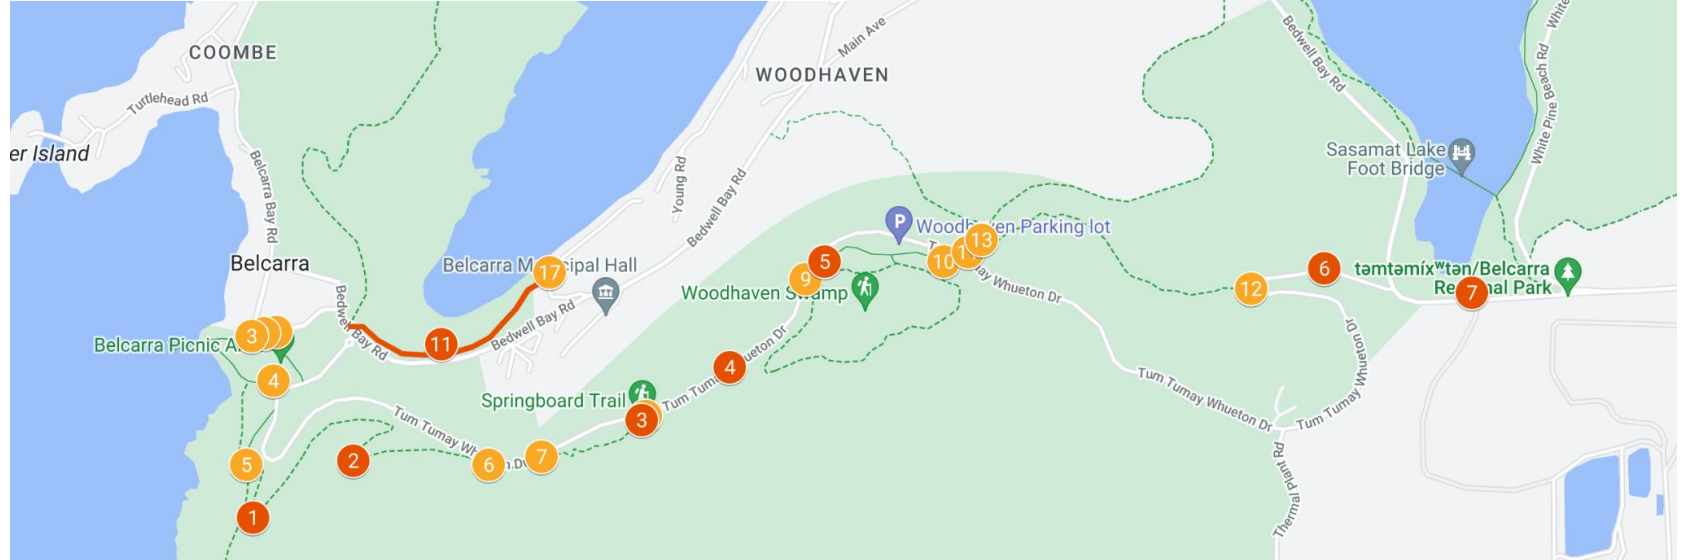
Map of Assessment route showing gate locations and problem areas

Orange dot = problem
Yellow dot = gate

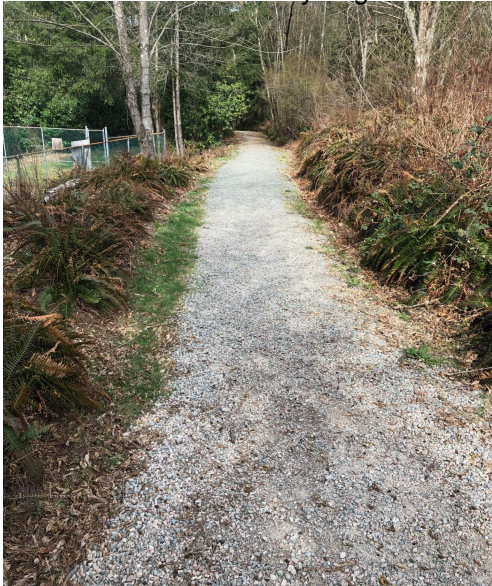
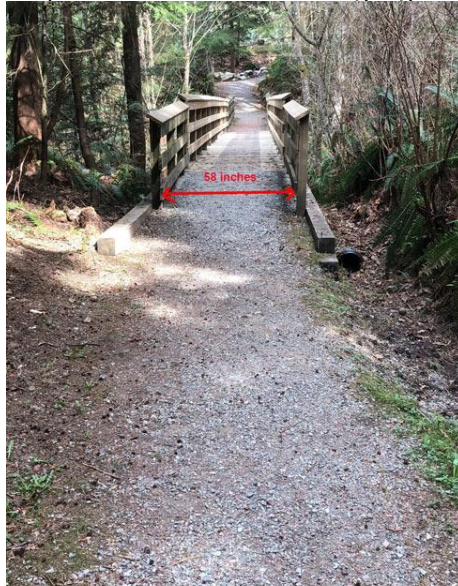
- All riders found this an easy trail as it is relatively flat, has a good crushed rock surface and a good width. The Ray Creek bridge measures 58" between the side boards. It is noted that this trail is equally as wide as many sections of the Springboard Trail.

All riders felt that this trail offers a safe accessible link, allows riders to avoid the busy, narrow and hilly Bedwell Bay Road and has less elevation gain than Springboard Trail.

Note: Bridge gap 58" wide

Recommendation: Allow cycling on Bedwell Bay Trail and add dual-use signage.

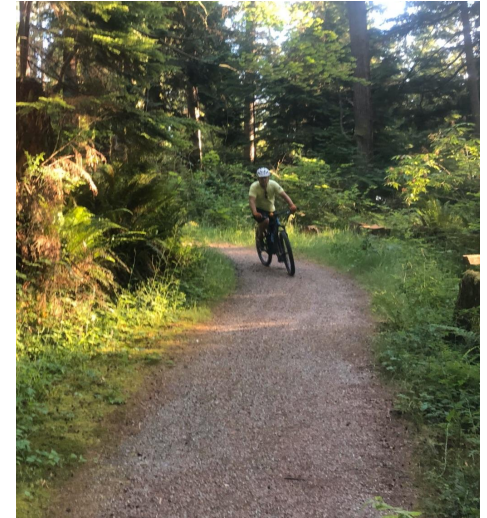
Many sections of the Springboard Trail are same width as Bedwell Bay Trail
