# Seaside Greenway South Assessment Ride 1

HUB Vancouver UBC Local Committee - *Seaside South Working Group*  
24 June 2015

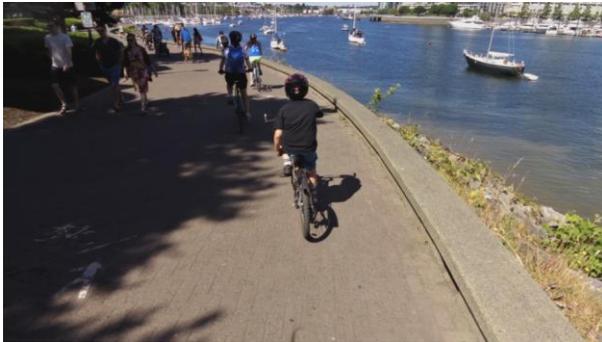
Figure 9

This segment of the Seaside Greenway is a wide multi-use path without any direction or mode separation. Although both pedestrian and cycling volumes are high along this segment, the width of the path reduces the conflicts somewhat. The path contains many curves, however, and this causes a number of problems including restricted sight-lines for people on bikes, and meandering of both cyclists and pedestrians.

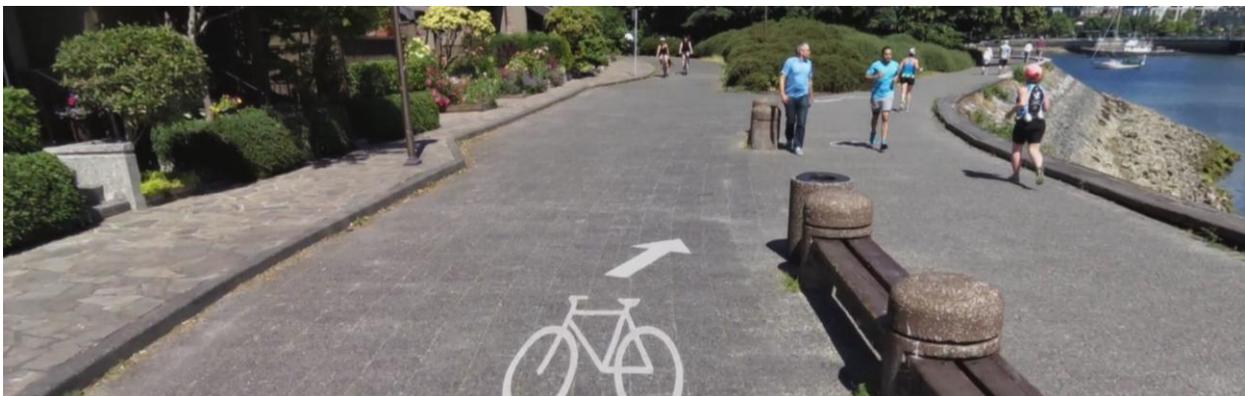
Figure 17

The most serious issue in this section is the flagstones. The flagstones are uneven, bumpy, slippery (particularly in wet and winter conditions), and in a poor state of repair. The flagstones cause problems for bikes with small wheels, both road bikes with narrow tires, and children's bikes with small diameter wheels and training wheels.

At the western end of this segment, people on bikes are poorly directed into the same space as pedestrians, through the bollards. Alternate routes seem available (up Greenchain Road, for example) but the lack of wayfinding signs means that few people on bikes use these alternates.

Bikes such as cargo bikes, tandem bikes, and bikes with tag-alongs or trailers have difficulty navigating through the bollards safely, due to the length of the bike and the bollard spacing.

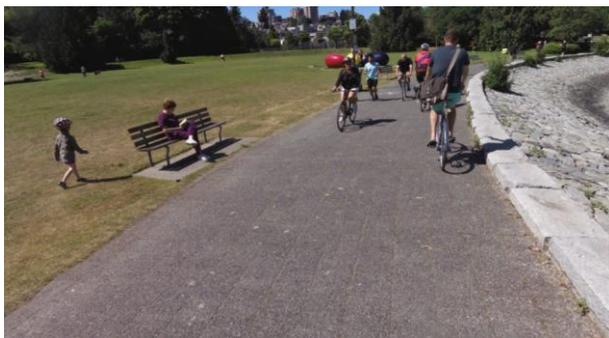
Figure 18

The segment of the Seawall Greenway along the north edge of Charleson Park is characterized by a narrow multi-use path consisting of a stone-brick surface, vegetation encroaching on one side (often by more than a foot or two), and off-leash dogs. There are no markings indicating direction or mode-separation, so confusion exists on where people should be. A large portion of the park is an off-leash dog park, and there is no separation of the main off-leash field from the two paths circling the park, often causing conflicts between people on bikes, dogs, and dog owners.

The path twists and turns its way around the park, and the combination of vegetation, the width of the path, and the sharpness of the turns creates considerable sight-line issues. It often occurs that a person on a bike comes around a corner only to unexpectedly discover several pedestrians stretched across the path. This is neither comfortable or safe for the cyclist or pedestrians.

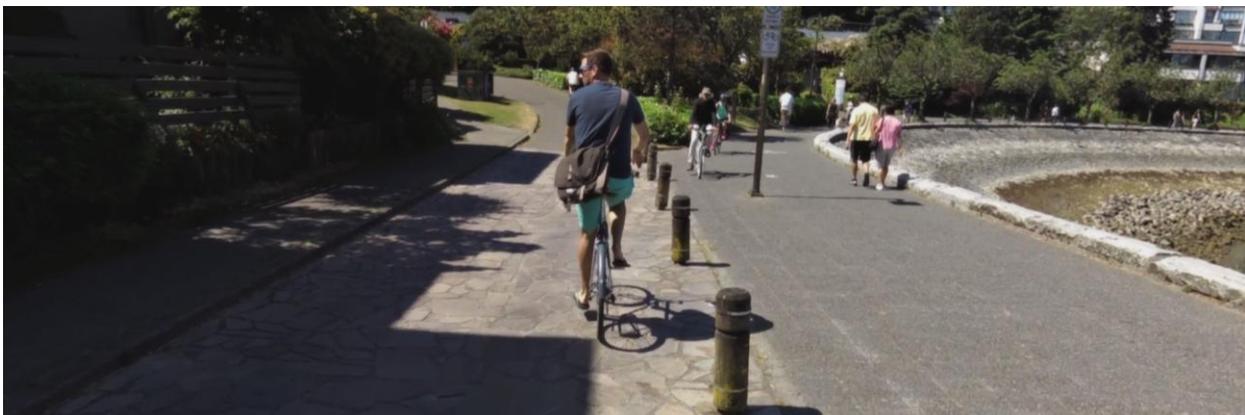
Figure 21

Further along the segment, the same flagstone treatment that was used near Stamp’s Landing is used once again bringing with it the same problems. Additionally, similar wooden bollards are used to provide modal-separation but at the western end of the path (which is called The Castings by this point) people on bikes and other path users are forced to share a very narrow path. To make things worse, people on bikes must navigate closely-spaced bollards to merge on to the path, and must deal with oncoming cycling and pedestrian traffic at the same time.

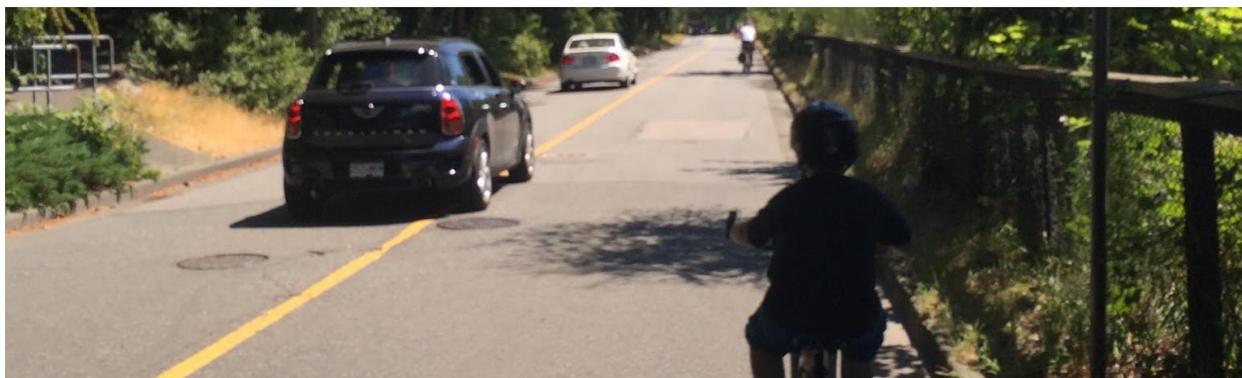
Figure 31

Along the whole of Charleson Road, motor vehicle traffic moves quickly. There are no sidewalks along the road, nor is there any bike lane. The narrowness of the road, high speed of the vehicles, and potential conflicts with pedestrians make this stretch uncomfortable for many people on bikes.
