RE: Cycling Infrastructure Deficiencies at Murray Creek Ravine on 40 Avenue

Observed infrastructure deficiencies

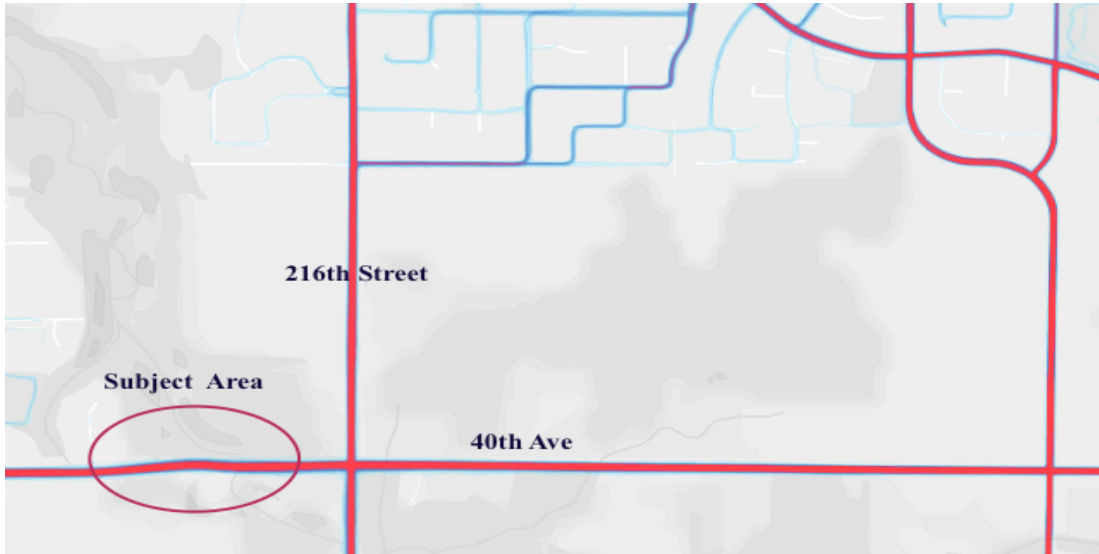
The safety of people who walk (pedestrians) and people who ride (cyclists) is put at risk when they attempt to negotiate their way along a dangerous section of 40 Avenue between 216 Street and 212 Street. 40 Avenue is a busy east-west corridor for passenger vehicles, dump trucks and commercial vehicles. A heat map feature on the STRAVA app, which is used by many recreational and commuter cyclists, shows that 40 Avenue is also a major east-west cycle route in the Township between Brookwood and the Fraser Highway. The nearest alternative east-west connectors for cyclists would be 16 Avenue or 48 Avenue. These routes would be major detours for cyclists.

Figure 1.1 The subject area is on 40 Avenue just east of 216 Street.

Improvements can be made long before major road upgrades at Murray Creek ravine are undertaken. HUB Cycling Langley strongly recommends the removal of the graded sidewalk and the creation of an at road level multi-user path on the north and south side of the highway. Elimination of the 1.35 meter raised sidewalk creates a 1.75 meter wide path from the edge of the fog line. An asphalt curb should be added to the outside of the fog line so that motor vehicles cannot stray onto the MUP. The south sidewalk comes to an end a short distance east of the chain link fence by a driveway entrance. Beyond this point the eastbound sidewalk is at road level with a 163 cm wide shoulder until the intersection at 216 Street. This portion of the shoulder has sufficient room for pedestrians/cyclists and would only require the addition of a protective asphalt curb.

In the interim, an action that can immediately improve safety for users is to designate this section of 40 Avenue as a shared roadway. This can be done by adding sharrows and "May Use Full Lane" signage (Fig 1.9). Additionally, a speed reduction to 50 km/h will advise motorists to expect cyclists in their travel lane. A speed reader board should also be installed for east and westbound motorists. It should be noted that TAC standards state the minimum distance to the edge of a traffic lane for a specific speed of 60 km/h is 50 cm. The distances on 40 Avenue do not meet this standard. Measurements reveal a maximum variance of 28 cm between the curb and the edge of the white line.
